# Seawater Pump Station PHE Biofouling Treatment Hong Kong

HydroFLOW® reduced macrofouling and biofilm in PHE02, leaving its seawater channel substantially clearer and maintaining higher flow than untreated PHE01.

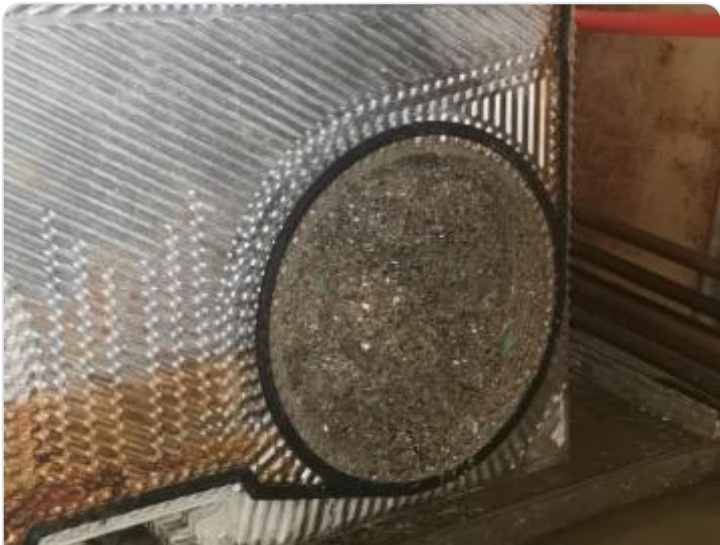
BEFORE

- Water channel blocked up to 3 ft
- Thick biofilm covered plate surfaces
- Macro-fouling restricted the water channel

PHE01: water channel blocked up to 3 ft

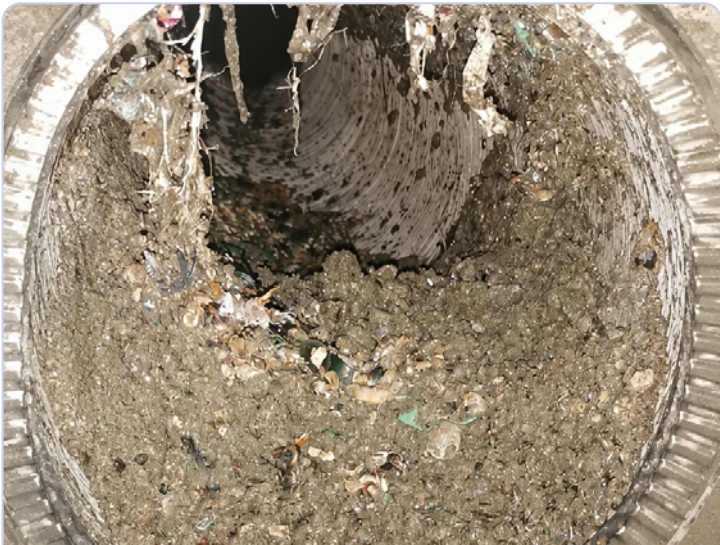
AFTER

- ✓ Water channel not seriously blocked
- ✓ Biofilm was much thinner
- ✓ Higher seawater flow was maintained

PHE02: water channel largely unblocked

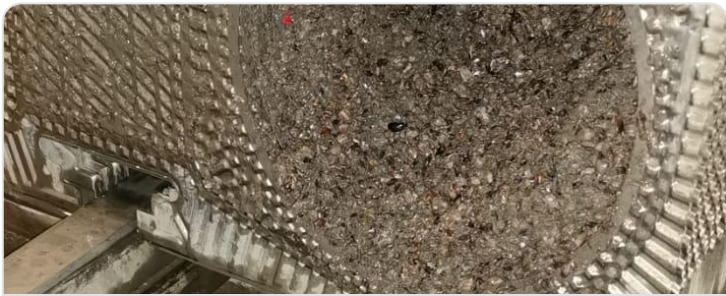
**INSPECTION**

*PHE01(untreated) inspection showed heavy fouling on 14/11/22*

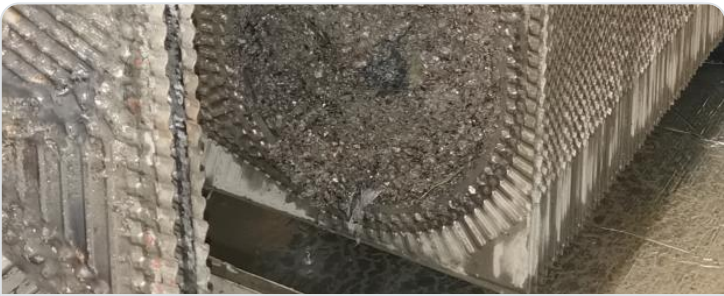
**INSPECTION**

*PHE02(treated) inspection showed similar fouling on 16/11/22*

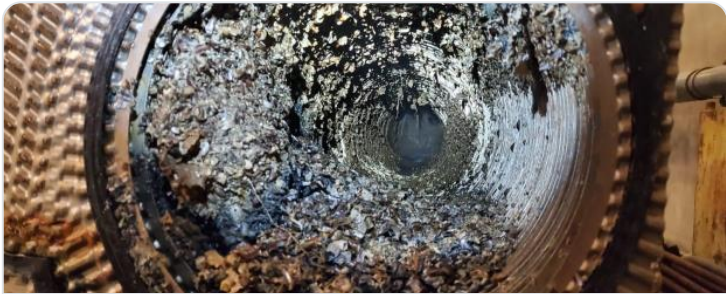
**INSPECTION**

*PHE01 (untreated) showed heavy fouling on 2/05/23*

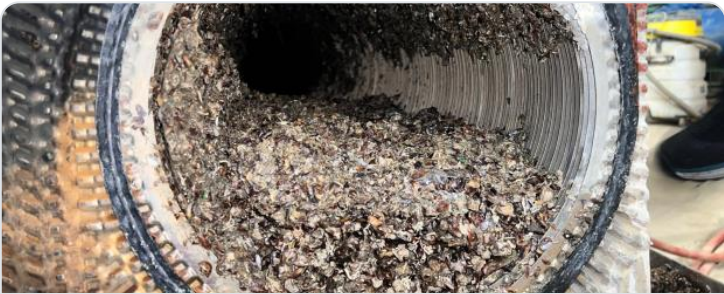
**INSPECTION**

*PHE02 (treated) held more detached shells than PHE01*

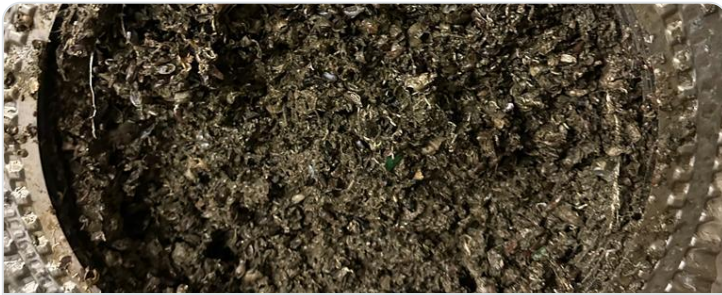
#### INSPECTION

PHE01 (untreated) Water channel blocked to 2 ft on 29/06/23

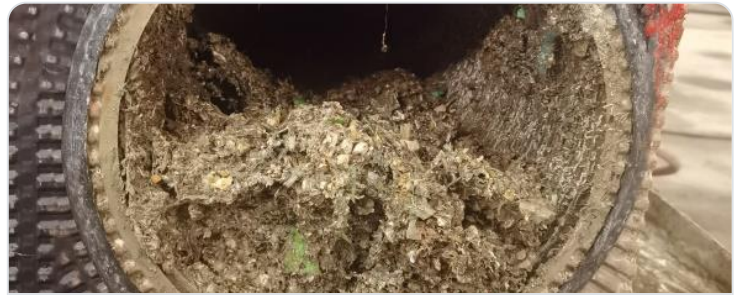
#### INSPECTION

PHE02 (treated) Water channel largely unblocked on 03/07/23

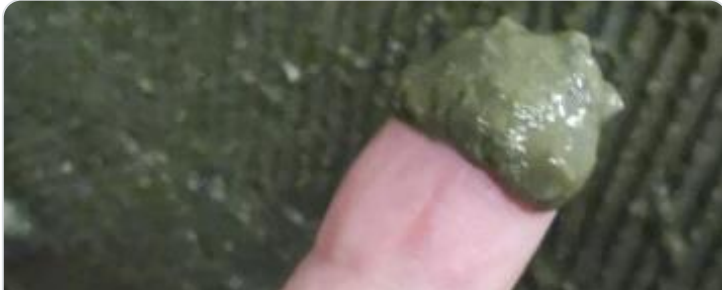
#### INSPECTION

PHE01 (untreated) showed Thick biofilm build-up on 05/09/23

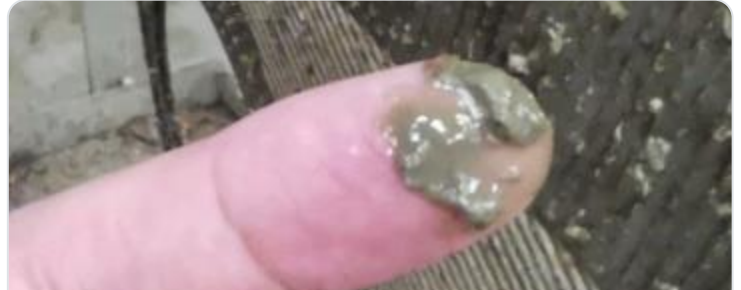
#### INSPECTION

PHE02 (treated) showed thinner biofilm on 30/08/23
