Case Study

Massive Texas Factory-USA

HydroFLOW® reduced chemical usage across a major Texas factory, delaying multimillion-dollar wastewater treatment plant upgrade, cutting operational costs, and improving heat transfer efficiency.

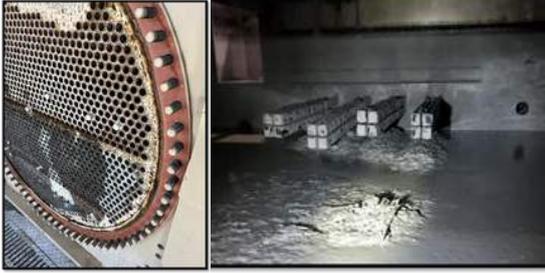
Before HydroFLOW®

Severe scale accumulation in the chiller heat exchanger and mineral deposits in the sheet metal washer led to reduced thermal efficiency, frequent cleanouts, and increased water and chemical use across the facility.

Cooling towers required high chemical use and frequent cleanouts, with scale in chiller tubes and washer systems.

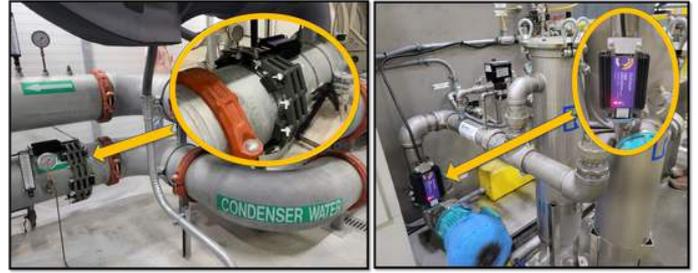
HydroFLOW® Installation

HydroFLOW i14" on chiller return (left) and HydroFLOW i100 on sheet metal washer (right)

- A HydroFLOW® i14" Custom unit was installed on the chiller return line
- An i100 unit was installed on the sheet metal washer recirculation line
