# Fish Pond Water Clarity Case Study Garstedt, Germany

HydroFLOW® improved pond water clarity, increasing visibility to full depth within one week and enabling algae to flocculate and be captured in the filtration system.

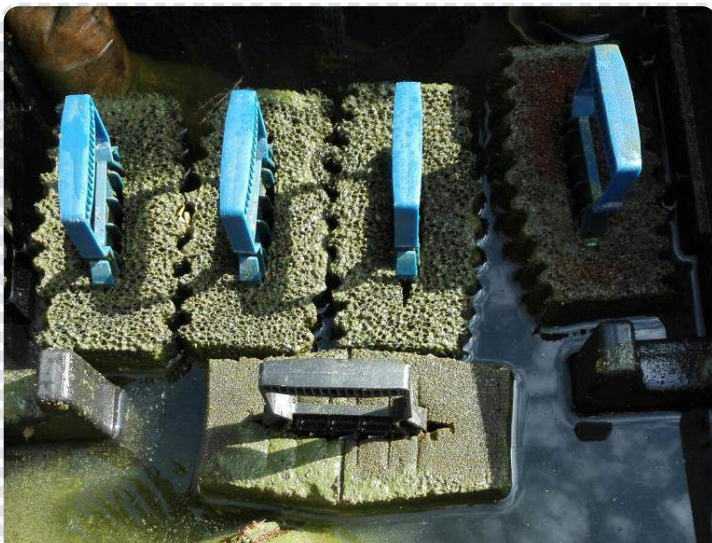
**BEFORE**

Filter units clogged with algae

- Limited visibility of around 80 cm
- Pond bottom not visible due to algae
- Filter units becoming clogged
- Sediment stirred by fish activity

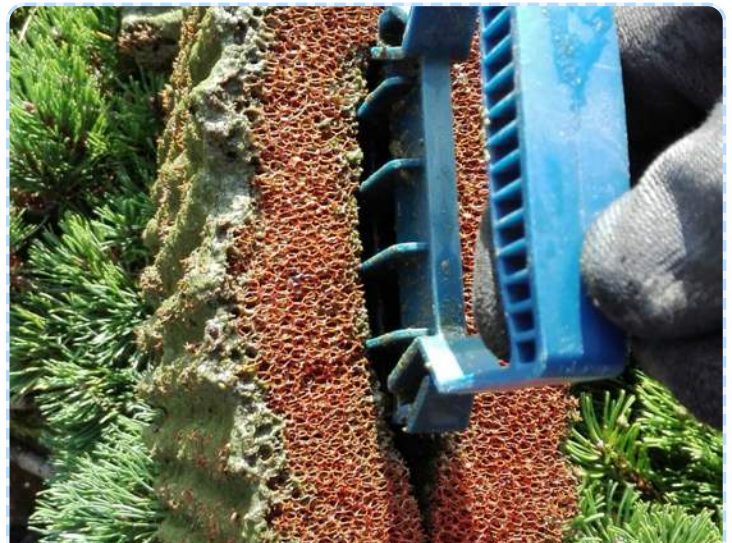
**AFTER**

Algae flocculated and captured on filter

Algae formed larger particles that were more easily captured by the filtration system.

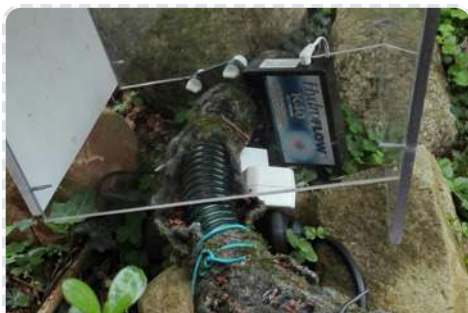
### INSTALLATION

*K40 installed on suction line before filter*

A *HydroFLOW*® K40 unit was installed on the suction line before the filtration system to treat the circulating water. Performance was monitored to assess changes in water clarity

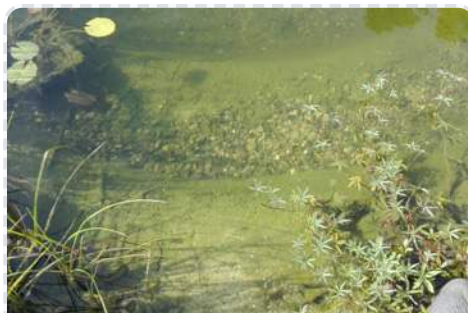
### SITE

*Visibility >160cm with pond bottom clearly visible*

Clarity improved from 80 cm to full pond depth (160 cm), bottom clearly visible

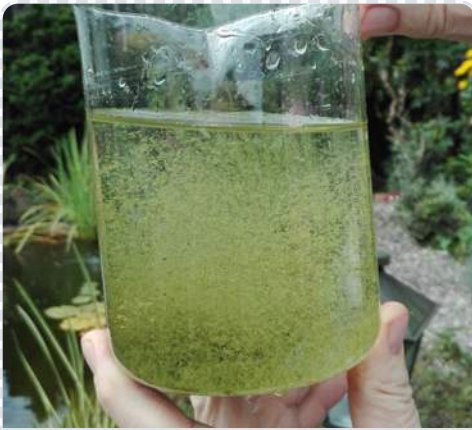
**BEFORE**

Algae and solids suspended in water

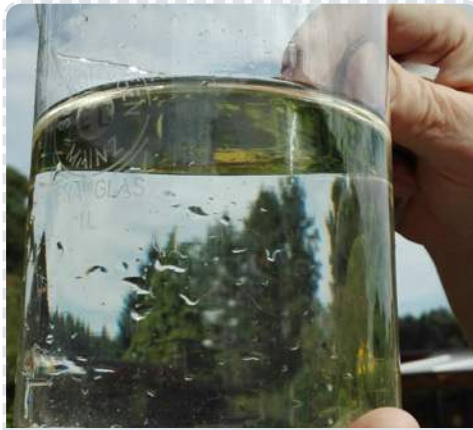
**AFTER**

Clearer water after filtration

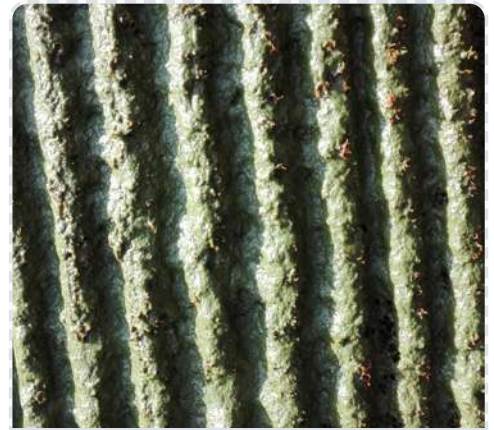
**RESULTS**

Flocculated algae captured on filter surface

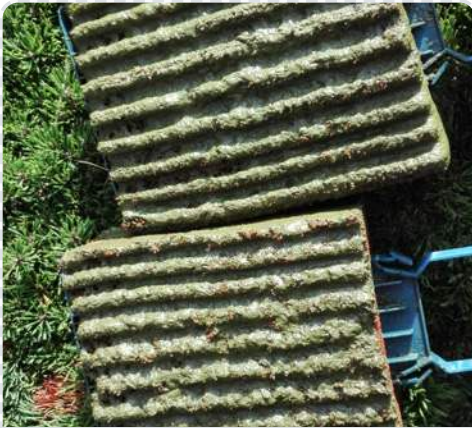
**RESULTS**

Filter units loaded with flocculated algae

Algae and suspended solids were captured in the filters, increasing filter loading.
