● COMMERCIAL HEATING/COOLING

Heat Exchanger Scale & Corrosion Case Study Haifa, Israel

A *HydroFLOW*® C120 unit treated scale in a heat exchanger, improving heat transfer, reducing pressure drop, and stabilising calcium levels without chemicals.

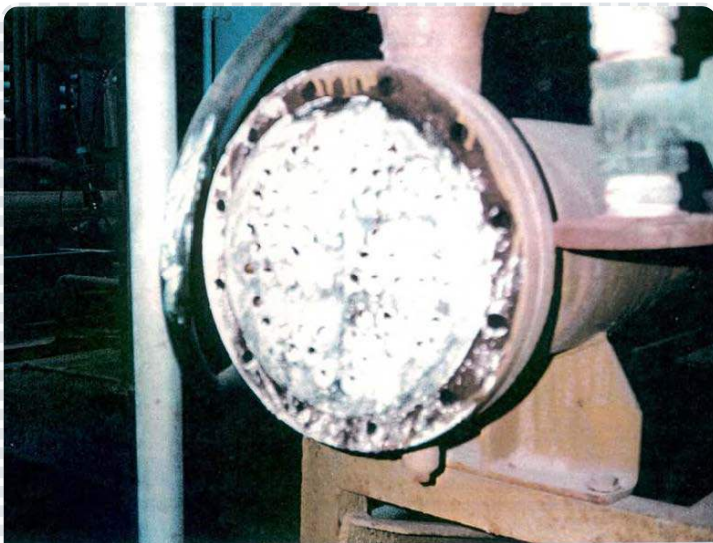
BEFORE

Heat exchanger tubes blocked by scale

- ✗ Severe scale blocking heat exchanger tubes
- ✗ High pressure drop across heat exchanger
- ✗ Ongoing chemical treatment required

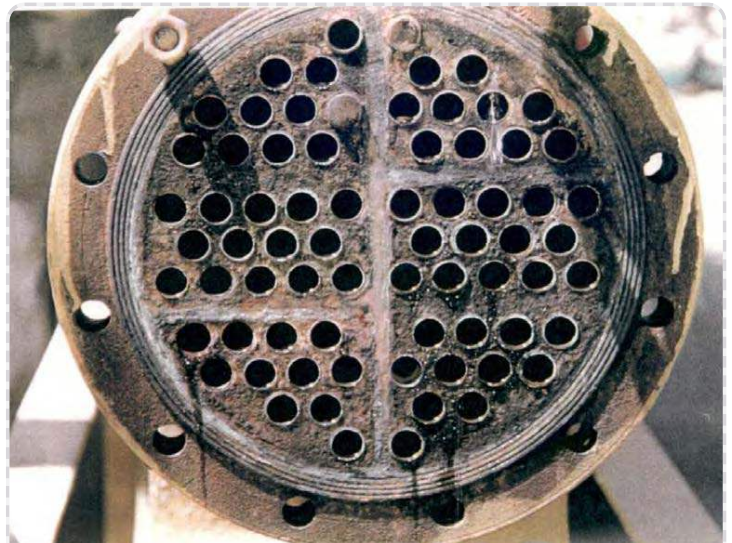
AFTER

Heat exchanger tubes clean

- ✓ Heat exchanger tubes observed clean after inspection
- ✓ Pressure drop reduced during operation
- ✓ Stable operation with reduced chemical reliance

Heat exchanger tubes and lids observed clean after inspection

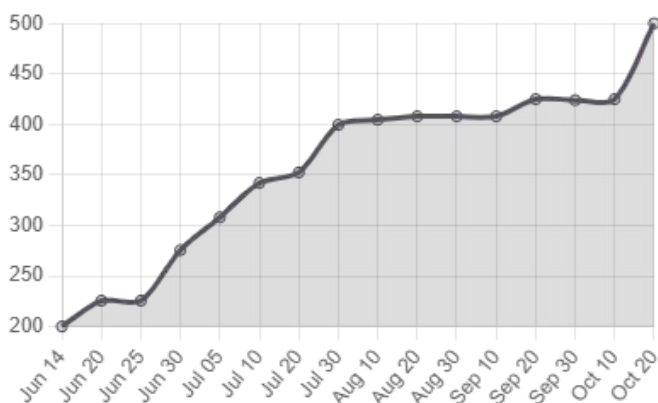
Heat Transfer Over Time

Heat transfer increased gradually from 200 to 500 kcal per hour

Heat transfer increased from 200 to 500 kcal per hour during the trial

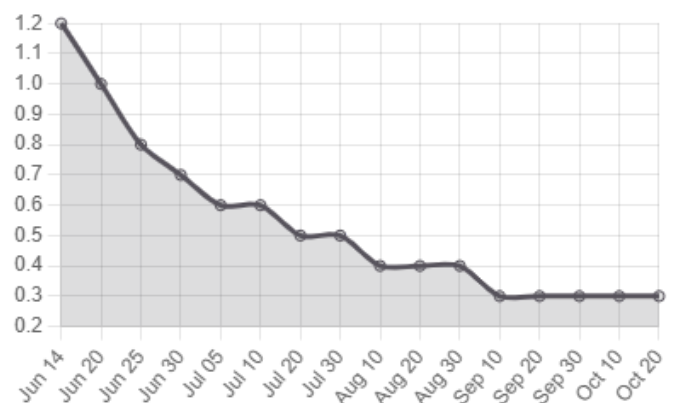
Pressure Drop Over Time

Pressure drop decreased from 1.2 ATS to 0.3 ATS over time

Pressure drop decreased from 1.2 to 0.3 ATS, improving flow conditions.

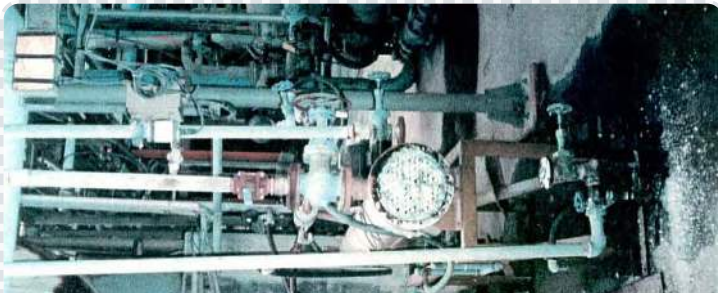
BEFORE

Heat exchanger with heavy scale before treatment

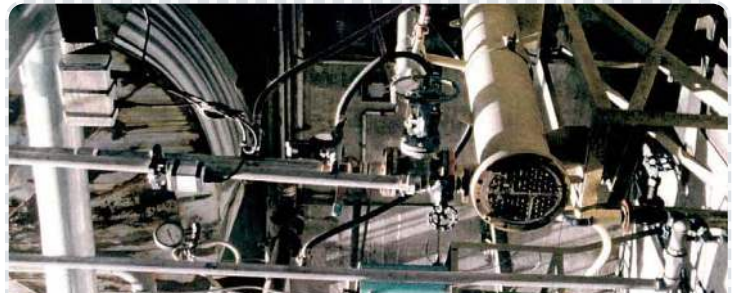
AFTER

Heat exchanger surfaces clean after inspection
