Seawater Heat Exchanger Case Study Cape Town, South Africa

Hydropath treatment reduced marine growth in a seawater line feeding Heat Exchanger 4, cutting maintenance, improving flow and reducing downtime during a 6-month trial.

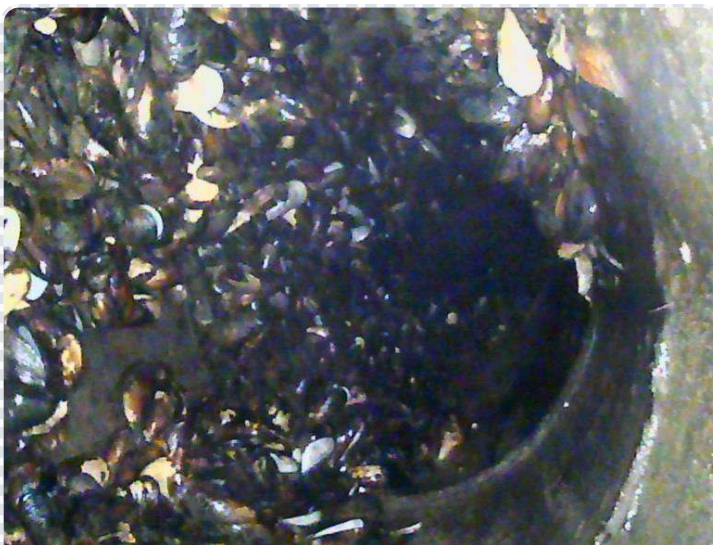
BEFORE

- ✗ Barnacles and mussels narrowed pipe bore
- ✗ Strainers blocked and downtime increased
- ✗ Periodic jetting needed to clear lines

Line before trial started

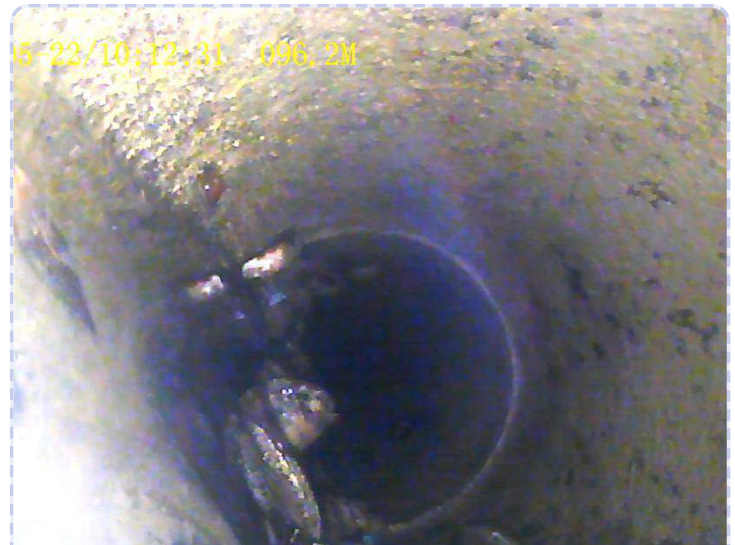
AFTER

- ✓ Large biofoul discharge after two weeks
- ✓ No new sea life formed in treated line
- ✓ Higher flow improved exchanger efficiency

Line condition after six months

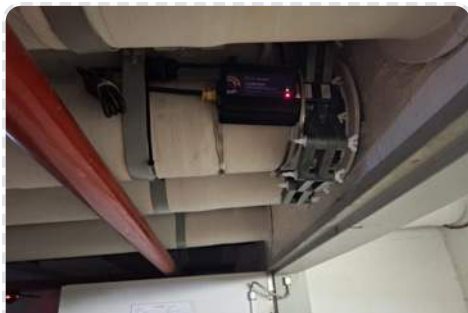
INSTALLATION

1 Custom on 200mm line

1x *HydroFLOW*® i Custom unit was installed in November 2023 on one of two 200mm pipelines feeding Heat Exchanger 4, between the heat exchanger and the seawater pump and filter packs.

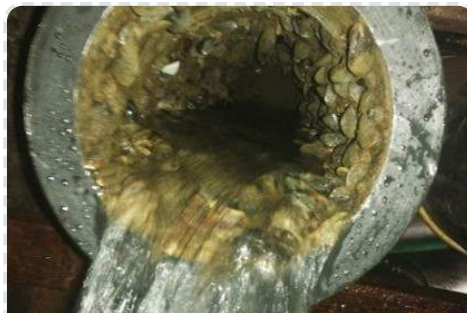
SITE

Biofouling before trial

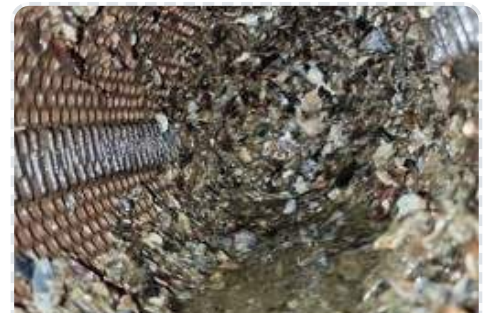
SITE

Mussels at intake filter

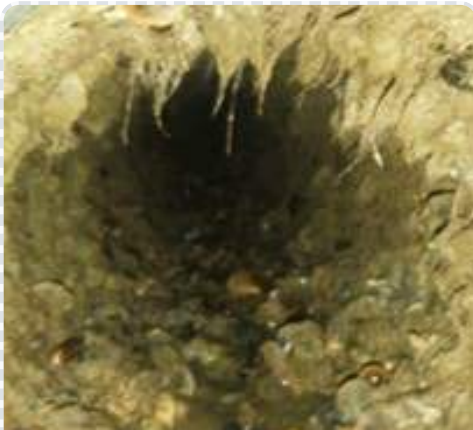
BEFORE

Heavy biofouling inside seawater intake pipe

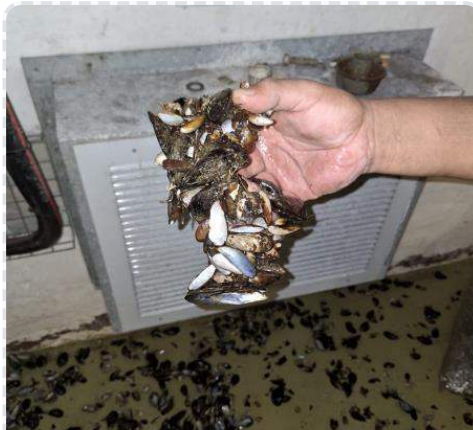
AFTER

Mussels discharged and collected at intake filter

Large amounts of sea life and mussel chunks were discharged after two weeks.

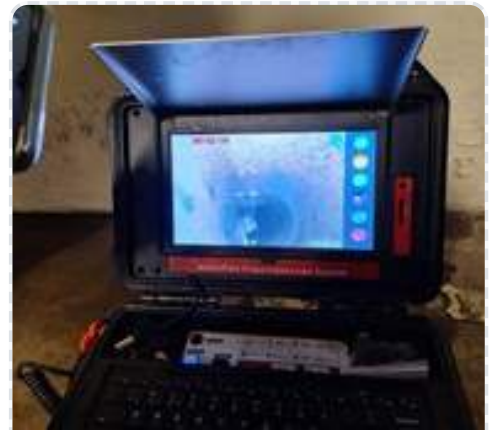
MONITORING

Camera inspection of internal pipe condition
