Raw Milk Piping System Case Study **Aguadulce, Panama**

HydroFLOW® S38 reduced chemical use and cleaning requirements in a raw milk piping system, improving efficiency and lowering operating costs.

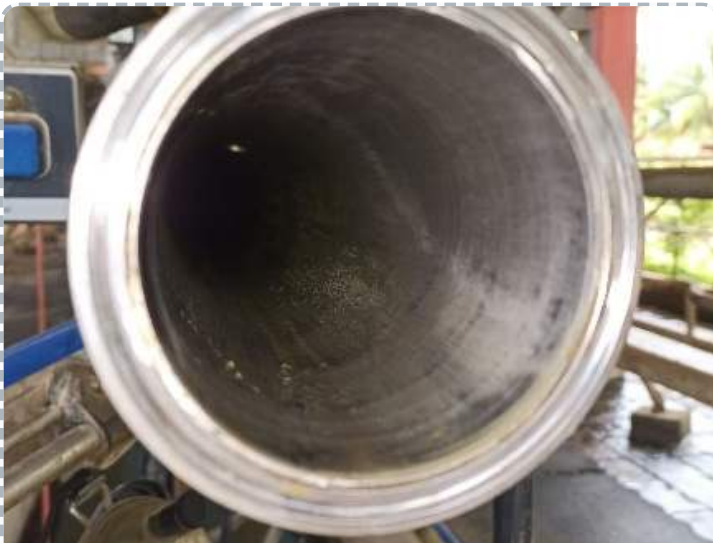
BEFORE

Pipe interior with milk scale buildup

- High consumption of milk scale remover
- Heavy use of alkaline cleaner daily
- Extraordinary cleaning every 21 days
- Hygiene risk from inconsistent residue removal

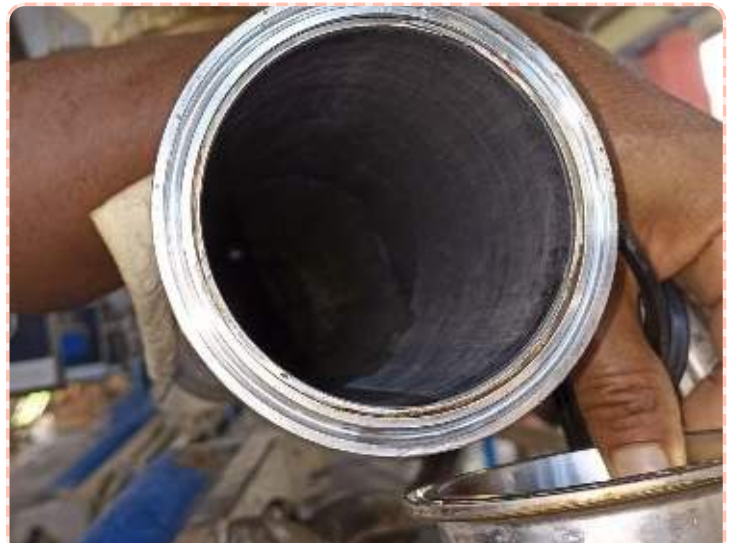
AFTER

Pipe interior remained clean

System inspections confirmed clean pipe after 30 days and during continued operations

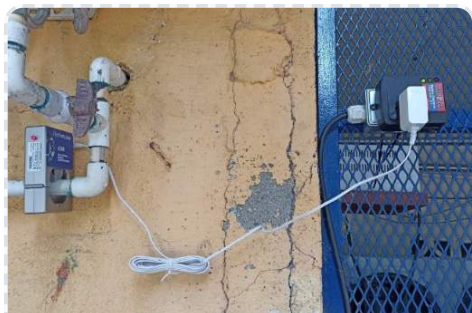
INSTALLATION

S38 on heater inlet

Unit installed at the cold water inlet of the electric water heaters serving the raw milk piping cleaning system. Performance was monitored over an extended period, including long-term verification

Cold water inlet of electric water heaters

1/2" CPVC pipe

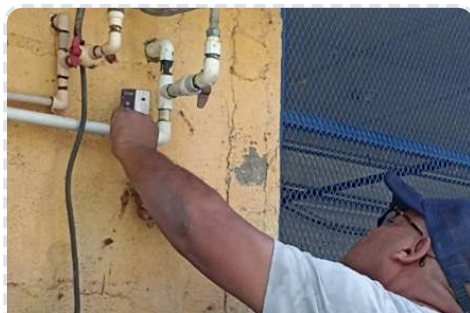
INSTALLATION

Cold water inlet install

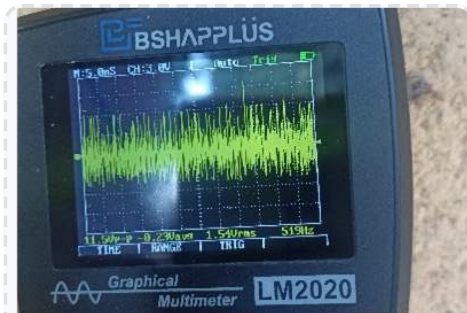
MONITORING

Signal monitoring active

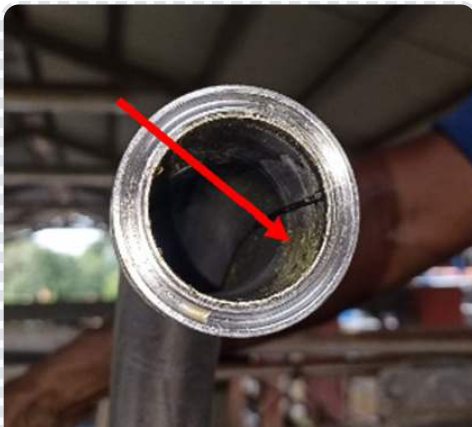
**BEFORE***Pipe condition prior to treatment*

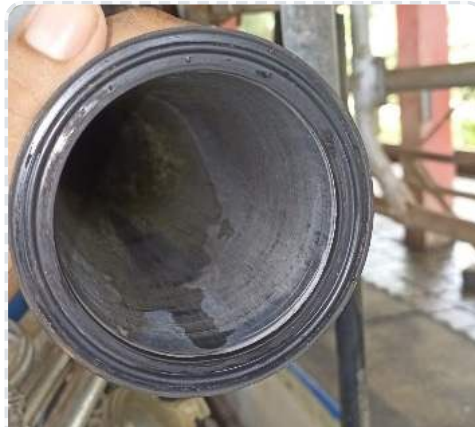
**AFTER***Sept 23, 2022: Pipe remained clean during use*

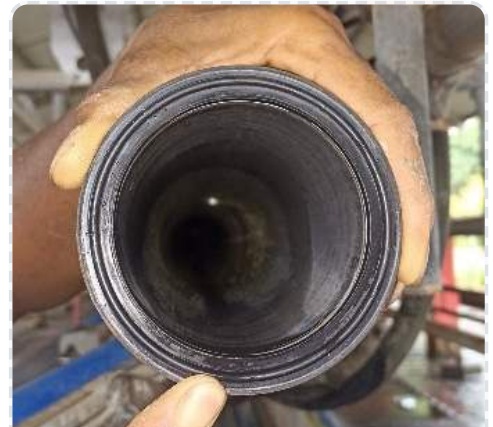
**RESULTS***Sept 30, 2022: Clean after over a month without cleaning*

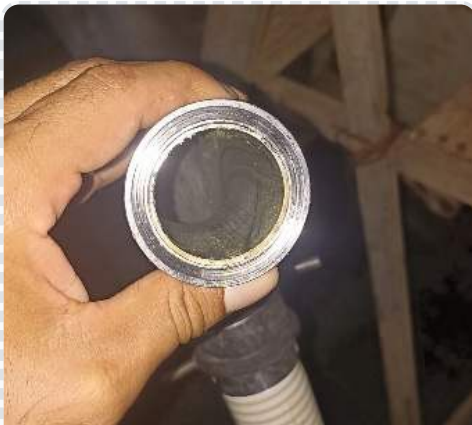
**RESULTS***Oct 19, 2022: Continued effective pipe cleaning*

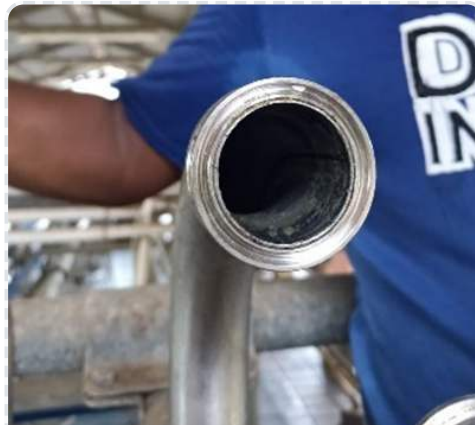
**RESULTS***Oct 28, 2022: Pipe clean at inspected points***HYDROPATH** **Ready to reduce chemical use in dairy cleaning?**
