Fresh Water Generator Case Study Car Carrier

HydroFLOW® installed on vessel's fresh water generator seawater feed. After 9 months, no slime or mud found, only light removable scale, and cleaning completed in 2 to 3 hrs without chemicals.

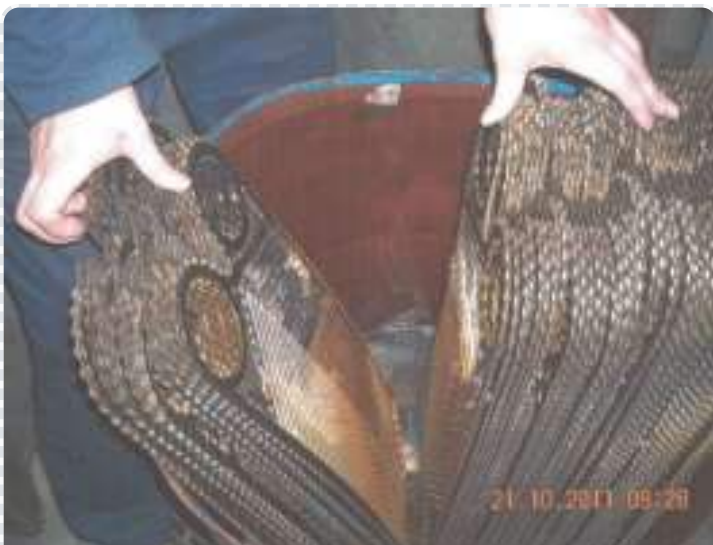
BEFORE

- ✗ Scale required chemical soaking
- ✗ Cleaning could take up to 24 hours
- ✗ FWG cleaned shortly before trial start

FWG before, October 2011

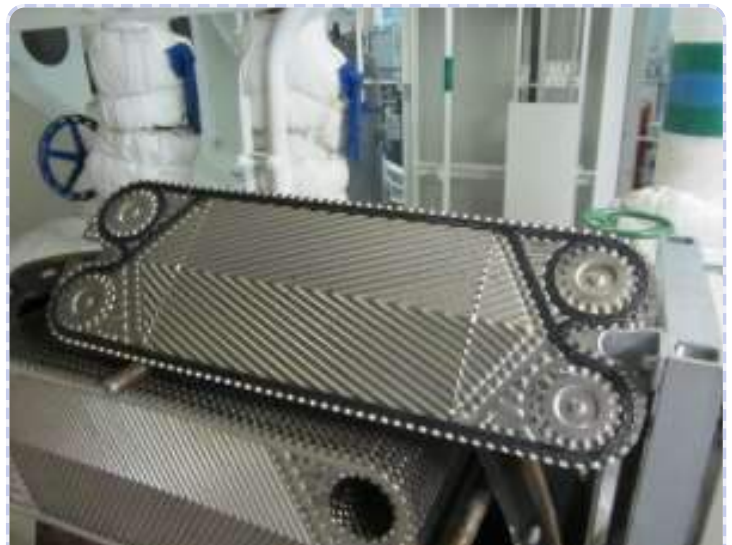
AFTER

- ✓ No slime or mud at inspection
- ✓ Light scale removed by hand
- ✓ Cleaning finished in 2 to 3 hours

FWG after, August 2012

Inspection found no traces of slime or mud on the FWG plates.

Some internal scale remained but was easily removed by hand.

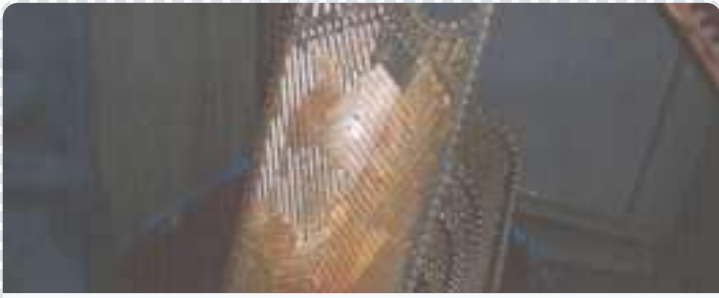
BEFORE

Heavy scale on FWG plates before treatment

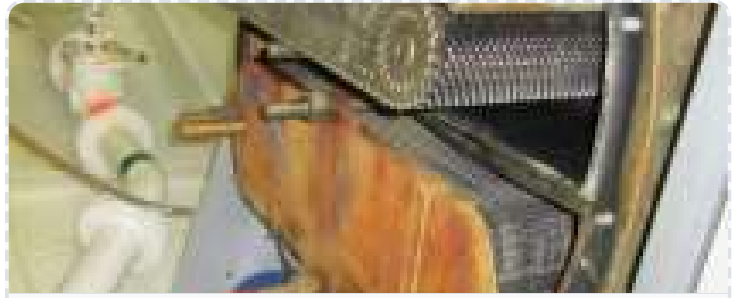
AFTER

Clean FWG plates with light removable deposits
