• MARINE

Main Cooling System Case Study Car Carrier

HydroFLOW® installed on Main Cooling System prevented barnacles and salt accumulation with only a thin, easily removable slime layer observed at inspection.

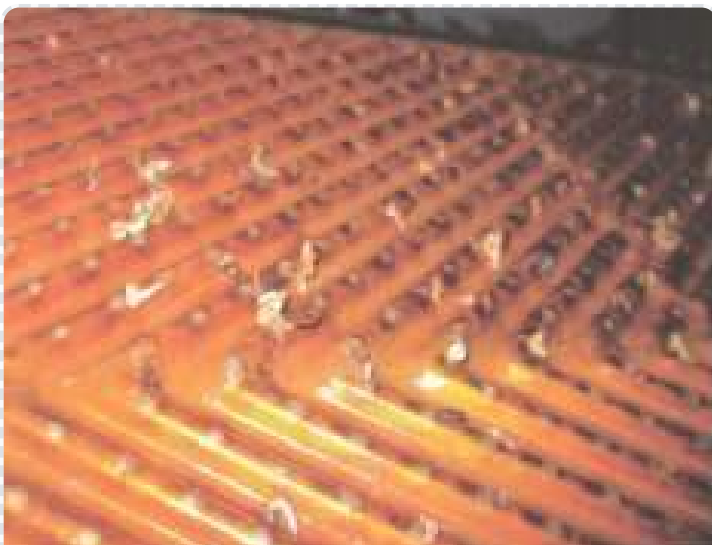
BEFORE

- ✗ Large amount of barnacles on plates
- ✗ Water flow reduction affected cooling
- ✗ Filter needed manual scrubbing

Cooling system before July 2011

Hydropath Marine Custom 12" unit was installed on the sea water feeding pipe of Main Cooling System #2. When the system was opened in July 2011, the plates contained a large amount of barnacles, causing water flow reduction that affected cooling efficiency. When opened again in August 2012, the plates were clean of scale and barnacles, with only a thin slime layer that was easily washed away.

Barnacle build up on the cooling plates was reducing water flow and affecting cooling efficiency.

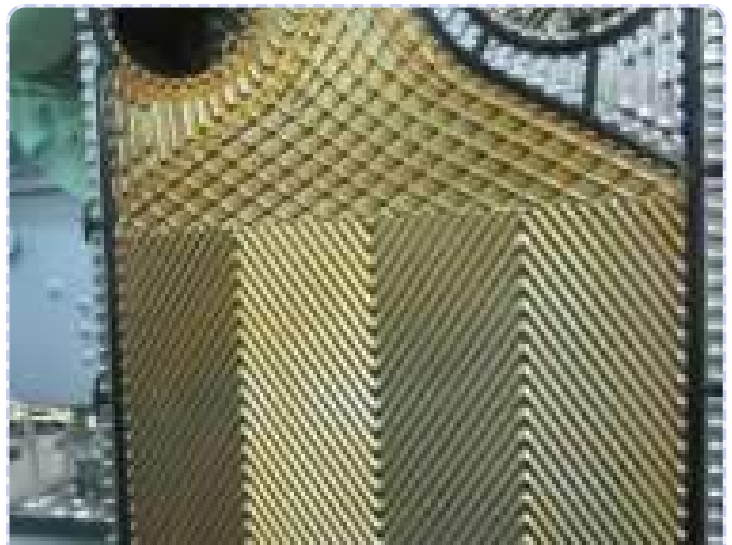
AFTER

- ✓ No barnacles on plates
- ✓ Thin slime layer washed away easily
- ✓ Filter cleaned without manual scrubbing

Cooling system after Aug 2012

In August 2012 the plates were found clean of barnacles.

A thin slime layer covered the plates and was easily washed away.

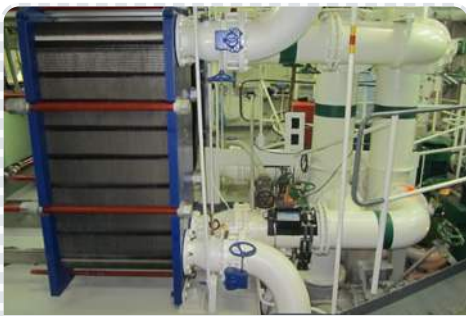
INSTALLATION

On Sea water feeding pipe

Hydropath Marine Custom 12" unit was installed on the sea water feeding pipe of Main Cooling System #2 to control and reduce barnacle and biofouling on the cooling plates.

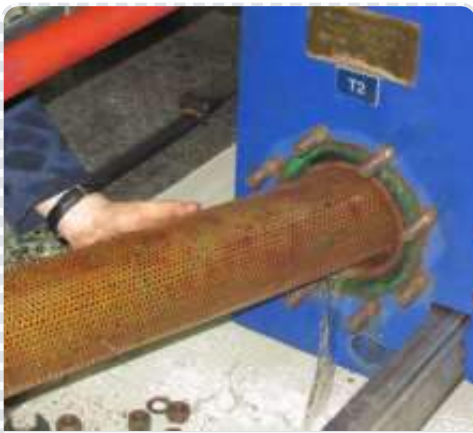
**AFTER***Filter free of barnacles after inspection*

The particles filter was clean of barnacles and easy to wash.

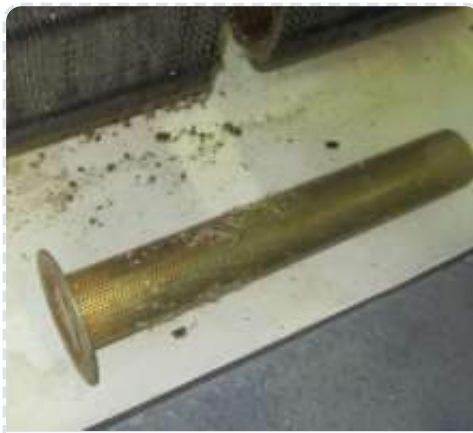
**AFTER***Clean particles filter after treatment*
