# Freshwater Generator Case Study: MV Detroit Express Hong Kong

Onboard MV Detroit Express, *HydroFLOW*® treatment reduced fresh water generator cleaning frequency, eliminated chemical use, and left only soft scale that was easily removed.

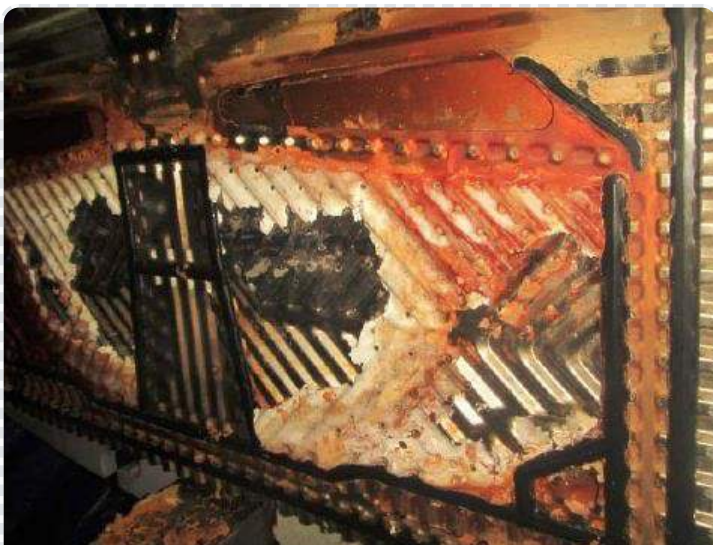
BEFORE

FWG before cleaning

The freshwater generator needed frequent CIP cleaning and opening for manual cleaning, with chemical dosing and cleaning also required.

- CIP cleaning was needed every 10 to 12 days.
- FWG opened monthly for cleaning.
- Scale, bacteria, algae and slime caused fouling.
- Chemicals used for dosing and plate cleaning.

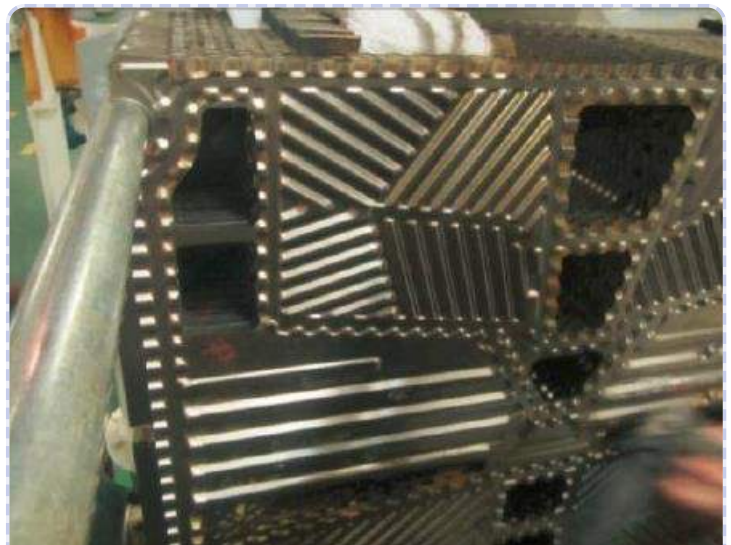
AFTER

FWG plates after cleaning

Soft deposits were easily removed without chemicals.

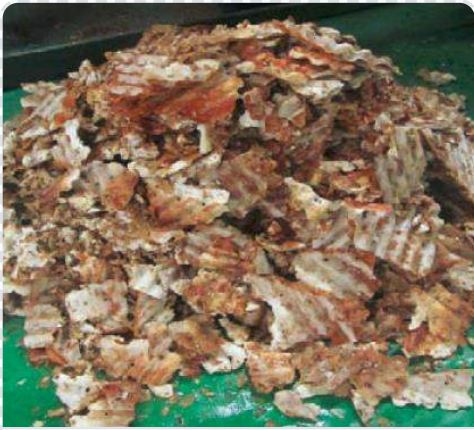
### RESULTS

Removed soft scale without chemicals

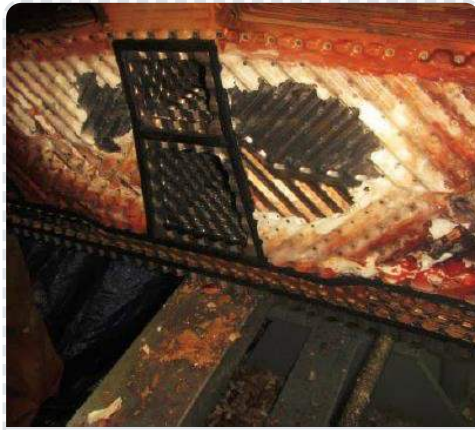
### BEFORE

Heavy fouling on FWG plates before cleaning

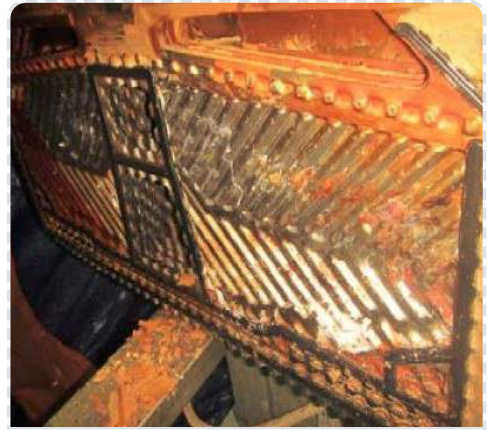
### BEFORE

Severe scale and deposits on plates before cleaning

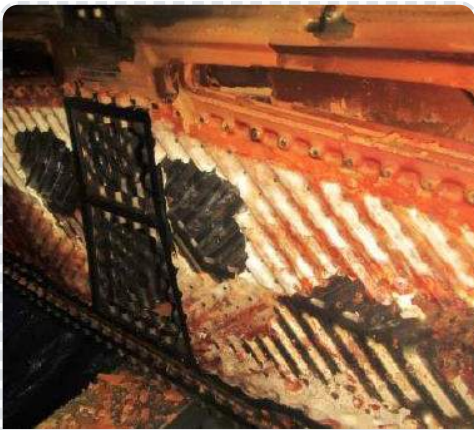
### BEFORE

FWG plates covered with scale and marine deposits

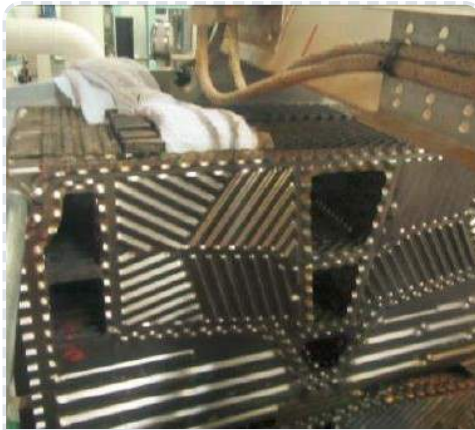
### AFTER

Clean heat exchanger plates after treatment

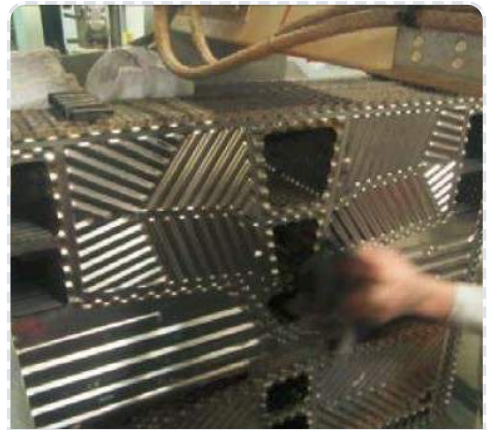
### AFTER

Soft scale easily removed by hand without chemicals

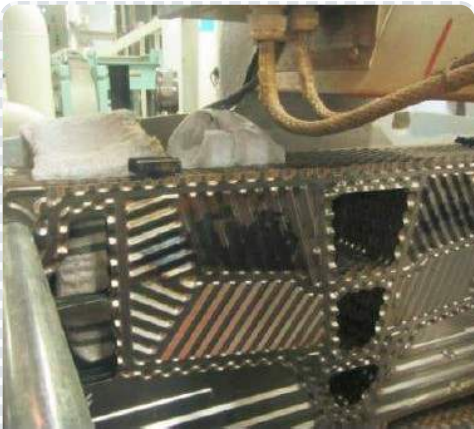
### AFTER

Clean plates with minimal residual deposits

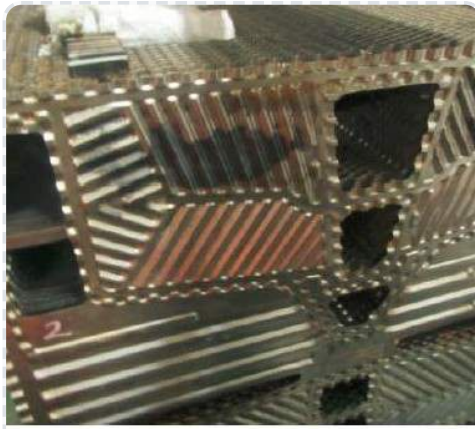
### AFTER

Improved plate condition after HydroFLOW treatment
