MARINE

Fresh Water Generator Case Study M/V Hermes Leader

HydroFLOW® units on MV Hermes Leader controlled scale formation, extended maintenance intervals, and reduced cleaning downtime.

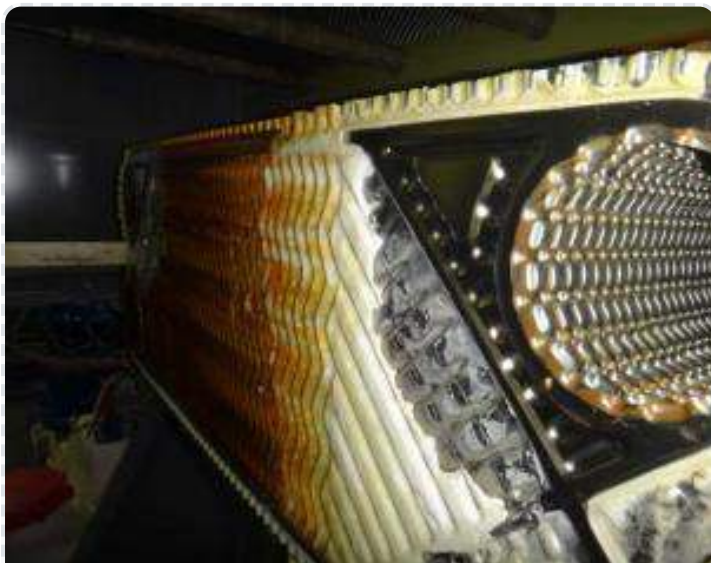
BEFORE

FWG plates with scale

- ✗ Scale build-up on FWG plates
- ✗ Water production reduced over time
- ✗ Cleaning could risk plate damage

- Scale accumulated on FWG heat exchanger plates.
- Water production reduced to around 17 m³/day
- Manual scraping could risk plate damage
- Cleaning downtime needed to be reduced

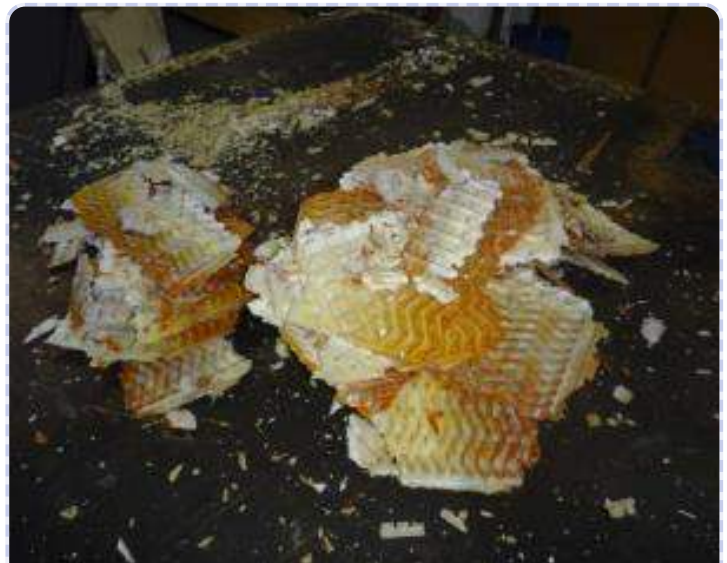
AFTER

Scale removed from FWG plates

- ✓ Scale deposits were easily removed from plates
- ✓ Only minor residue required brushing
- ✓ Cleaning time was reduced

When the plates were opened, most accumulated scale detached easily.

Only a small amount of residue remained, requiring light brushing.

Approx. 7 kg of salt deposits were removed from the plates after 4,000 hours of operation.
