## Fresh Water Generator Case Study MV Hoegh America

HM100 was installed on the vessel's FWG. Over 6 months, water production remained stable at 25 MT/day, while cleaning time reduced to under 2 hours without chemical dosing

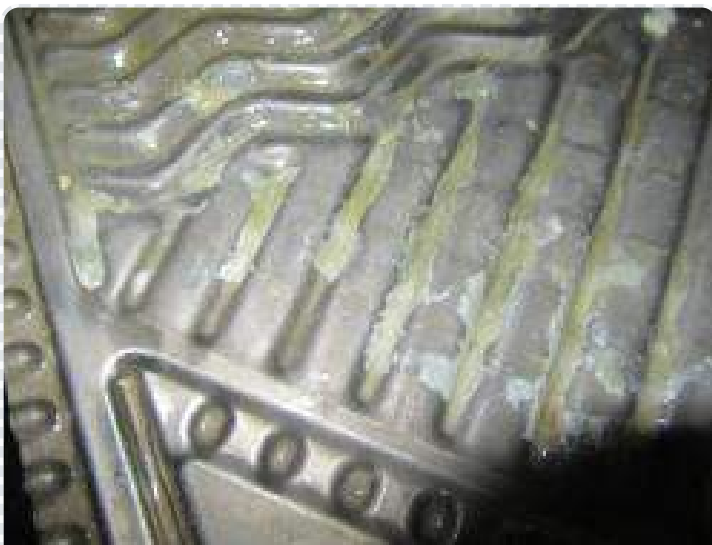
BEFORE

FWG plates with heavy scale build-up

- ✗ Up to 3 mm scale on titanium plates
- ✗ Chemical dosing required for operation
- ✗ Cleaning took 24-48 hours

- FWG performance reduced as scale built up on titanium plates
- Up to 3 mm of scale present despite regular chemical dosing
- Cleaning took 24–48 hours and risked plate damage
- Operators aimed to reduce material and labour costs

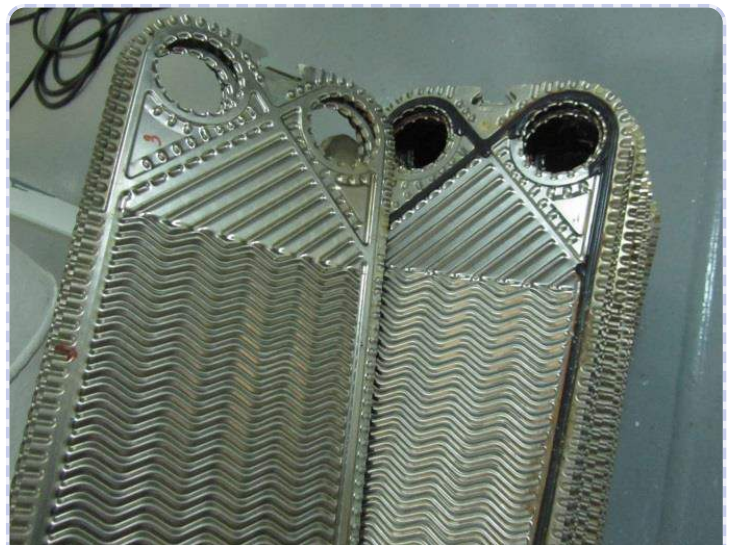
AFTER

FWG plates clean with loose scale only

- ✓ Water output maintained at 25 MT/day
- ✓ Plates clean with loose scale only
- ✓ Cleaning done in under 2 hours without chemicals

Plates were mostly clean, with only loose scale removable by hand.

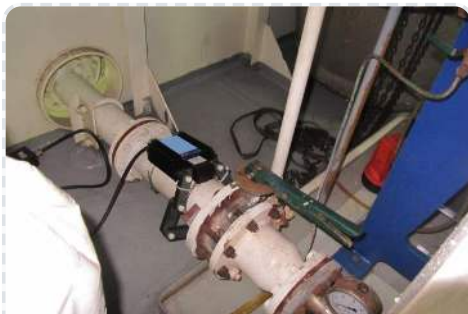
### INSTALLATION

Unit on inlet

A HM100 unit was installed on the 4-inch seawater inlet pipe approximately 1 metre before the FWG inlet, connected to the EJB and main power supply.

4 inch seawater inlet pipe, 1 m before FWG

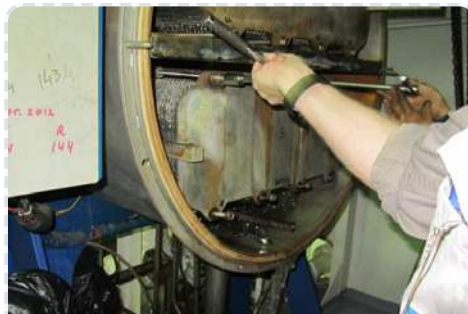
### SITE

Internal FWG inspection

The seawater side chamber was clean, with no visible scale, mud or slime.

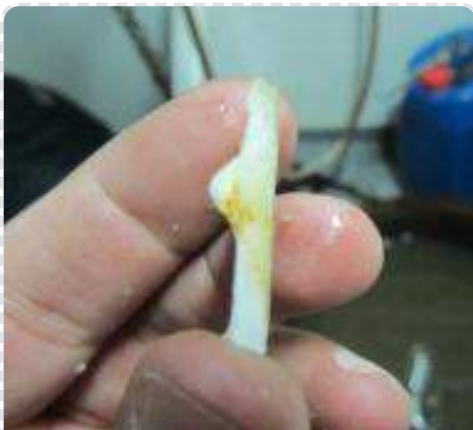
**BEFORE***Soft scale deposit sample from FWG plates*

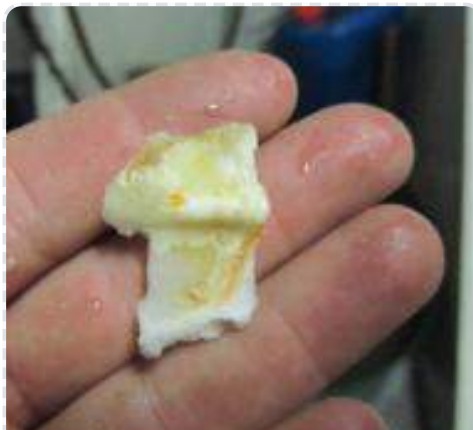
**BEFORE***Scale fragment removed from titanium plates*

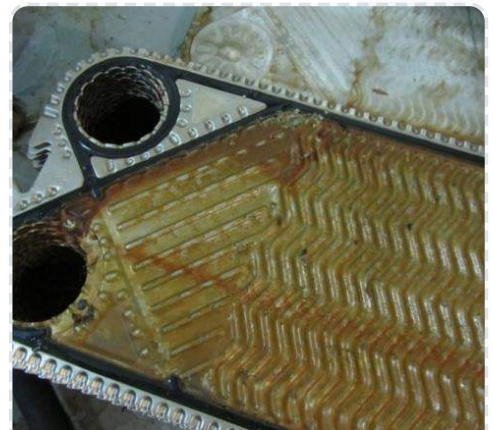
**BEFORE***Heavy scale build-up on FWG heat exchanger plates*

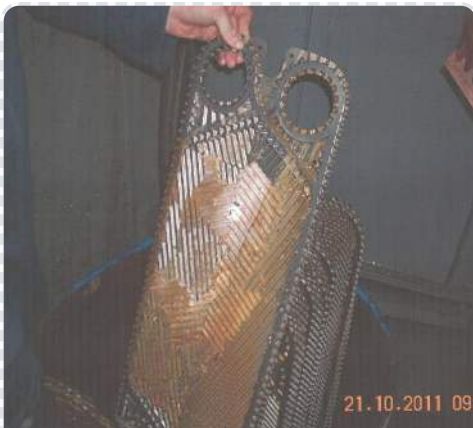
**BEFORE***FWG plates with significant scale before cleaning*

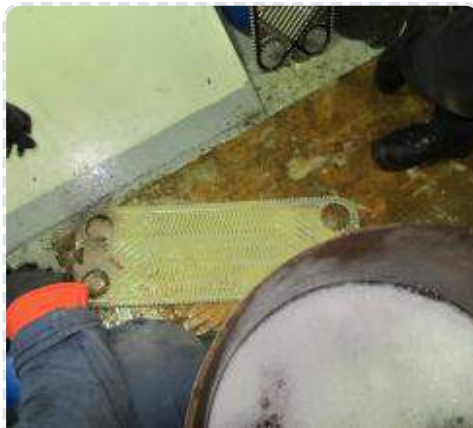
**RESULTS***Removed scale and cleaned plates during maintenance*

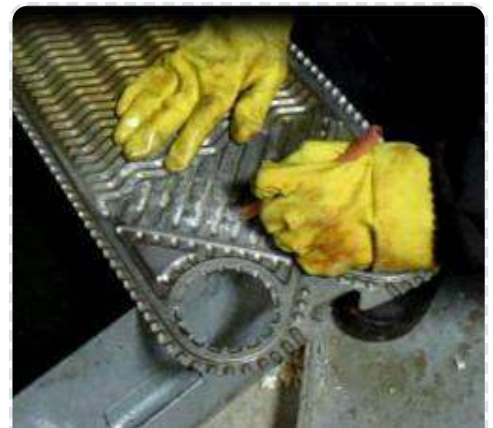
**RESULTS***Loose scale easily removed from plate surfaces*

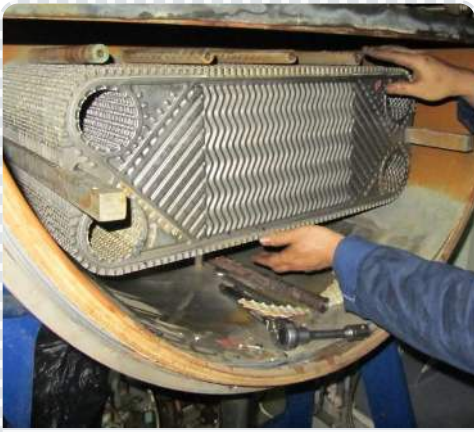
**AFTER**

Clean FWG plates after scale removal

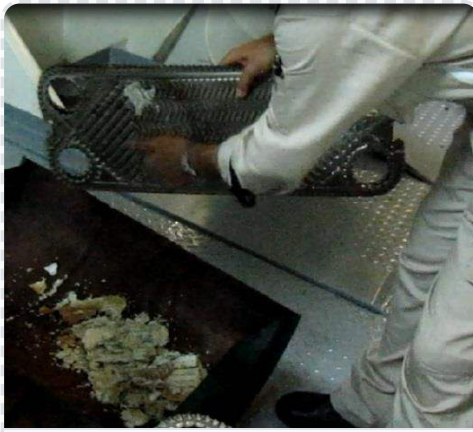
**RESULTS**

Scale deposits removed from plates during cleaning
