MARINE

Fresh Water Generator Case Study MV Hoegh Antwerp

A HM120 was installed on the FWG system. After 18 months, the system maintained full output with no reduction in performance and inspection confirmed clean plates with no chemical use.

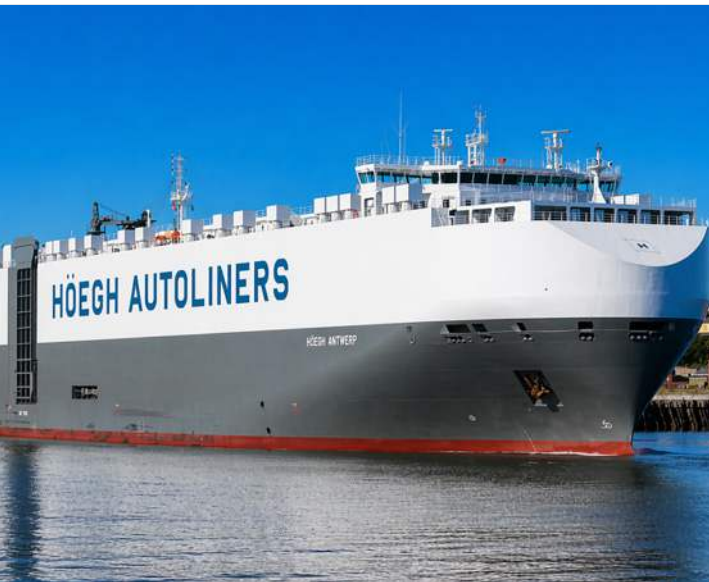
Clean plates

HM120 maintained FWG performance on MV Hoegh Antwerp over an 18-month period. The system operated at full capacity without chemical dosing or cleaning, and inspection confirmed clean plates with no scale observed.

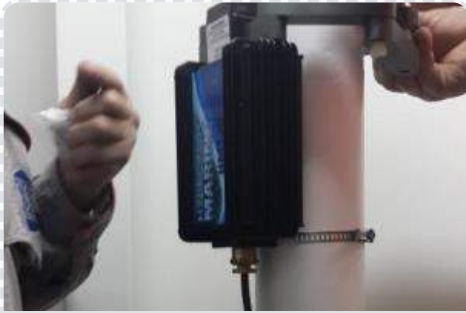
INSTALLATION

A HM120 unit was installed on the seawater inlet pipe approximately 10 metres from the FWG.

Seawater inlet pipe (approx. 10 m from FWG)

Unit on seawater pipe

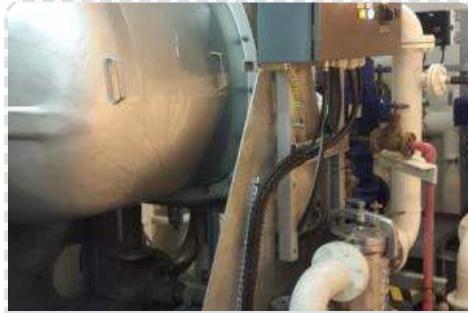
SITE

FWG system layout

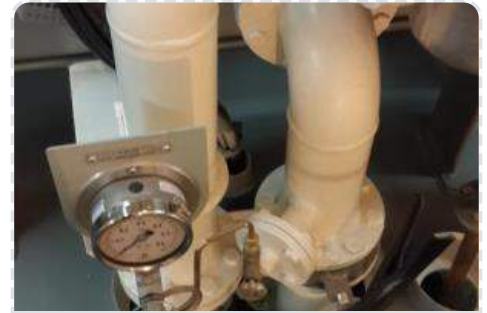
SITE

FWG system layout

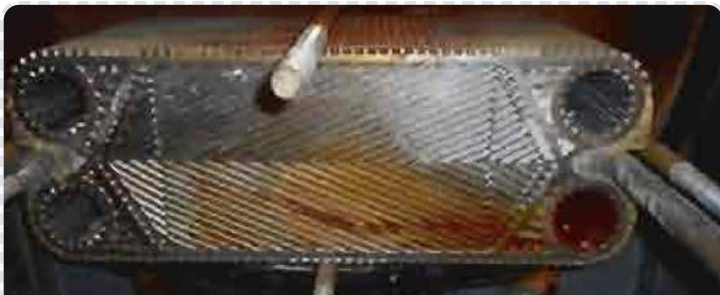
AFTER

FWG plates clean at inspection after 18 months.

Inspection showed no scale at opening.
