# Multi-Application Water Treatment Case Study Hong Kong

35 *HydroFLOW*® installations across an amusement park and its hotels, improving chiller, pool, fountain and kitchen water systems while reducing chemical use and maintenance.

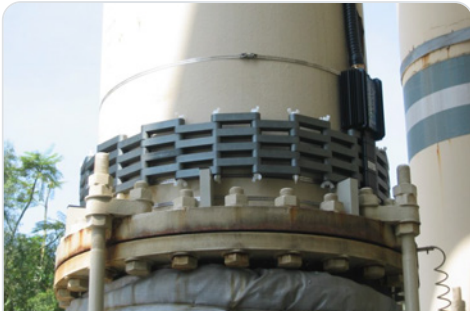
#### INSTALLATION

*Chiller plant install*

Hydrophat treatment helped keep condenser tubes scale-free while maintaining chiller performance.

Inhibitor use in the central chiller plant and sodium hypochlorite use in water systems were reduced.

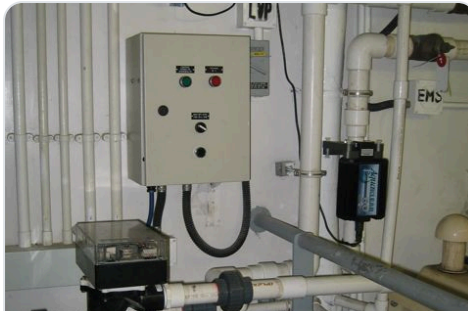
#### INSTALLATION

*on water feature system*

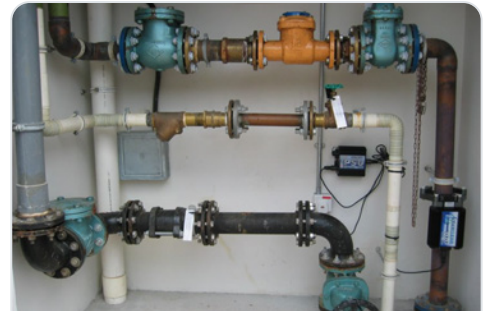
#### INSTALLATION

*On kitchen equipment line*

Steamer maintenance fell from one day with mechanical force to 30 minutes using a high-pressure water jet.

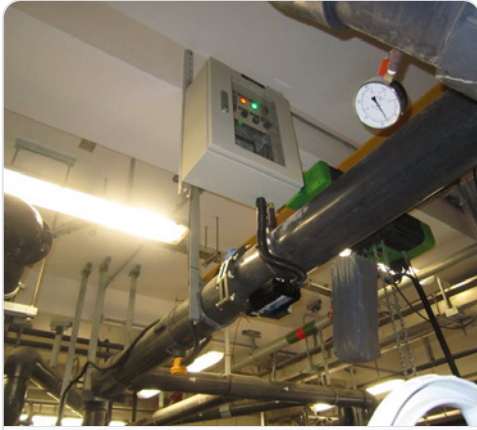
### INSTALLATION

Water feature pipework and controls

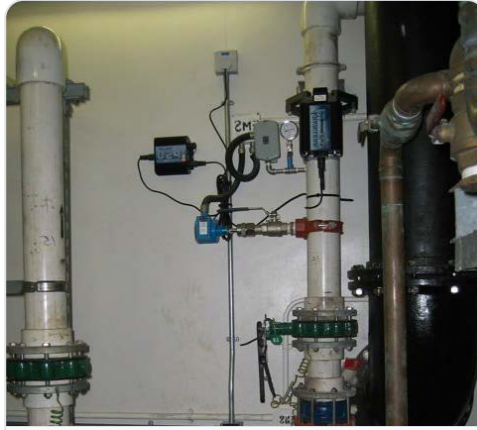
### INSTALLATION

Fountain treatment control assembly

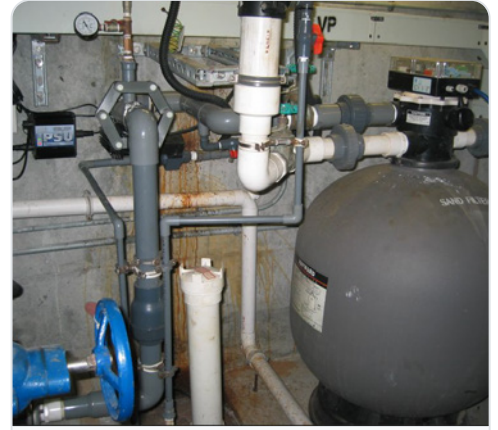
### INSTALLATION

Water feature filtration system

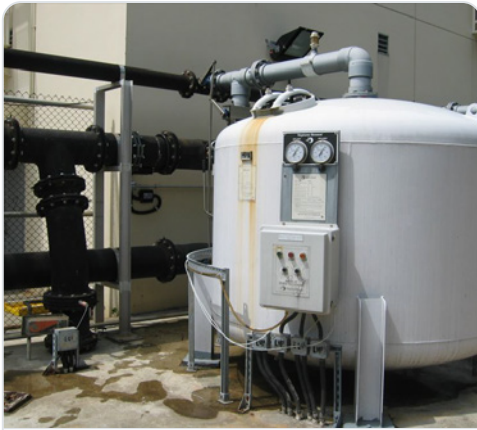
### SITE

Fountain filtration vessel

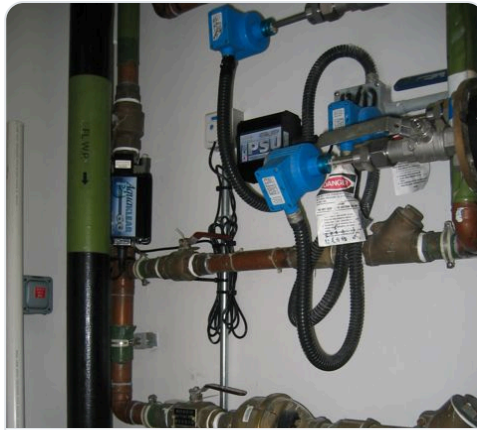
### INSTALLATION

Kitchen equipment water line

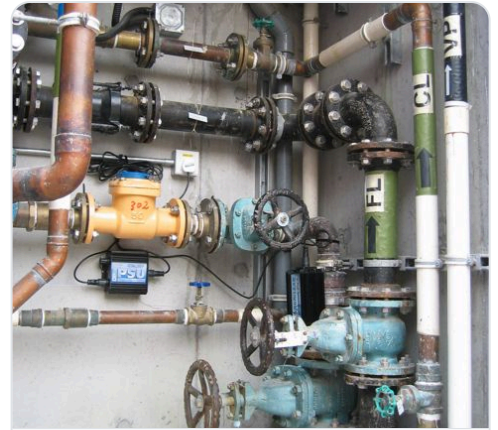
### INSTALLATION

Steamer supply pipework

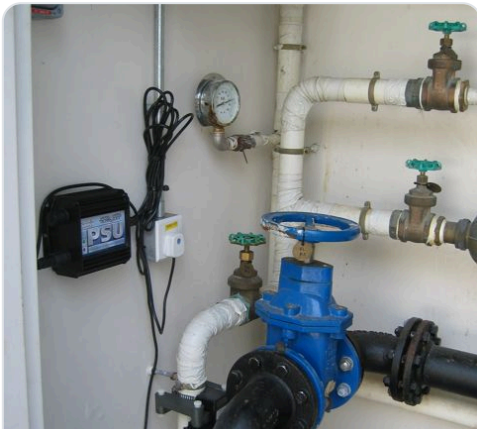
### INSTALLATION

Kitchen equipment control point

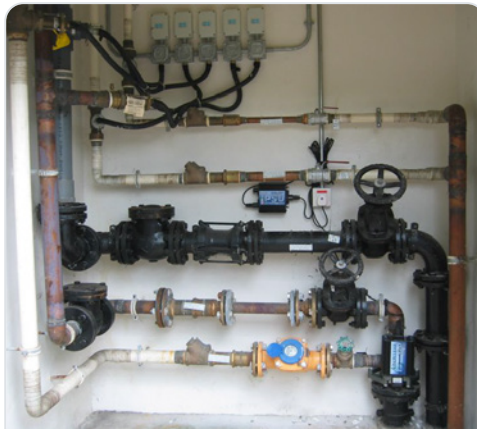
### INSTALLATION

Kitchen water treatment assembly
