# Seawater Cooled Chiller Plant Case Study Hong Kong

HydroFLOW® was trialled on a seawater cooled chiller plant before rollout across five commercial buildings, removing biofilm, improving COP by 10 to 15%, and enabling ATCS shutdown.

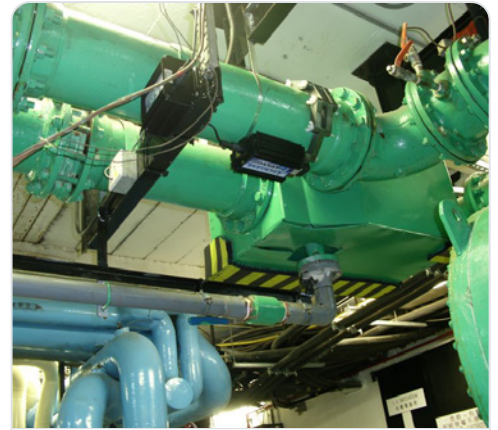
INSTALLATION

Pipework installation
