Seawater Cooled Chiller Plant Case Study Hong Kong

HydroFLOW® was trialled at Exchange Square and rolled out across five Hongkong Land buildings, removing biofilm, improving COP by 10–15%, and enabling ATCS shutdown after verification.

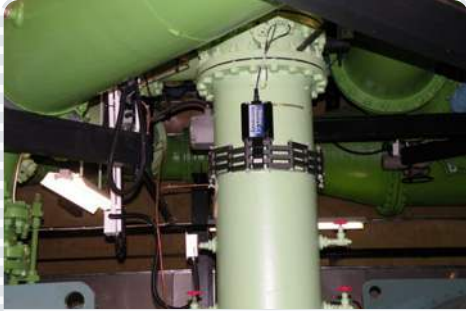
INSTALLATION

Exchange Square install

Hydropath treatment was first installed at Exchange Square on the seawater cooled chiller plant. After performance was verified, installation was extended to Landmark, Jardine House, Prince's Building and Alexandra House.

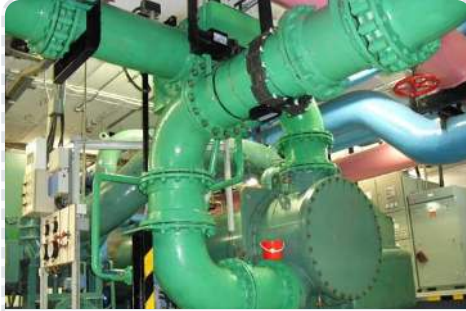
INSTALLATION

Jardine House install

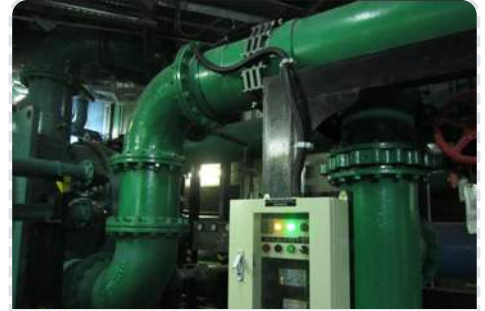
INSTALLATION

Landmark install

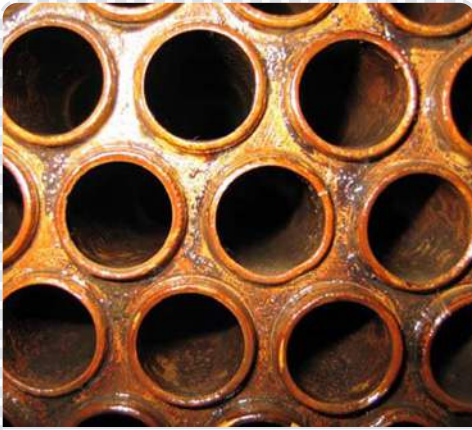
AFTER

Clean condenser tube surface after biofilm removal

After two months, condenser tubes were free from biofilm

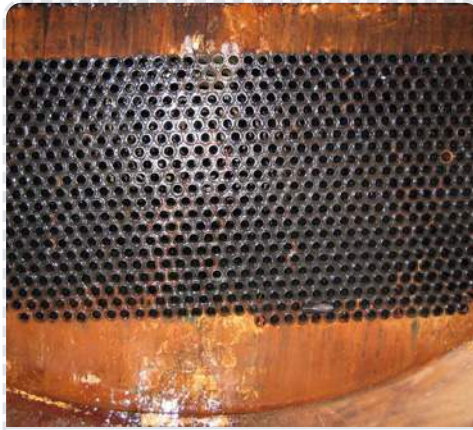
AFTER

Tube sheet free from biofilm after treatment

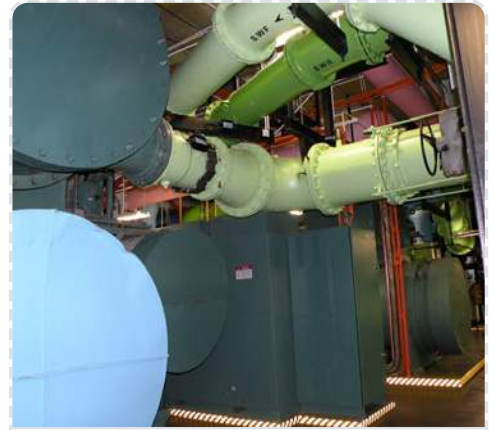
INSTALLATION

Installation at Exchange Square plant room

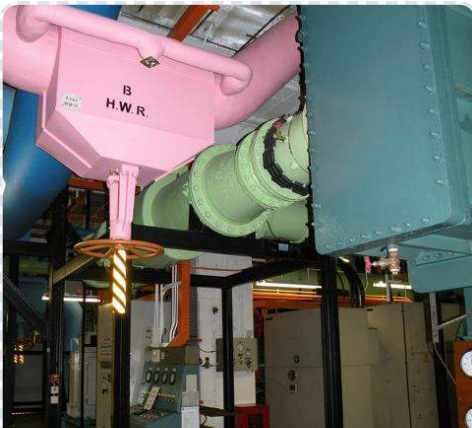
INSTALLATION

Plant room installation, Exchange Square

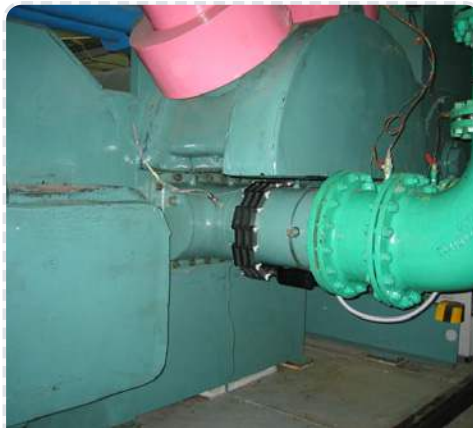
INSTALLATION

Installation at Jardine House

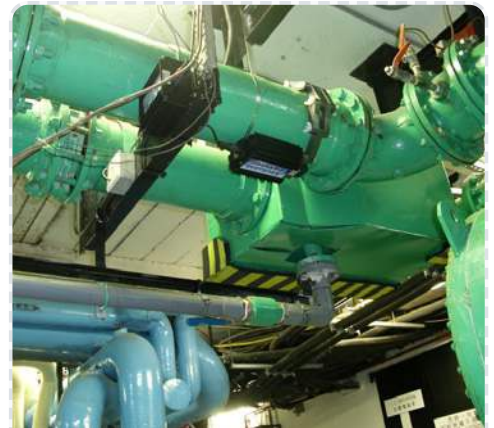
INSTALLATION

Pipework installation, Jardine House

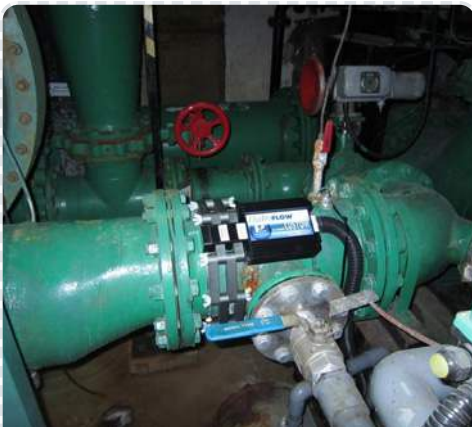
INSTALLATION

Installation at Landmark

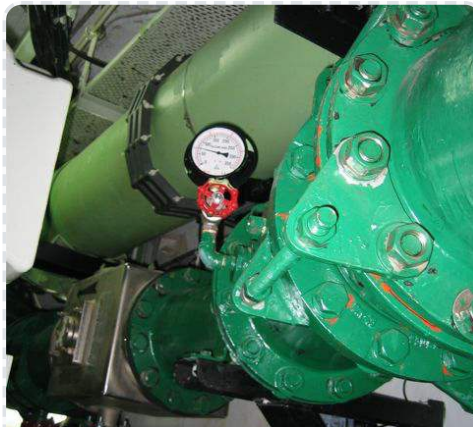
INSTALLATION

Installation at Prince's Building

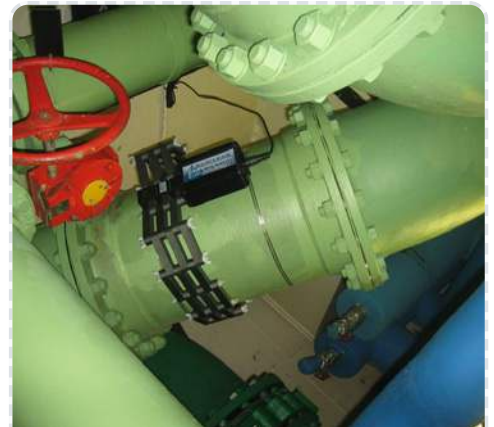
INSTALLATION

Installation at Alexandra House
