● COOLING TOWER

# Cooling Tower Case Study Hong Kong

HydroFLOW® treatment removed remaining scale in condenser tubes within 12 months and reduced maintenance across over 50 shopping malls.

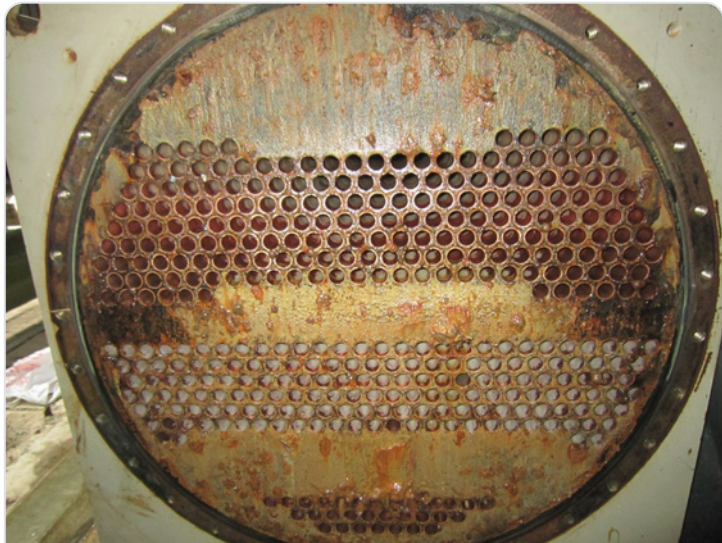
BEFORE

Scaled condenser tubes before

- Annual condenser tube cleaning required
- Scale build-up affecting performance
- Continuous chemical dosing in use

A commercial property group operates a large portfolio of retail and commercial properties. More than 50 sites use freshwater cooling tower systems for chiller plants. These systems relied on chemical dosing and annual condenser cleaning to maintain performance. A pilot study was carried out with the condenser tubes left uncleaned before *HydroFLOW*® installation.

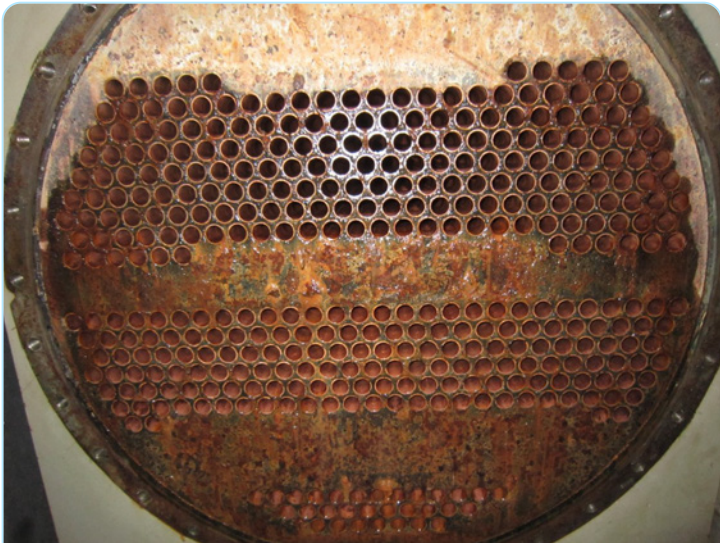
AFTER

Clean tubes after treatment

- ✓ Scale fully eliminated after 12 months
- ✓ Cleaning only done when needed
- ✓ Improved chiller performance maintained

After 12 months of *HydroFLOW*® operation, the remaining scale was completely gone.

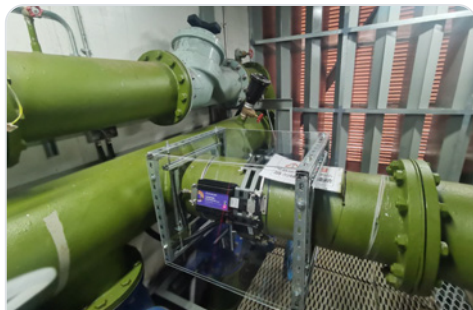
### INSTALLATION

*HydroFLOW on pipework*

Cooling tower and condenser water pipes

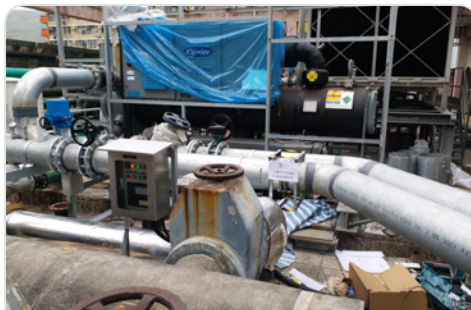
### SITE

*Cooling system setup*

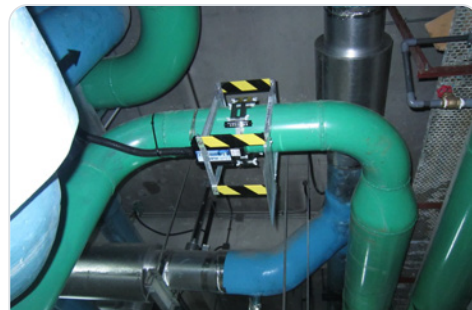
### INSTALLATION

*HydroFLOW on pipe*

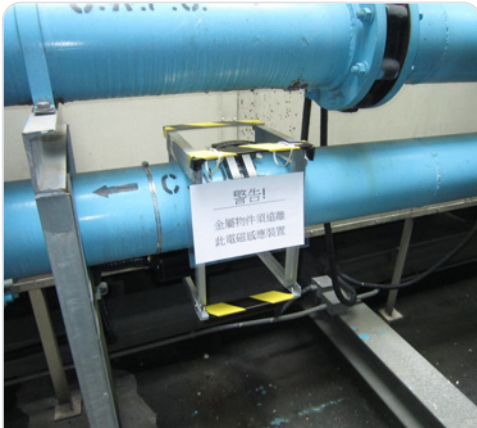
**INSTALLATION***HydroFLOW® installed beneath protective grating*

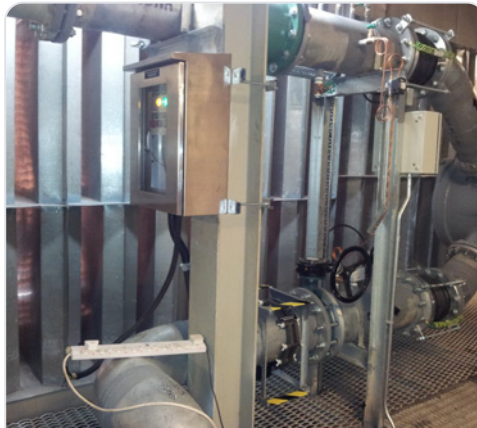
**INSTALLATION***HydroFLOW® unit with adjacent control panel*

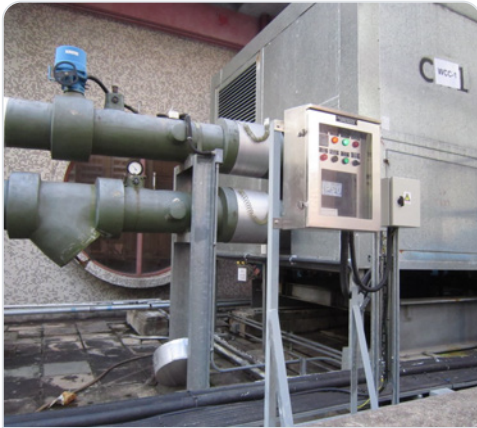
**SITE***Cooling water pipework and control assembly*

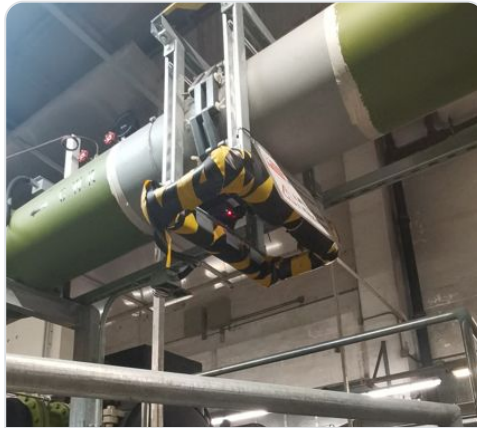
**INSTALLATION***HydroFLOW® units installed on pipework*

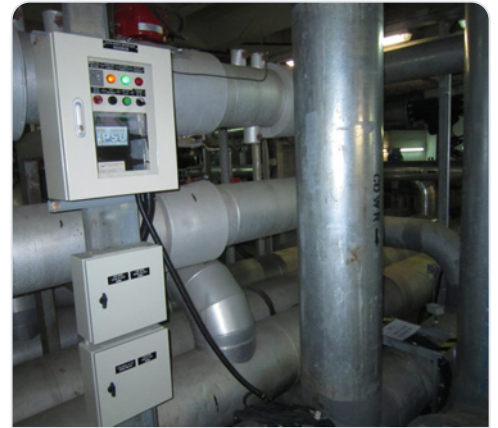
**SITE***Control panels integrated within pipework system*

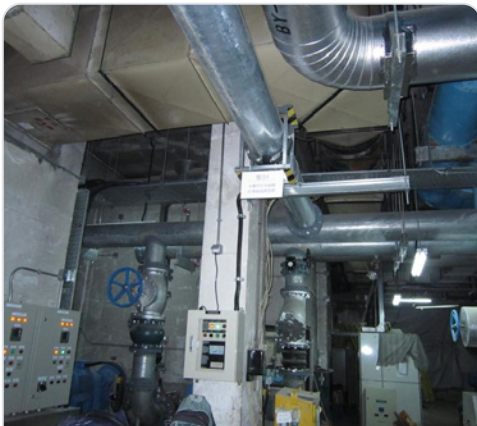
**SITE***Plant room showing full pipework layout*

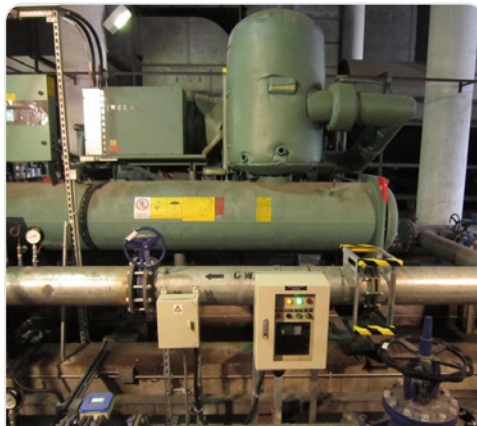
**INSTALLATION***Chiller unit with connected system pipework*
