# RO Desalination Plant Case Study Kibbutz Ma'agan Michael, Israel

HydroFLOW® improved RO recovery, reduced biofouling and extended cartridge lifespan in a high salinity desalination plant.

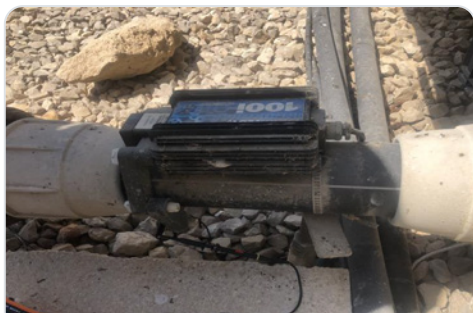
### INSTALLATION

Unit on feed pipe

3x HydroFLOW® i100 units were installed on the raw water feed and post high pressure pump lines to reduce biofouling and improve RO system performance.

Feed line and post high-pressure pump

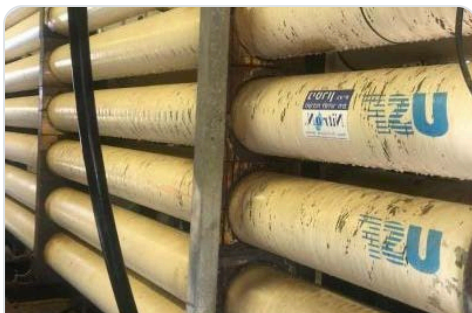
### SITE

RO membrane system

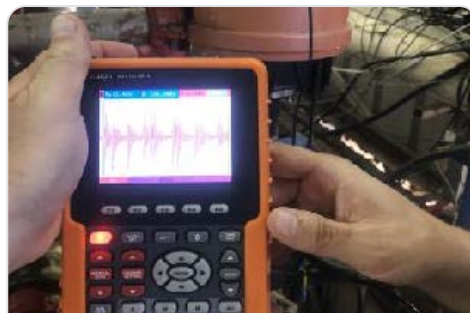
### MONITORING

Signal Verification
