Injection Mould Cooling System Case Study Wadowice, Poland

HydroFLOW® units treated scale and biofilm in an injection mould cooling system, improving heat transfer, stabilising cycle time, and reducing maintenance.

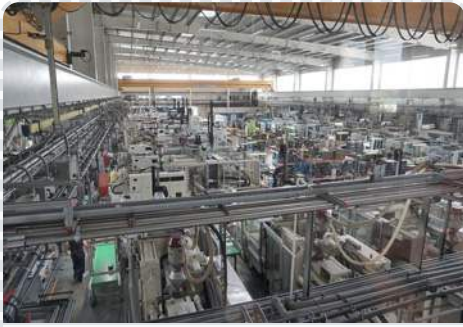
HydroFLOW® P120 and S38 units were installed on cooling circuits and the heat exchanger to treat the system and reduce mineral and biofilm deposits.

2x HydroFLOW® P120, 1x HydroFLOW® S38

INSTALLATION POINT

Cooling circuits and heat exchanger

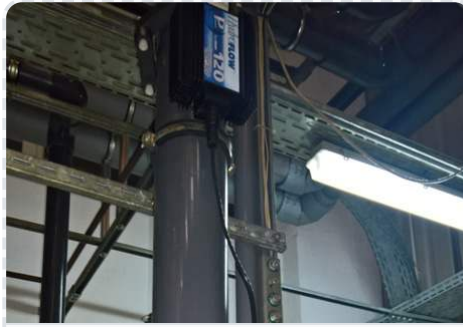
INSTALLATION

HydroFLOW® unit installed on cooling line

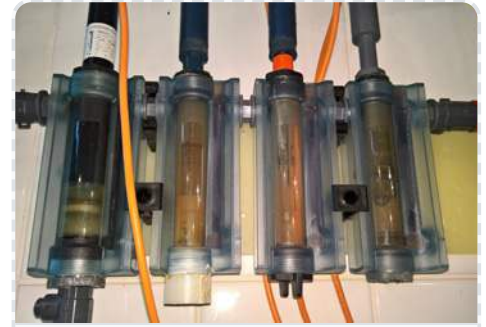
SITE

Rotometers fouled with deposits before treatment

- Scale and biofilm in mould cooling channels
- Monthly cleaning required for rotometers
- Reduced heat transfer capacity
- Increased cycle time and operating costs
