Wave Pool Case Study Ukraine

HydroFLOW® treatment improved water clarity in a public health centre wave pool while reducing chlorine consumption and backwashing frequency during the trial.

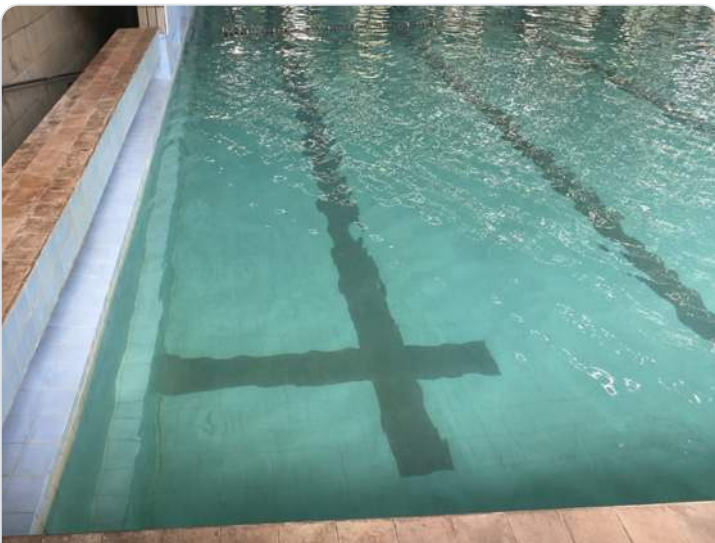
BEFORE

Pool condition on 27 July 2018

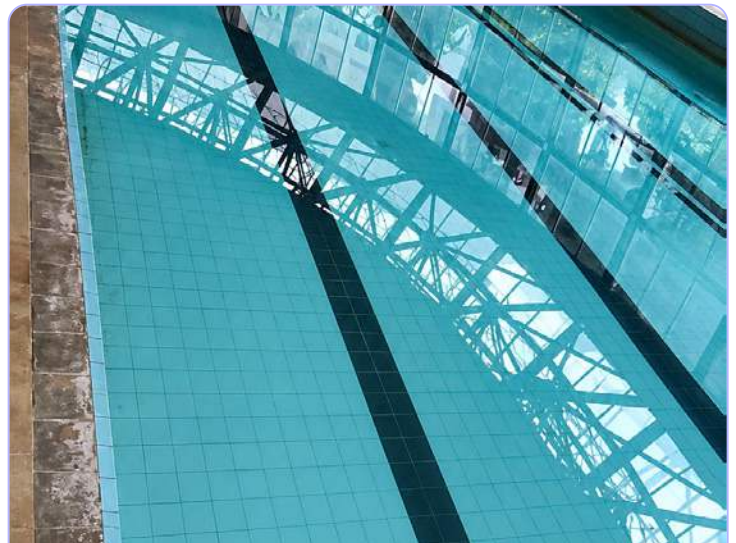
AFTER

Clearer pool water on 17th July 2018

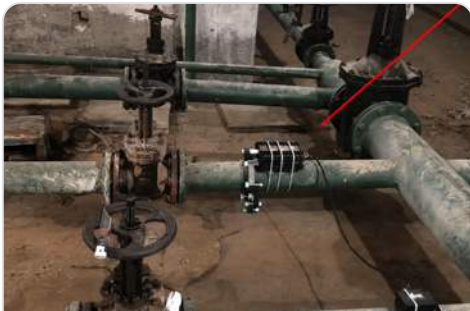
INSTALLATION

HydroFLOW® fitted to pool pipework

A *HydroFLOW*® unit was installed before the circulation pump and sand filters on 27 June 2018 to improve filtration performance and reduce chlorine dependency.

Before pump on sand filter supply

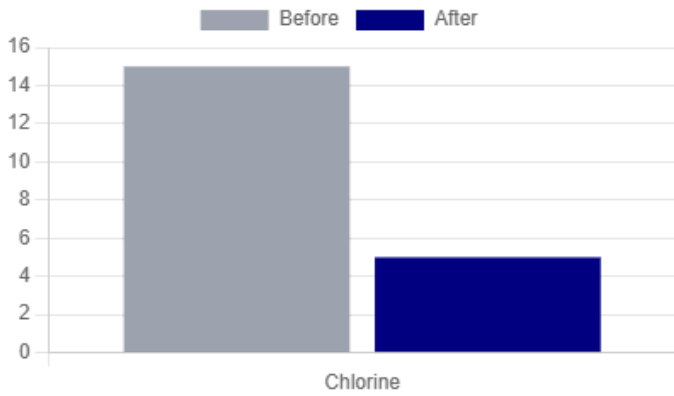
Daily Chlorine Consumption (L)

Daily chlorine use reduced from 15L to approximately 5L.

Daily chlorine consumption dropped from 15 litres to 4-6 litres.

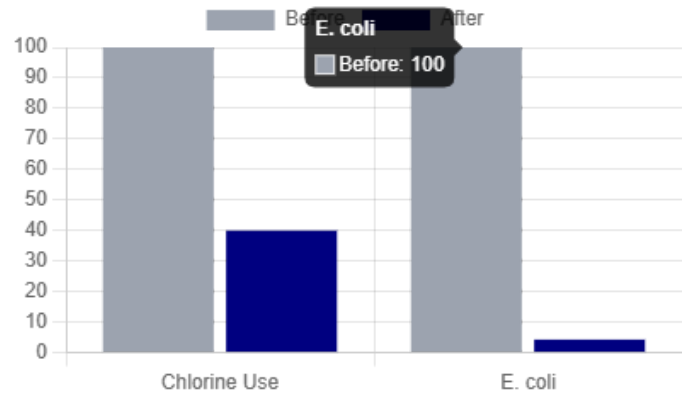
Pool Condition Improvements (%)

Measured reductions during the trial period.

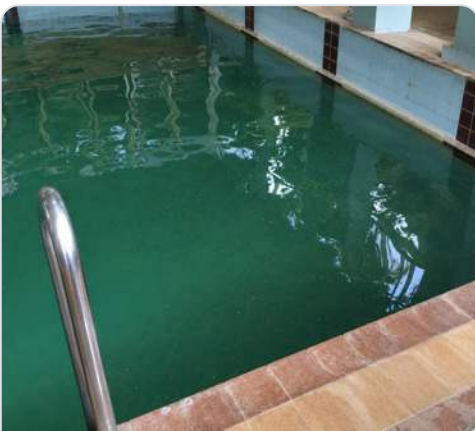
BEFORE

Pool condition before installation 27 June 2018

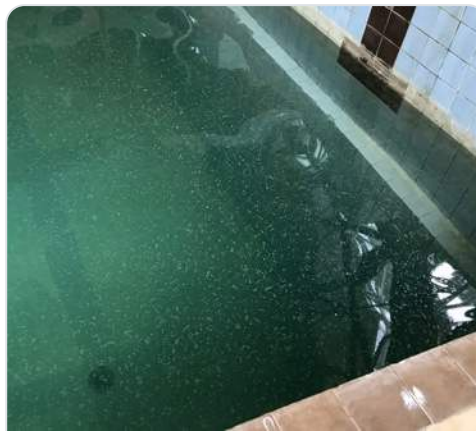
BEFORE

Unsatisfactory water clarity CL = 1.2

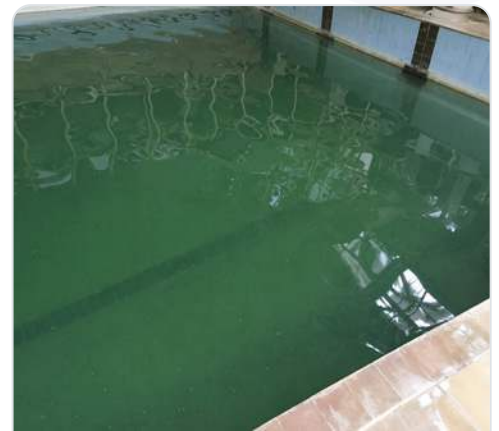
BEFORE

Surface biofilm visible before trial 27 June 2018

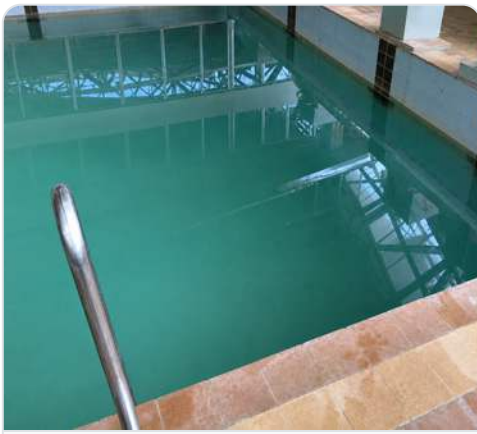
AFTER

Clear blue water after 12 days 09 July 2018

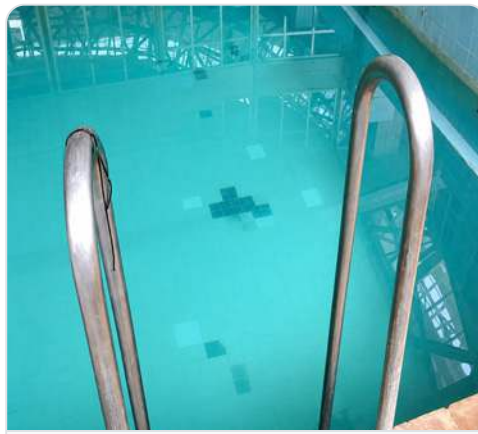
AFTER

Improved clarity at CL = 0.6

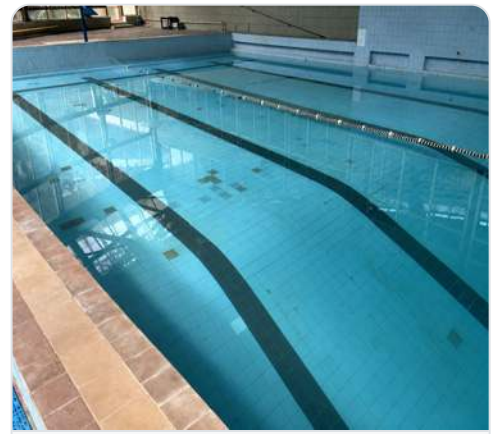
AFTER

Pool water restored during trial
