# Seawater Intake Biofouling Control Case Study Chile

HydroFLOW® Custom i20" unit was used to controlled marine biofouling in a seawater intake line over 223 days, maintaining flow without cleaning or chemical dosing during the trial.

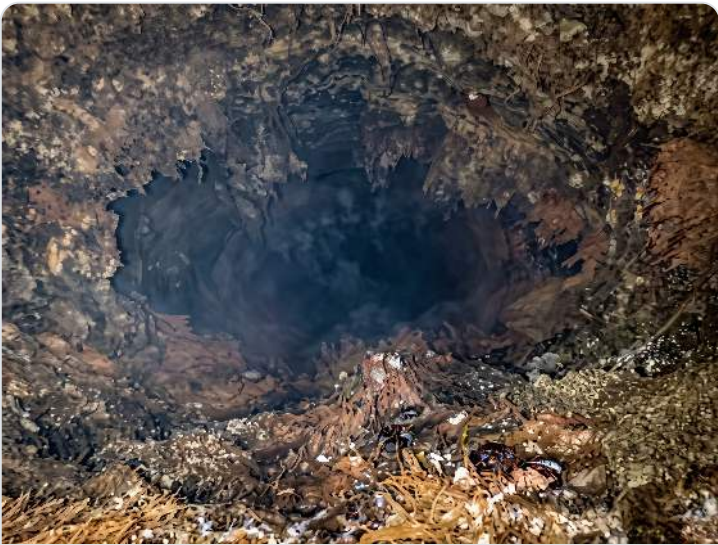
BEFORE

Control line with mussel fouling

- Marine growth embedded in intake piping
- Flow restrictions increased cleaning needs
- Chemical reliance risked higher impact

Line 6 showed larvae, small shells and mature mussels over 3 cm.

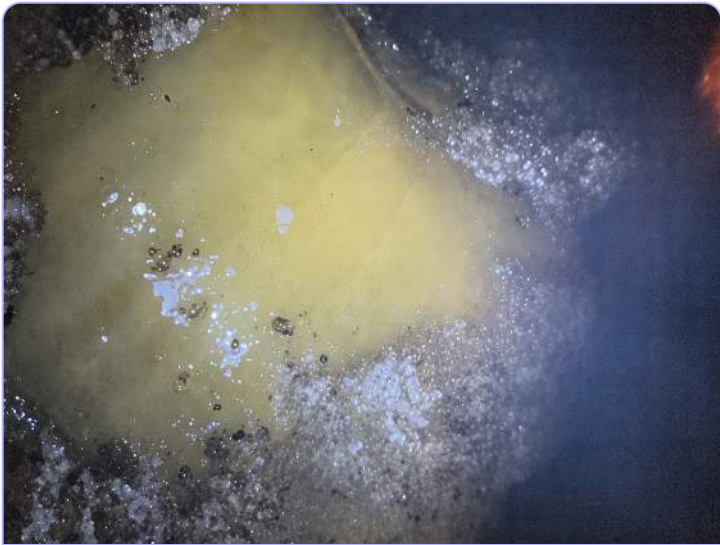
AFTER

Treated line after 223 days

- ✓ No mussel proliferation in treated line
- ✓ Pipe surface visible and odour-free
- ✓ 223 days without cleaning or chemicals

No mussel proliferation was observed in the treated line during the trial.

The treated line remained visibly clear, with pipe colour and material exposed.

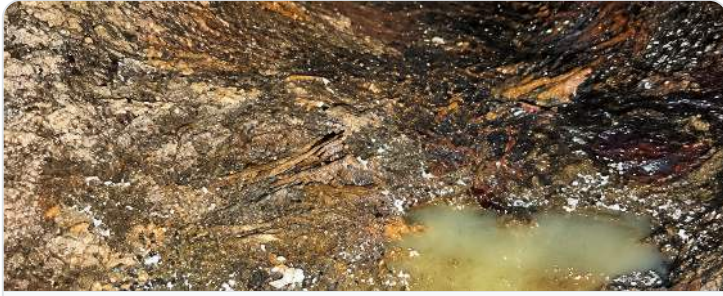
### INSPECTION

2nd opening test area scraped clean

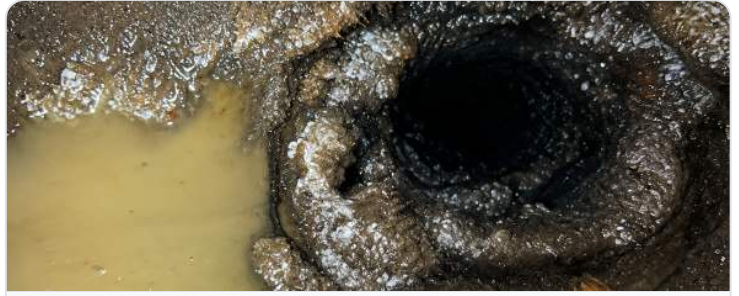
### INSPECTION

3rd opening scraped area remains clean
