# Gypsum Mine Pump Scaling Case Study **Italy**

A *HydroFLOW*® unit was installed on a gypsum mine dewatering system, reducing severe calcium sulphate and carbonate scaling and keeping the pump operational after 3 months.

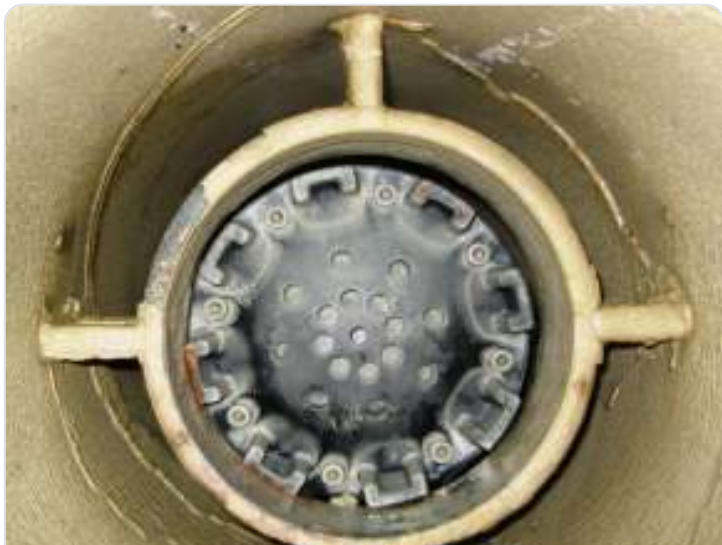
**BEFORE**

- Pump blocked every three months
- Impellers clogged with hard scale
- Regular acid cleaning required

*Pump condition at trial start*

- Pump impellers blocked due to heavy scale deposits
- Engine overheating caused by scaling build-up
- Acid cleaning required every three months
- Metal rings and hydraulic joints cracked

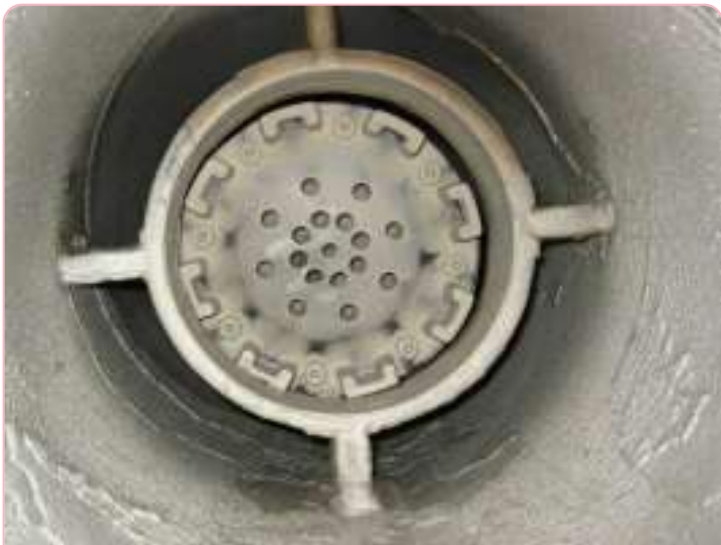
**AFTER**

- ✓ Pump remained operational
- ✓ Only light powder coating found
- ✓ Scale formed as suspended crystals

*Pump after 3 months operation*

Inspection found only a light powder coating inside the pump.

Minerals formed powder-like crystals in suspension instead of hard scale.

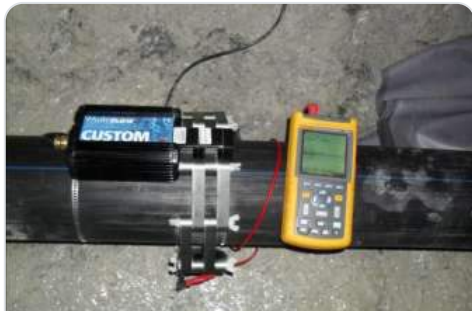
### INSTALLATION

*Installed unit*

A *HydroFLOW*® custom 200mm unit was installed on the flexible pipeline between the underground pump and mine entrance, approximately 350m from the pump.

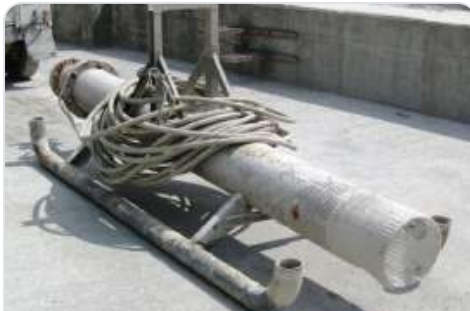
### SITE

*Underground pump*

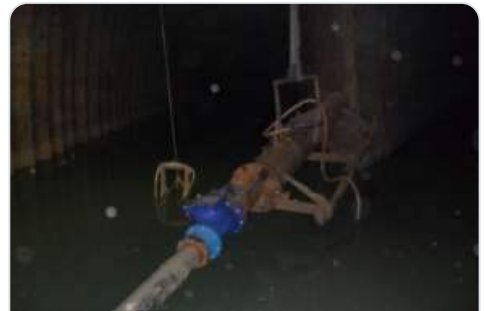
### SITE

*Underground pump*
