# Steam Boiler Scale Removal Case Study Minnesota, USA

HydroFLOW® helped gradually reduce existing boiler scale deposits, improve heat transfer efficiency and support reduced maintenance requirements on a 60 HP steam boiler.

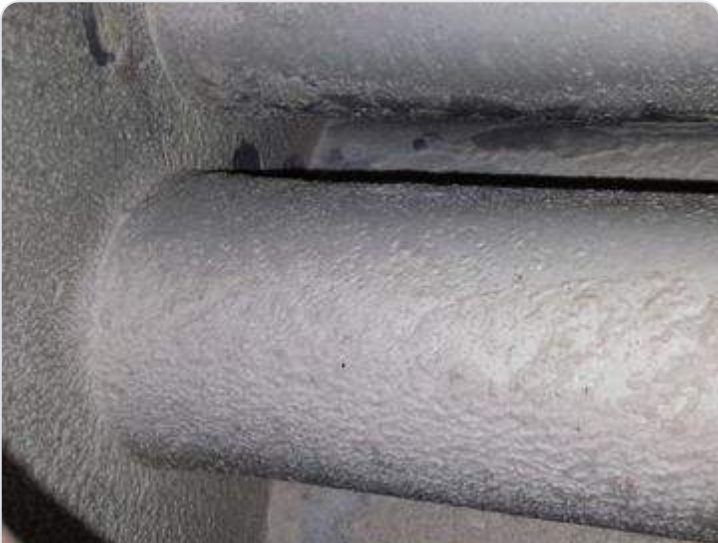
BEFORE

- ✗ Heavy scale coated boiler tubes
- ✗ Scale accumulation continued despite chemicals
- ✗ Acid cleaning was being considered

Heavy scale on boiler tubes

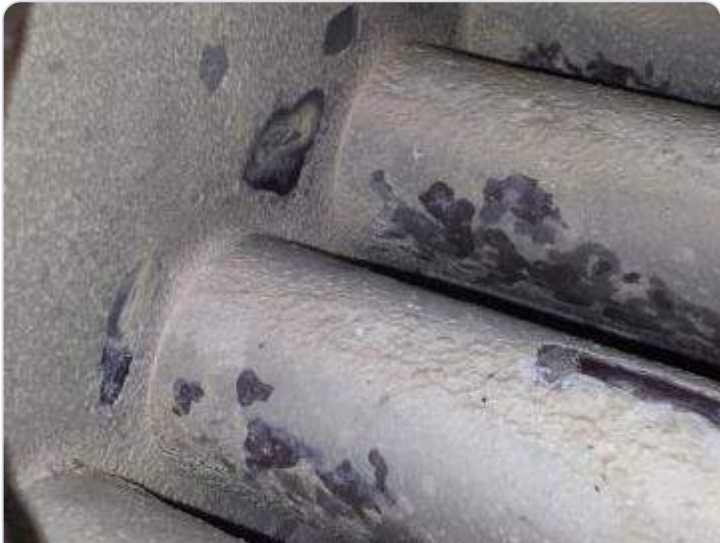
AFTER

- ✓ Scale became brittle and began breaking away
- ✓ Stack temperature reduced steadily
- ✓ Scale debris purged through blow-down

Brittle scale breaking away

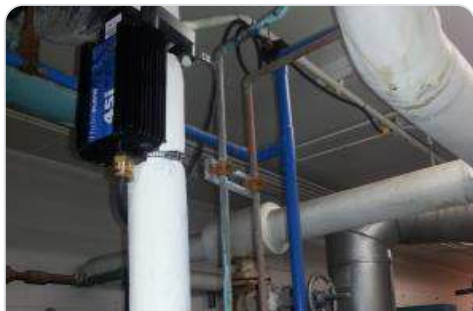
### INSTALLATION

One *HydroFLOW® i45* unit was installed on the feed water line entering the 60 HP steam boiler while existing water treatment remained active.

*HydroFLOW® i45 installation*

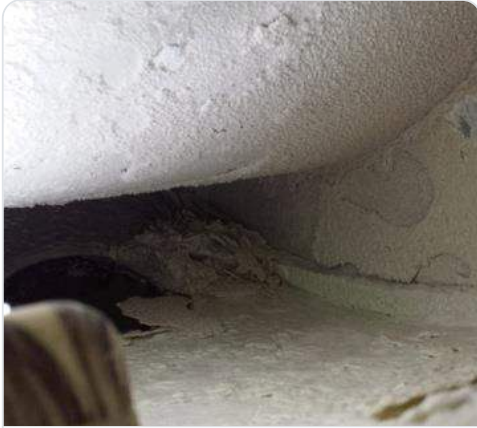
**BEFORE**

Heavy scale before treatment

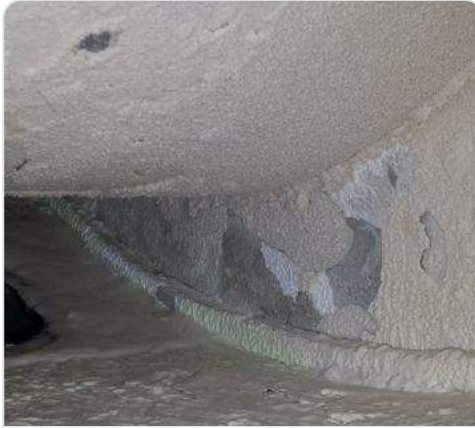
**AFTER**

Scale becoming brittle

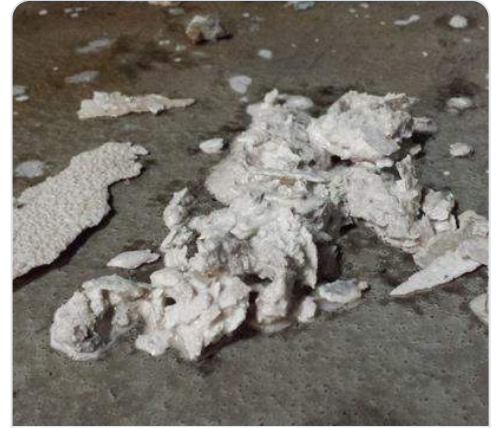
**INSPECTION**

Scale debris after blow-down

Increased blow-down helped purge loosened scale deposits
