# Hospital Heat Exchanger Case Study Acre, Israel

HydroFLOW® eliminated limescale buildup in a high-demand hospital hot water system, extending cleaning intervals from 3 months to 17 months without chemicals.

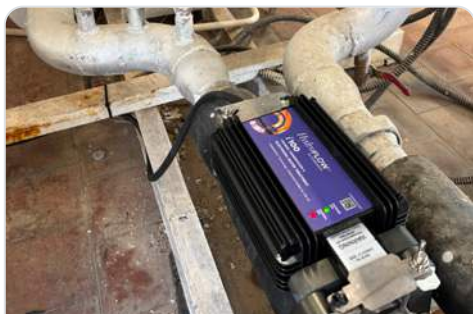
### INSTALLATION

i100 on exchanger inlet

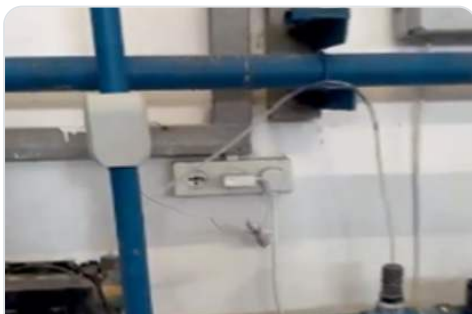
### INSTALLATION

Pearl Plus on make-up line

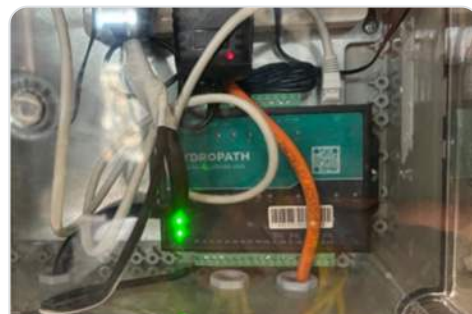
### MONITORING

HydroKNCT control cabinet

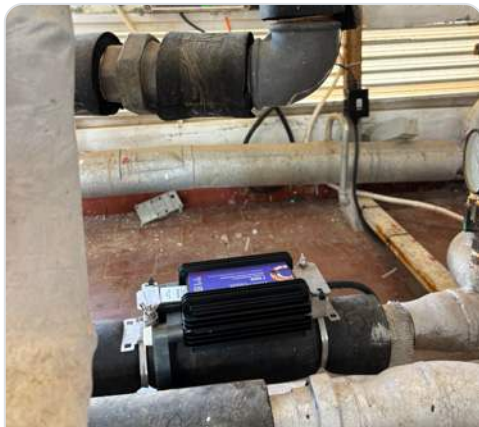
### INSTALLATION

i100 unit on heat exchanger inlet line

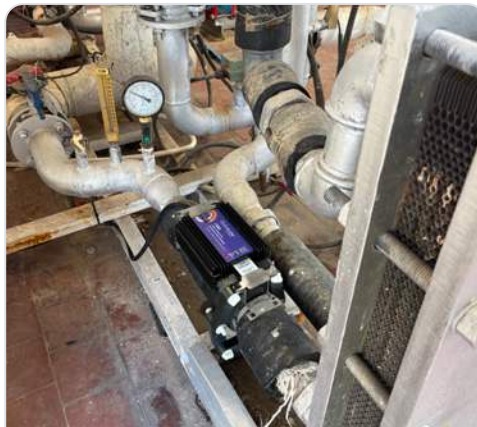
### INSTALLATION

HydroFLOW® installation on pipework

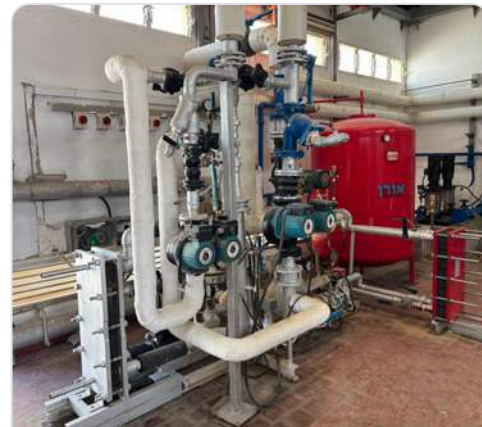
### SITE

Heat exchanger system at Mazor Medical Center

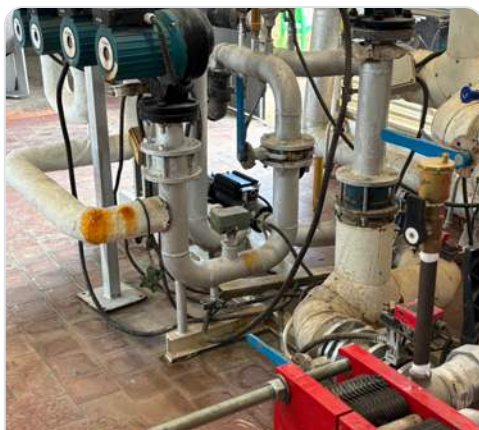
### INSTALLATION

HydroFLOW® unit in operation

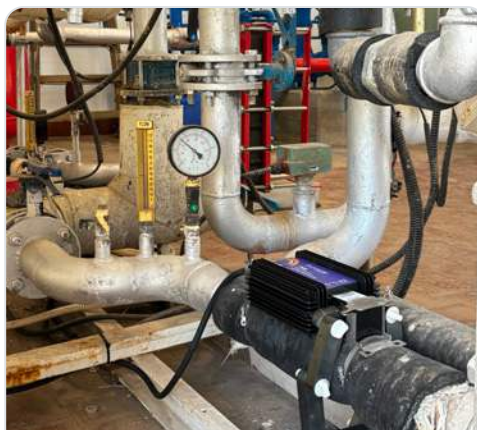
### INSTALLATION

HydroFLOW® installation
