FOOD INDUSTRY

# Apple Packing Facility Industrial Water Heater Treatment **US Northwest**

HydroFLOW® reduced scale on ageing heaters in 2011, helping them operate for 14 more years. When new heaters were fitted in 2025, treatment was upgraded with latest HydroFLOW® units.

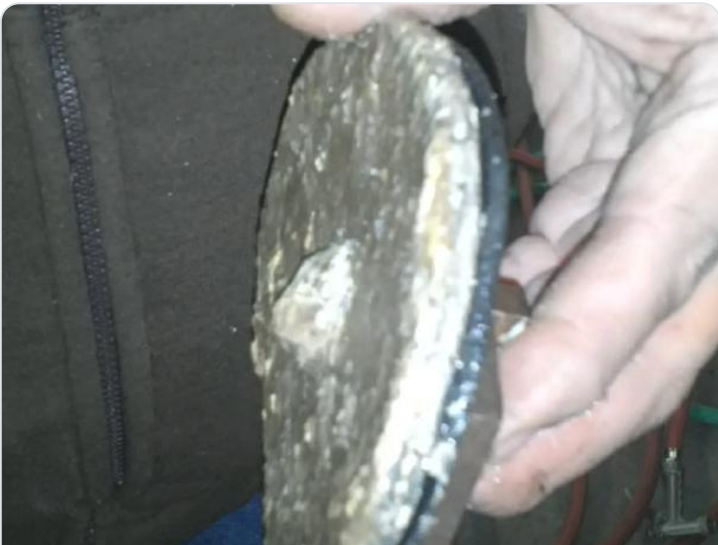
### BEFORE

Heavy scale on ageing heater components

- Scale fouled heater tubes and tank walls
- Maintenance demand was extensive
- Premature equipment failure was a risk

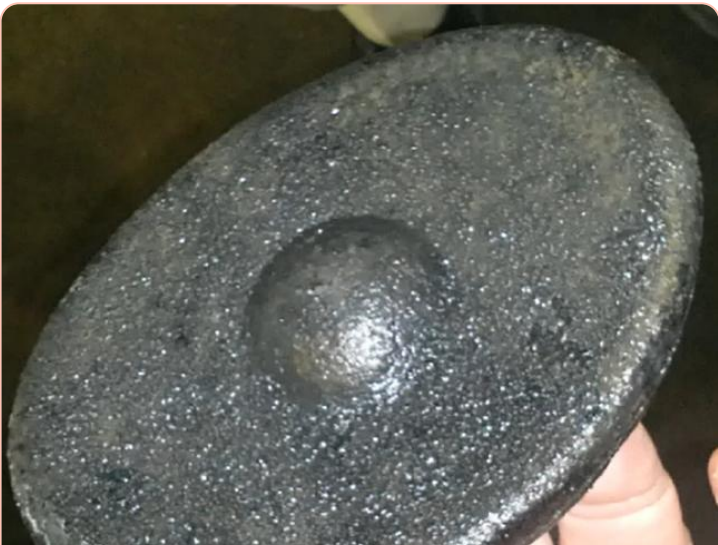
### AFTER

Over 70% less scale after three months

- ✓ Deposits reduced by over 70% in three months
- ✓ Existing heaters ran for 14 more years
- ✓ New heaters protected with monitored treatment

Scale on heater tubes and tank walls reduced by over 70% within three months.

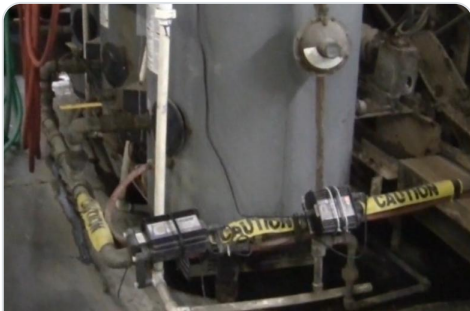
#### INSTALLATION

*Initial HydroFLOW*® unit on heater feed

Incoming water line feeding three heaters

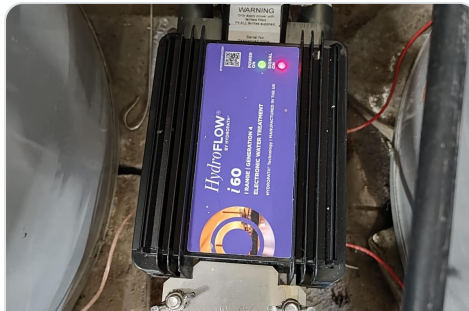
#### INSTALLATION

*Upgraded i60 installed*

1x *HydroFLOW*® i60

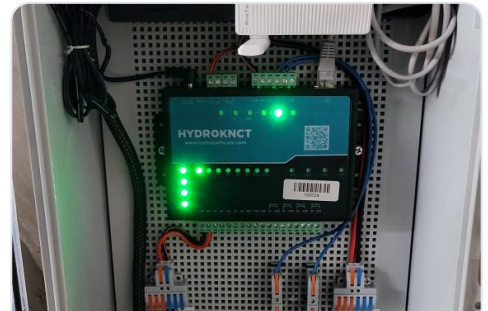
#### MONITORING

*HydroKNCT remote monitoring device*

*HydroFLOW®* reduced limescale deposits by over 70% within three months on three ageing water heaters. The heaters then remained operational for a further 14 years. When they were replaced with high-efficiency models, the facility upgraded to latest *HydroFLOW®* units with *HydroKNCT* IoT device was installed and linked with the *Hydropath Care* remote monitoring software.

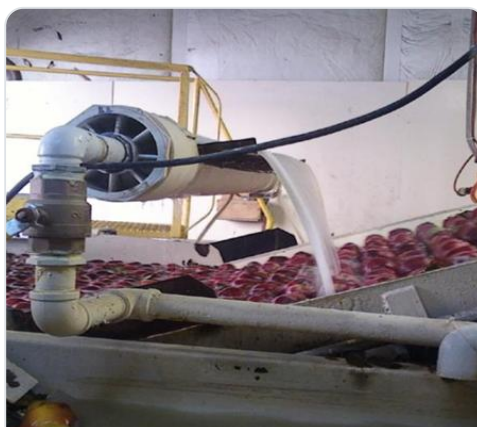
**SYSTEM***Heated water supplied to the apple-washing process*

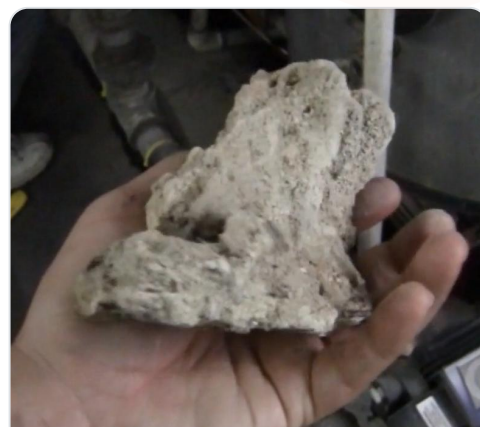
**BEFORE***Heavy limescale removed from the heater system*

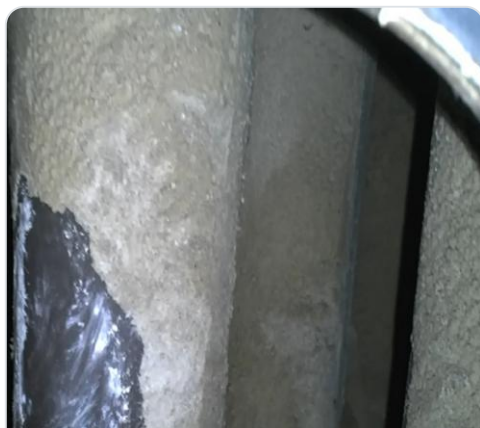
**BEFORE***Heavy limescale coating the heater component*

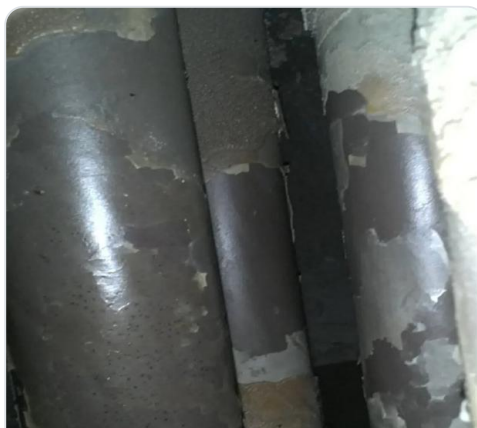
**AFTER***Reduced deposits on the same heater component*

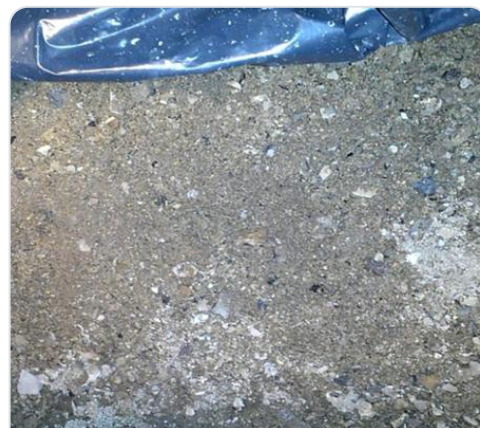
**RESULTS***Limescale debris released from the heater system***HYDROPATH** **Ready to protect industrial water-heating equipment?**
