HOTEL INDUSTRY

# Resort Hot Water Heater Scale Control Case Study Jamaica

HydroFLOW® C150 controlled severe limescale in hotel hot water systems, improving heater performance, reducing maintenance and restoring equipment condition.

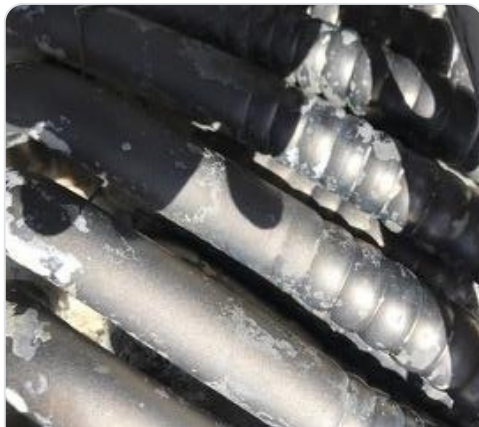
### AFTER

Heater coils showing reduced scale after treatment

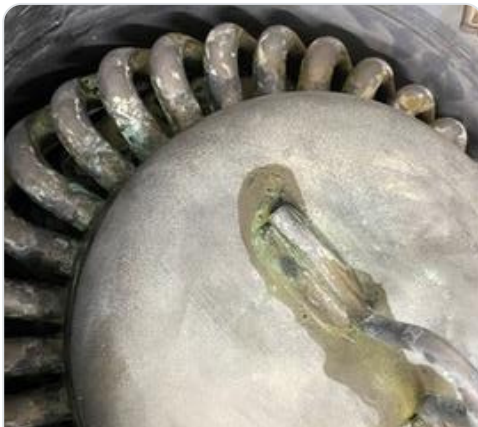
### INSPECTION

Heater coils with softened scale deposits

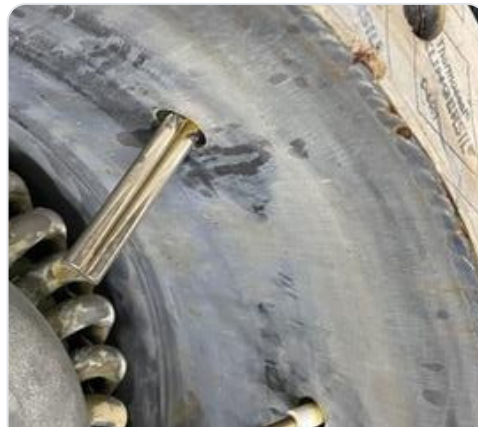
### INSPECTION

Heater core remained clear after 3 months

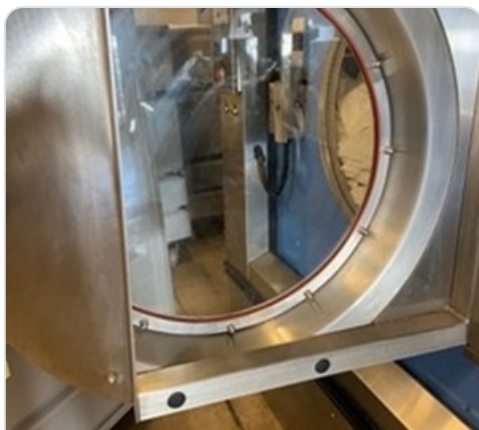
### RESULTS

Washer window no longer caked with scale after 5 months

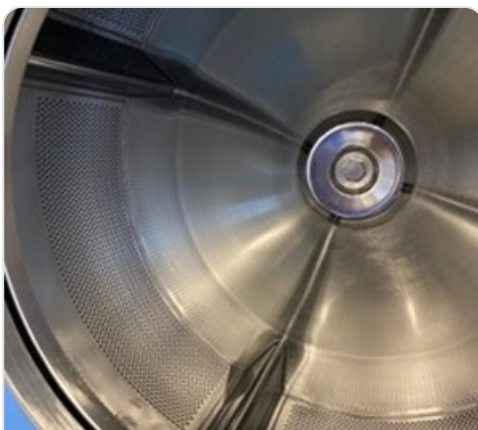
### RESULTS

Washer internals remained clear after 5 months
