HOTEL INDUSTRY

# Hotel Dishwasher Limescale Treatment **Honolulu, Hawaii**

Hydropath treatment produced a noticeable reduction in dishwasher limescale within 60 days and reduced visible water spotting on dishes and glassware.

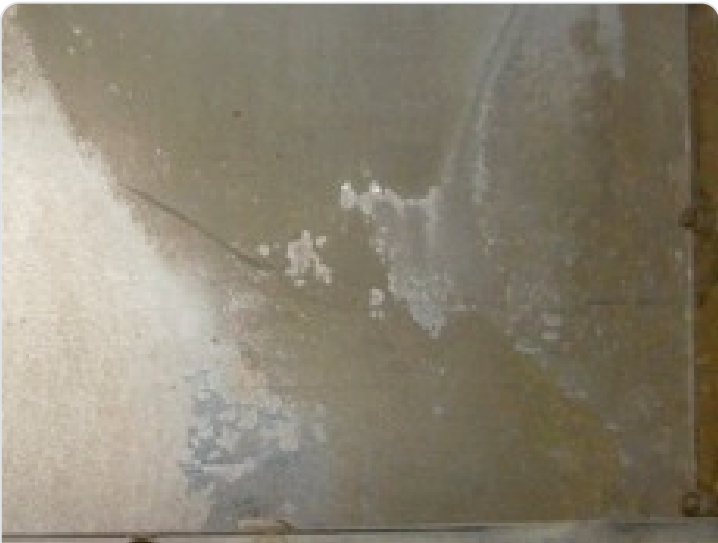
BEFORE

Visible limescale before treatment

- Scale accumulated inside the dishwasher
- Visible deposits affected internal surfaces
- Water spots affected dishes and glassware

Limescale built up inside the hotel dishwasher, affecting surfaces, heat transfer and washed items.

- Scale accumulated across internal surfaces
- Build-up could reduce heat-transfer efficiency
- Water spotting affected dishes, particularly glassware

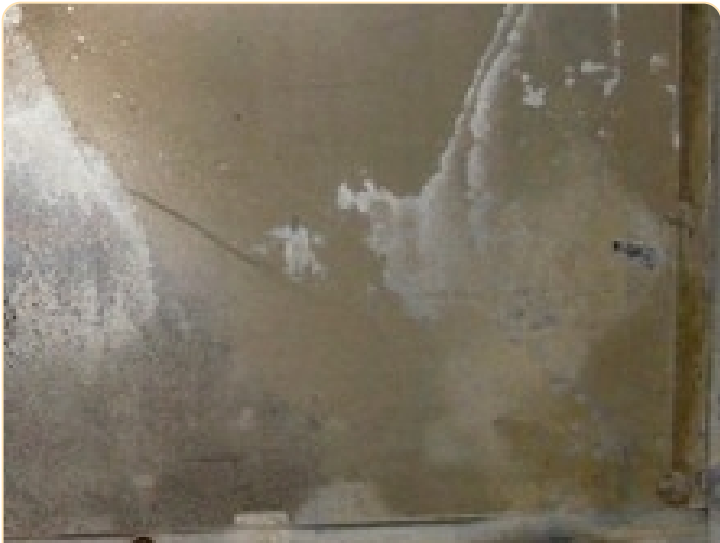
AFTER

Reduced limescale after six month

- ✓ Noticeable scale reduction within 60 days
- ✓ Dishwasher performance was reported to improve
- ✓ Water spotting was significantly reduced

Later inspections showed reduced visible limescale on monitored surfaces.

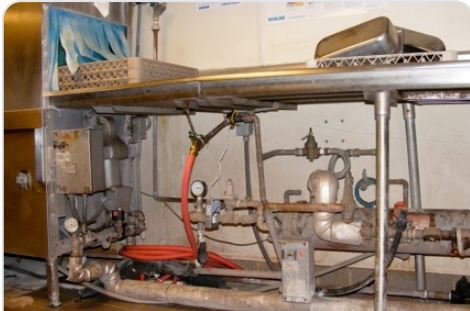
### INSTALLATION

*S38 on dishwasher pump line*

One *HydroFLOW*® S38 was fitted to the 3/4-inch galvanised pump line between the filter heater and dishwasher. Follow-up inspections tracked changes in visible limescale.

3/4-inch galvanised pipe

Pump line between filter heater and dishwasher
