# Hotel Hot-Water Tank Limescale Treatment Alberta, Canada

Hydropath treatment kept two hotel hot-water tanks running without cleaning for six months, after previously requiring cleaning every 6 weeks

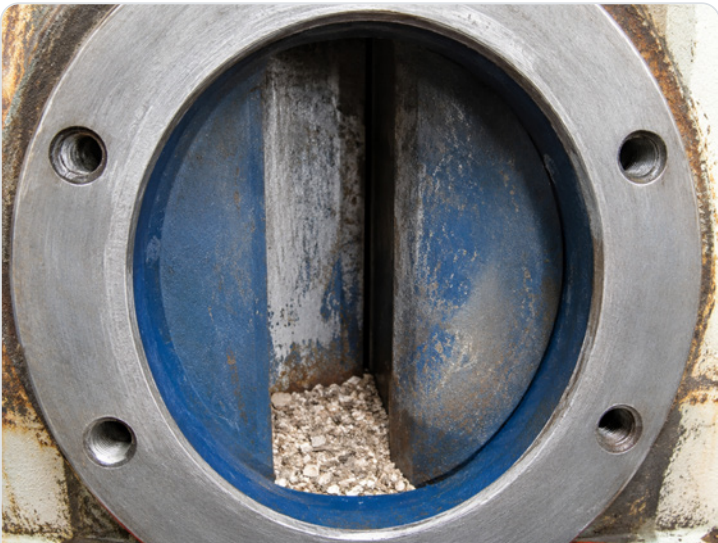
BEFORE

Scale removed after six weeks

- Around 1 inch of scale accumulated every six weeks
- Tank drains clogged and required high-pressure unblocking

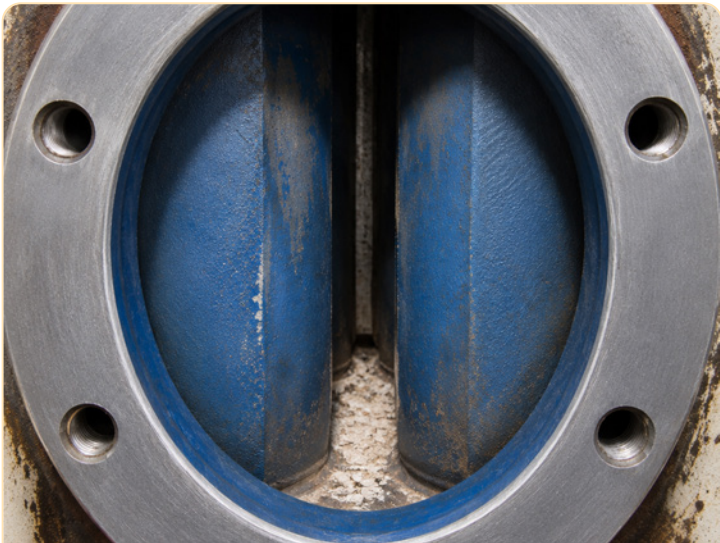
AFTER

Scale-Free Flue After Six Months

Scale fell from around 1 inch every six weeks to about 1/16 inch after six months.

One *HydroFLOW*® C100 treated the cold-water feed to two 80-gallon hotel hot-water tanks. Cleaning had required a full maintenance day every six weeks, while scale also affected three guest suites. Over the next six months, no routine tank cleaning was needed, drains flowed freely, all three suites returned to use and inspection found scale-free flues with only light removable deposits.
