# Irrigation System Limescale Treatment **Liguria, Italy**

Hydropath treatment stopped sprayer clogging and valve drips, helping a six-acre Cycas nursery maintain steady irrigation without pressure fluctuations.

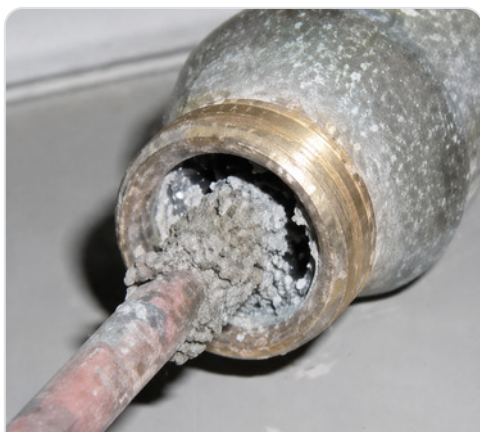
BEFORE

Mineral deposits inside a bottom valve

- Spray nozzles blocked frequently as mineral deposits accumulated
- Sprayers had to be dismantled, chemically cleaned and reassembled
- Deposits on seals caused shut-off valves and hydraulic rails to drip
- Deposit build-up affected both spray nozzles and valve seals
