# London Wastewater Struvite Control Case Study London, Ohio, USA

A 35-day trial reduced struvite accumulation, softened existing deposits and removed a significant amount of scale without chemical assistance.

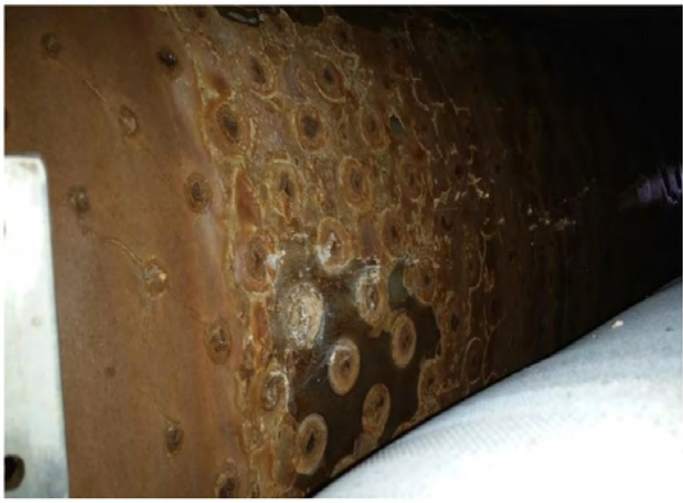
BEFORE

Struvite blocking the drum holes

- 1/4-inch struvite coated the belt press
- Years of deposits blocked first-roller holes
- Cleaning risked significant plant downtime

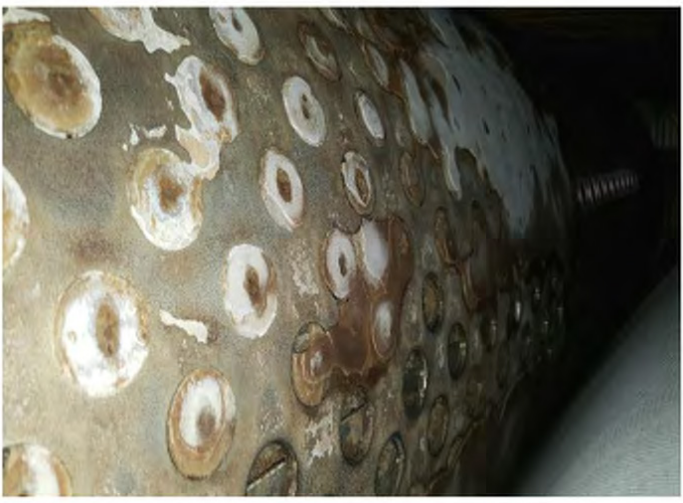
AFTER

Over half the drum holes open

By the end of the evaluation, over half the holes on the first roller were open.

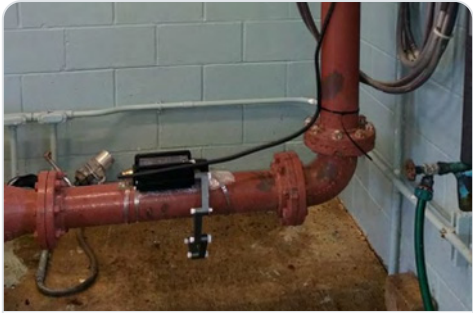
### INSTALLATION

*HydroFLOW*® unit on the sludge feed pipe

One *HydroFLOW*® i Range unit was fitted to the four-inch iron sludge feed pipe, approximately 30 ft before the belt press, and operated throughout the 35-day evaluation.

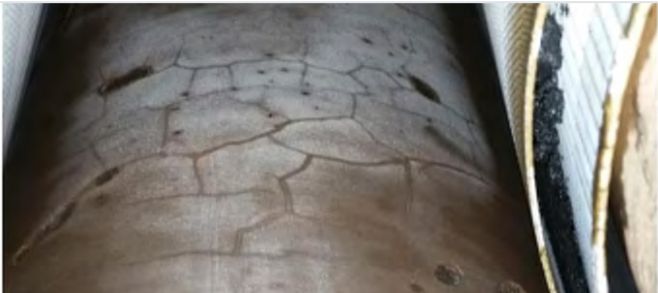
**BEFORE**

Bottom roller before the 35-day evaluation

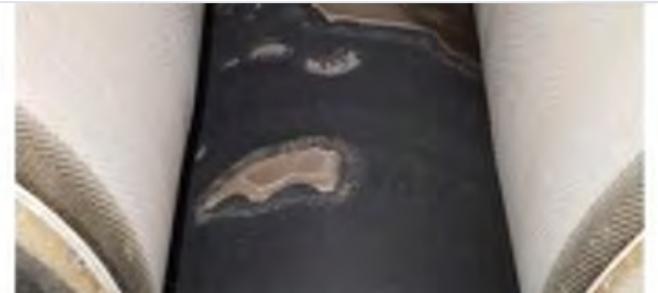
**AFTER**

Bottom roller after the 35-day evaluation

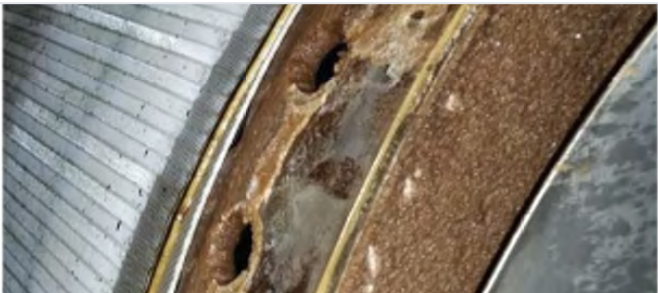
**BEFORE**

Side of roller before the 35-day evaluation

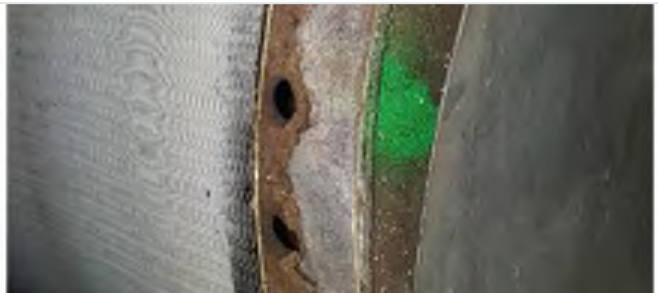
**AFTER**

Side of roller after the 35-day evaluation

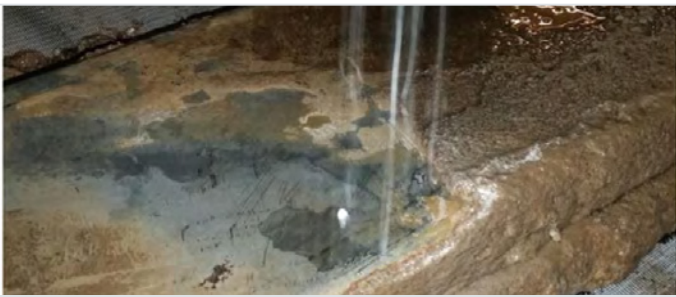
**BEFORE**

*Bottom beam before the 35-day evaluation*

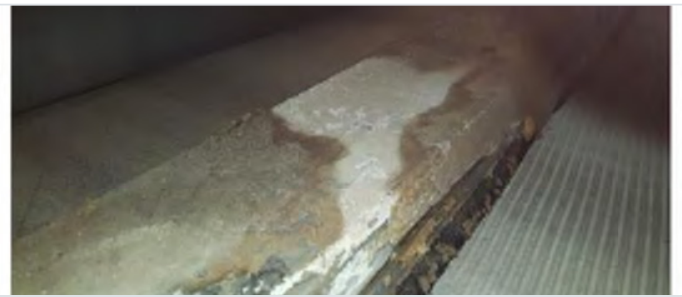
**AFTER**

*Bottom beam after the 35-day evaluation*

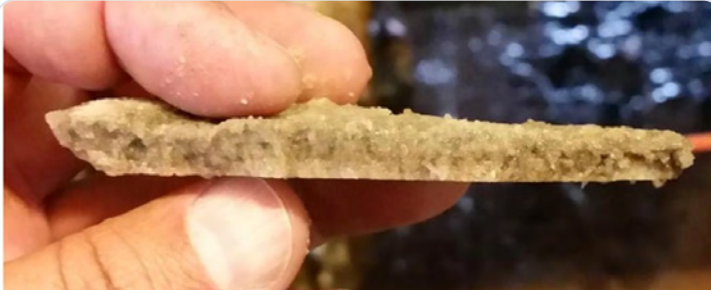
**BEFORE**

*1/4-inch struvite build-up inside the belt press*
