# Struvite Control Case Study Denver, Colorado, USA

A 60-day independent trial verified that Hydropath treatment prevented new struvite scale while gradually softening existing deposits for easier removal.

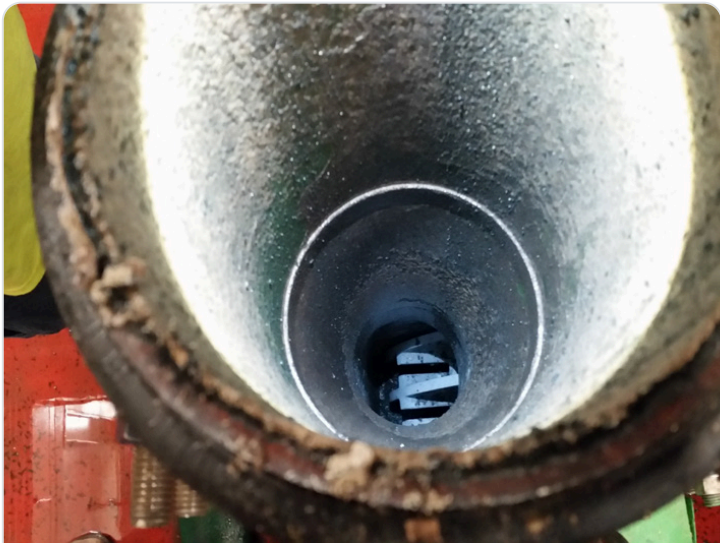
BEFORE

Heavy struvite on transfer pump

- Heavy, hard struvite restricted pipe diameter
- Transfer pump needed acid cleaning twice yearly
- Scale reached ~1/8 inch thick

- Hard scale reduced the internal diameter of the centrate discharge pipe.
- Heavy struvite encrustation forced the transfer pump offline for acid cleaning twice a year.
- Before the trial, scale was approximately 1/8 inch thick, hard and greyish.
- Centrate was transferred continuously, 24 hours per day.

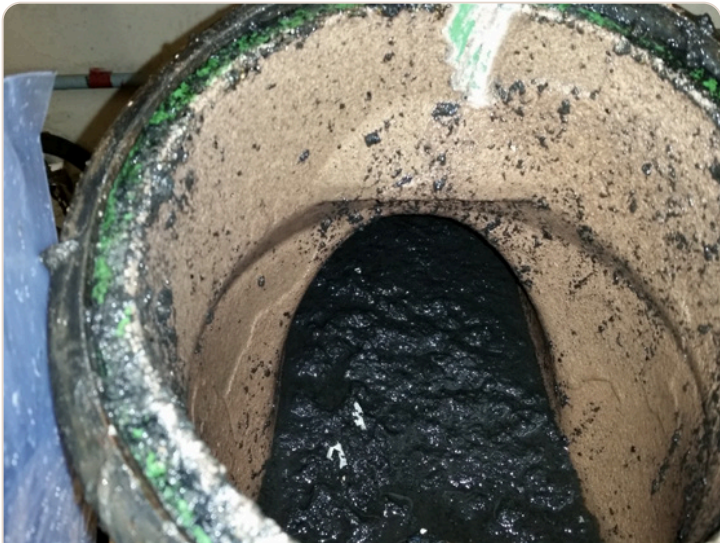
AFTER

Soft, thin scale after treatment

- ✓ Cleaned pipe sections remained free of deposits
- ✓ Existing scale became soft and easy to remove
- ✓ More clean pipe surface became visible

Existing deposits became thinner, softer and easier to wipe away.

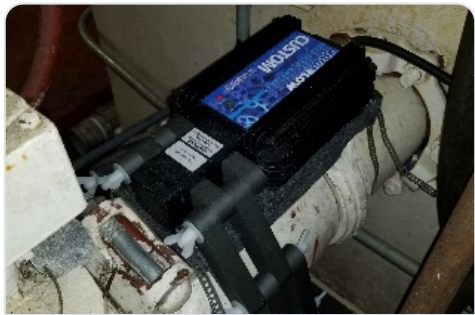
### INSTALLATION

*HydroFLOW® unit installed*

Two *HydroFLOW*® i Range units were installed on the centrate line, one at the transfer pump suction and one on the discharge side, with weekly sampling and visual inspections.

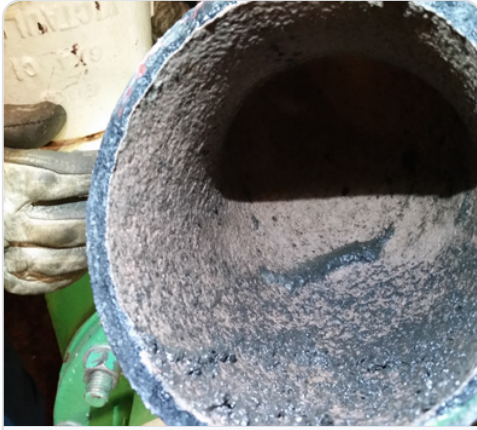
**BEFORE**

Heavy scale inside the transfer pump
