## Texas Hotel Hot Water Case Study **San Antonio, Texas**

HydroFLOW® i100 units improved hot-water flow across a 136-room hotel, drastically reducing low-flow alarms and cutting heater cleaning by 75%.

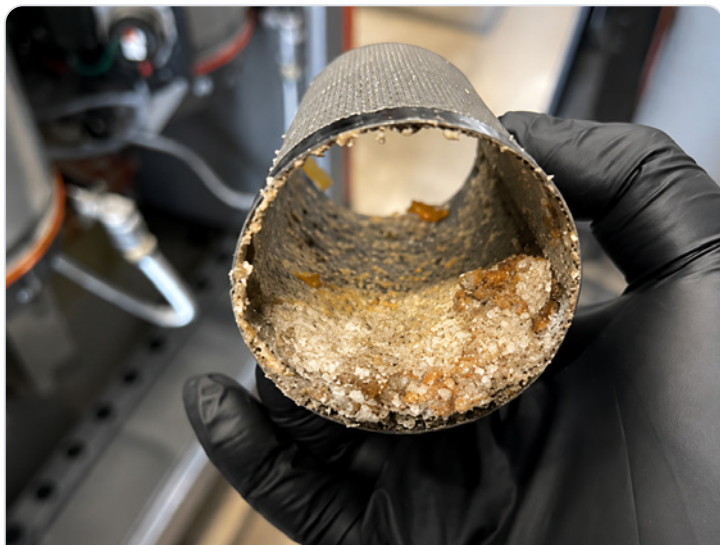
**BEFORE***Strainer heavily blocked by scale*

A four-storey, 136-room hotel in San Antonio faced severe scale problems from extremely hard water measured at 357 PPM, or 21 GPG. Scale restricted strainers, showerheads and faucet aerators, reducing hot-water flow and availability. The impact on guests became serious enough that the hotel provided room discounts and, in some cases, full refunds.

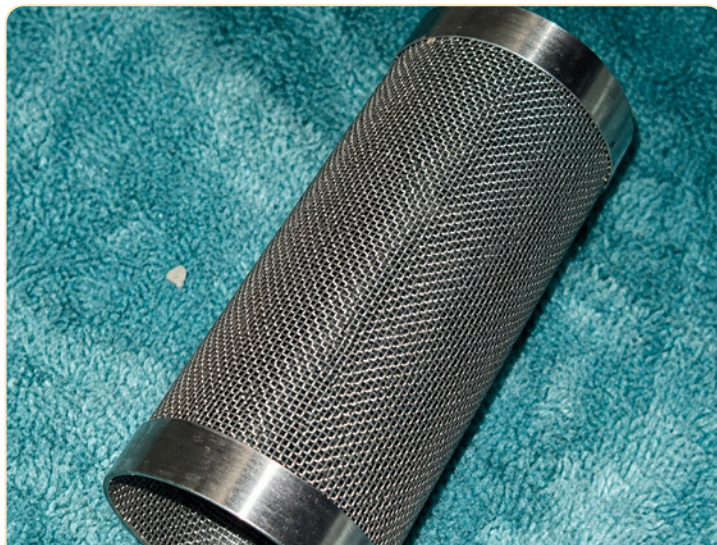
**AFTER***Clean strainer during maintenance*

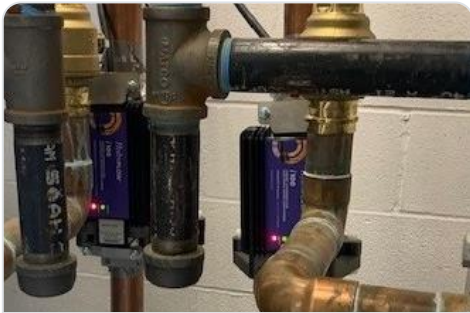
### INSTALLATION

*HydroFLOW*® units installed

Two *HydroFLOW*® i100 units were installed on the main water lines feeding the hotel's tankless water heaters.

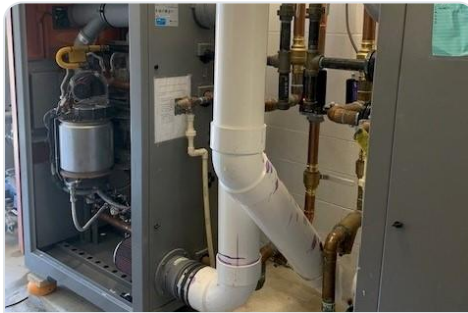
### PIPEWORK

*Tankless water-heater system*

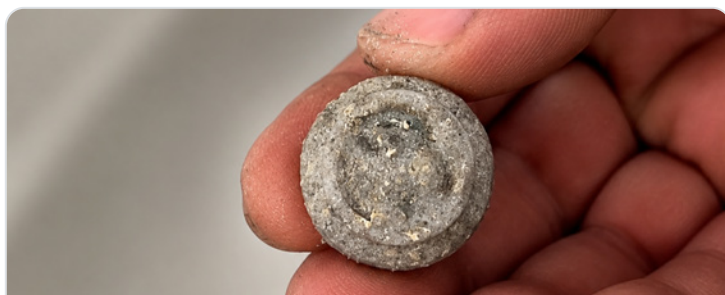
**BEFORE***Faucet aerator blocked by scale*

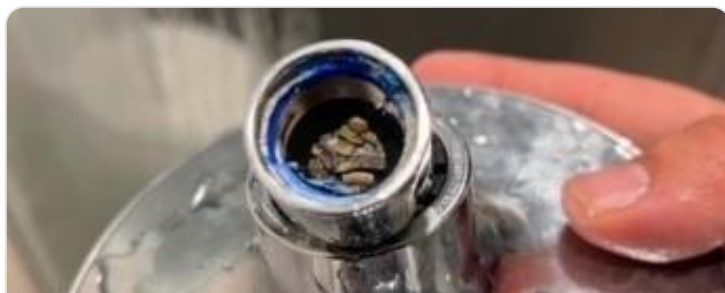
**BEFORE***Scale chunks blocking showerhead*
