# Walla Walla Struvite Control Case Study Walla Walla, Washington, USA

With Hydropath treatment, a cleaned section of the belt press drum stayed free of new struvite for eight weeks, while pan deposits softened for hose removal. Scale returned after switch-off.

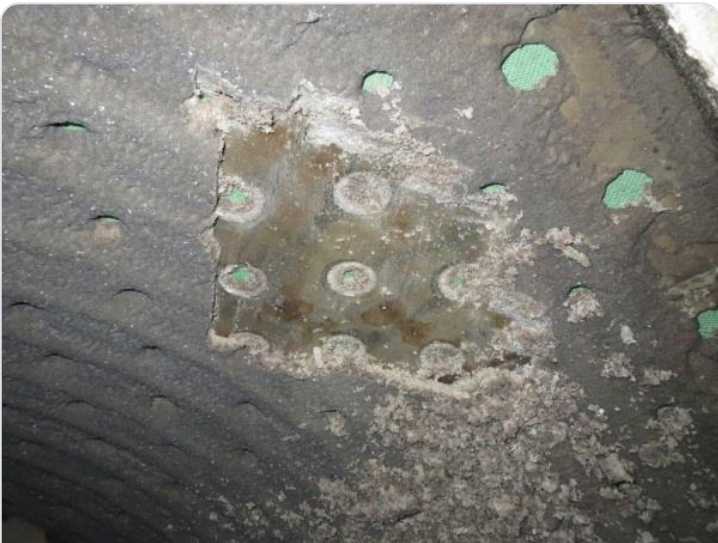
BEFORE

Cleaned drum section at trial start

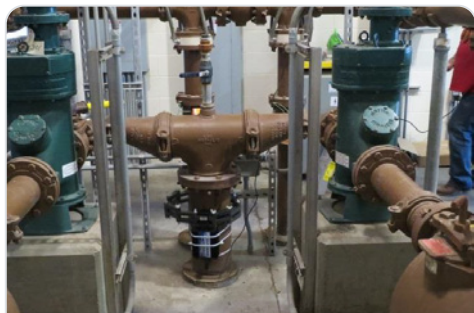
### INSTALLATION

*HydroFLOW*® Custom installed on the belt press

One *HydroFLOW*® Custom unit was installed on the belt press system. Cleaned 12 × 12 in drum and pan sections were monitored for eight weeks with the unit on, followed by seven weeks off.

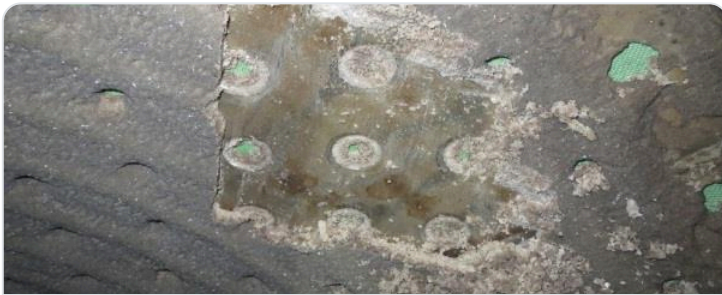
**BEFORE***Drum section cleaned to bare metal before treatment*

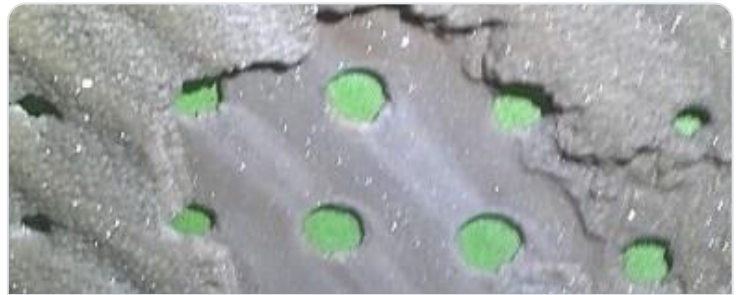
**AFTER***Drum remained clear after five weeks of treatment*

The cleaned drum section remained free from new scale for eight weeks of treatment.

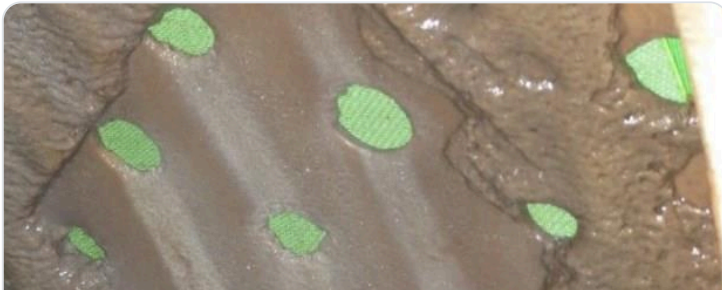
**AFTER***Drum stayed clear as existing struvite began to reduce*

Existing struvite layers on the drum were gradually removed during the treated period.

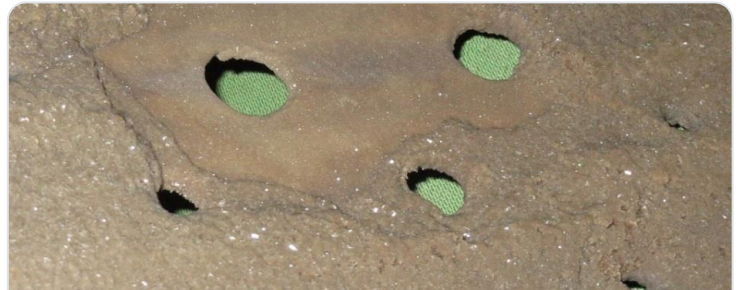
**INSPECTION***New struvite spread within four weeks of switching off*

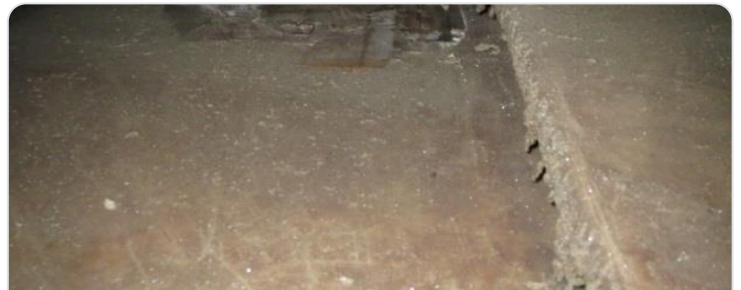
**BEFORE***Pan test section cleaned at the start of the trial*

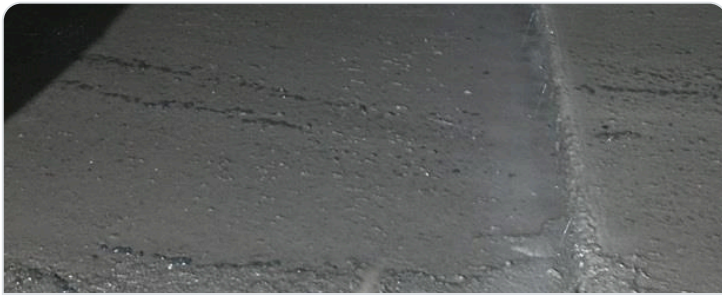
#### AFTER

Soft pan deposits after five weeks of treatment

After five weeks, pan deposits were soft enough for clear finger marks to be made.

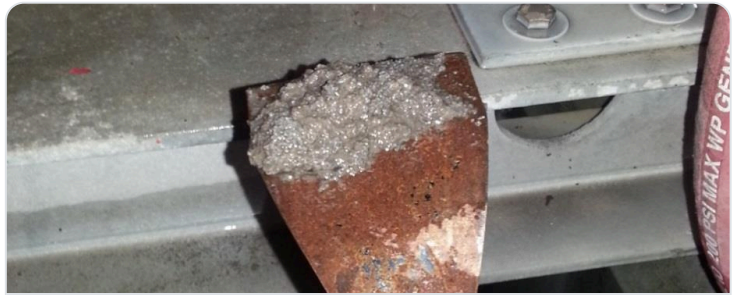
#### RESULTS

Soft struvite paste removed after eight weeks

After eight weeks, softened pan deposits could be washed off easily with a hose.

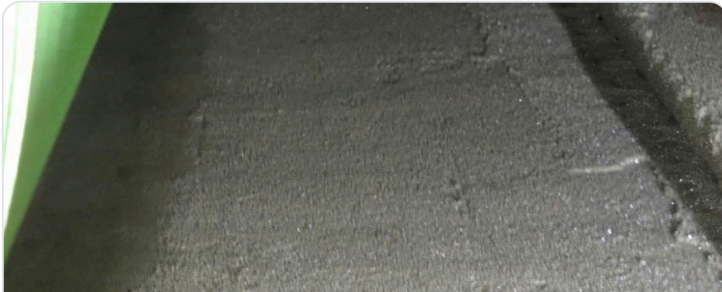
#### INSPECTION

1/8-inch pan scale after four weeks off

A 1/8-inch pan layer formed within four weeks after the unit was switched off.

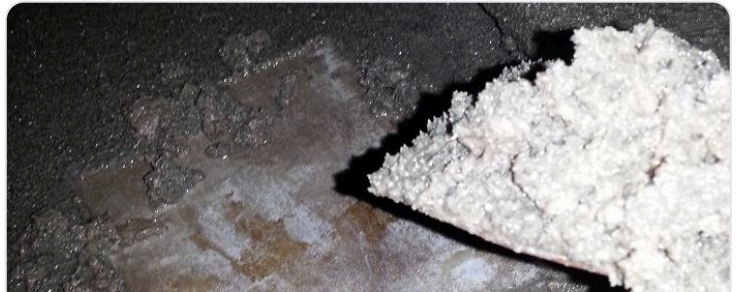
#### INSPECTION

1/4-inch pan scale after seven weeks off

After seven weeks off, the drum had 1/8-inch hard scale and the pan had 1/4-inch scale.
