# Boise Paper MIC Case Study Wallula, Washington, USA

Hydropath technology inhibited microbial induced corrosion in Boise Paper's starch line, preventing new nodules from forming while existing nodules gradually broke down over a 15-week trial.

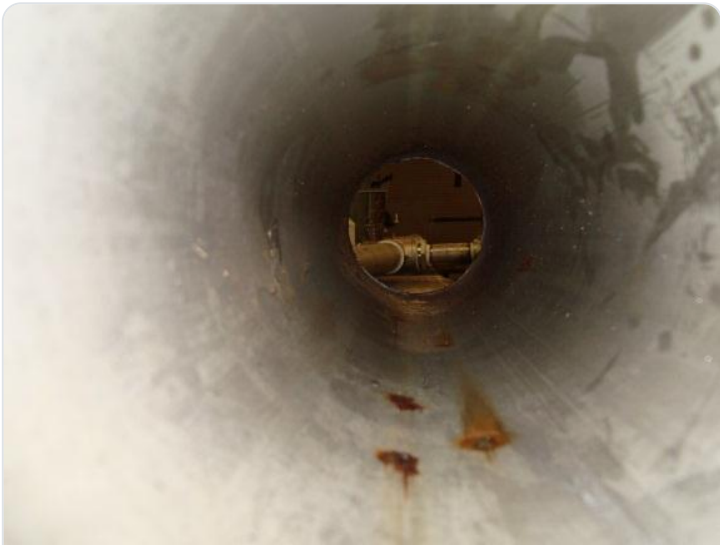
BEFORE

- Existing nodules in contaminated pipe
- Risk of pin-hole leaks from MIC
- Clean pipe required ongoing protection

Contaminated pipe spool section

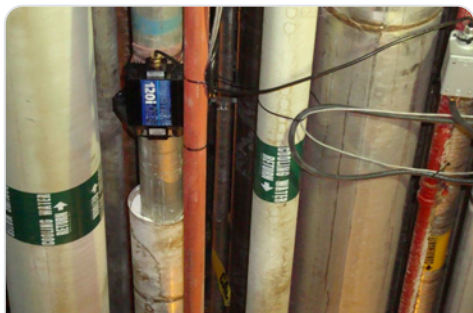
### INSTALLATION

1x *HydroFLOW*® i120 was fitted on the stainless steel W3 starch line, approximately 3 metres upstream of the monitored test spool sections.

*HydroFLOW*® i120 installed on line

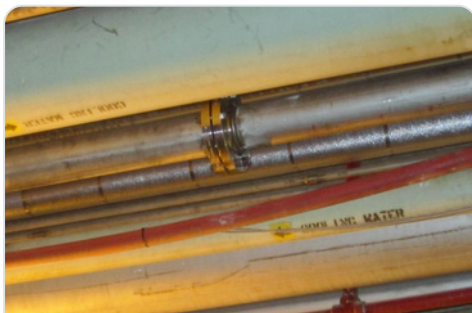
### PIPEWORK

*Clean pipe spools*

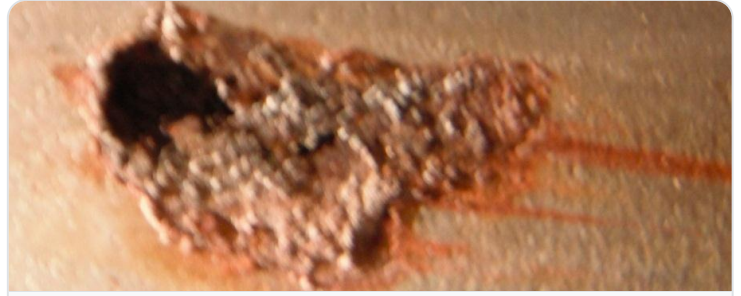
**AFTER**

*First Nodule after 15 weeks*

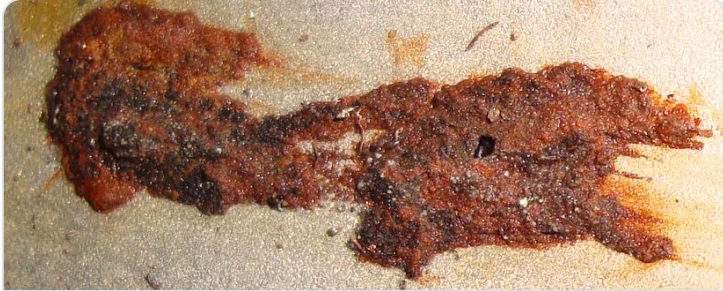
**BEFORE**

*Second Nodule*

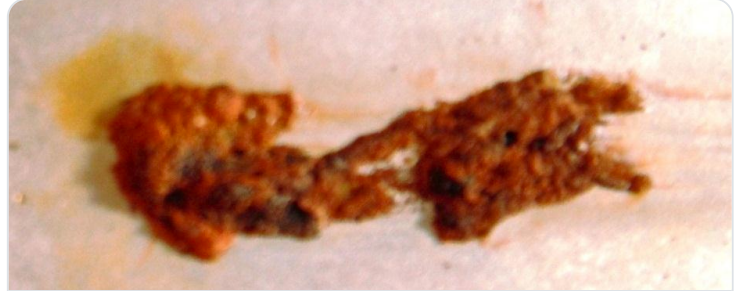
**AFTER**

*Second Nodule after 15 Weeks*

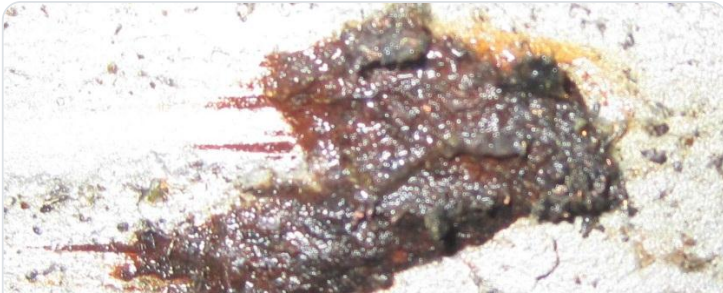
**BEFORE**

*Third Nodule*

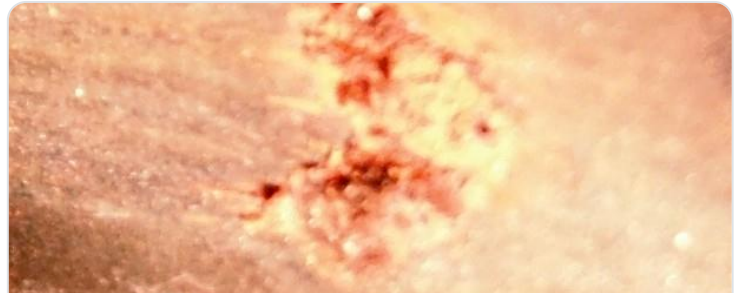
**AFTER**

*Third Nodule after 15 Weeks*

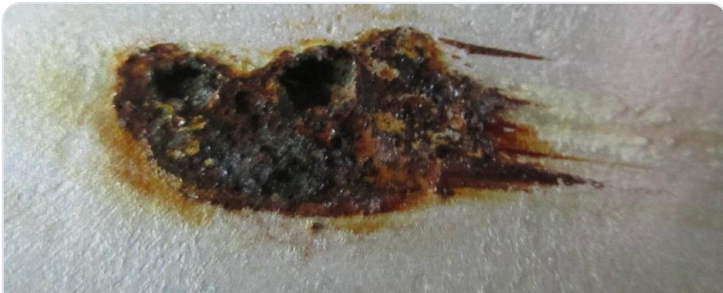
**BEFORE**

*Fourth Nodule*

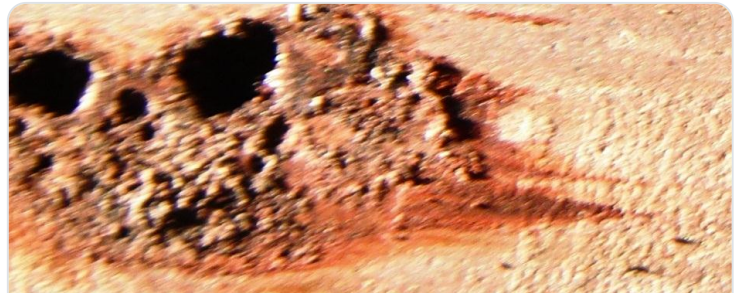
**AFTER**

*Fourth Nodule after 15 Weeks*
