# Hospital Ice Maker Scale and Biofilm Control **Central Kentucky, USA**

A 90-day *HydroFLOW*® HS38 evaluation progressively removed scale and biofilm from an ICU ice maker, easing maintenance and reducing the risk of contaminated ice reaching staff and patients.

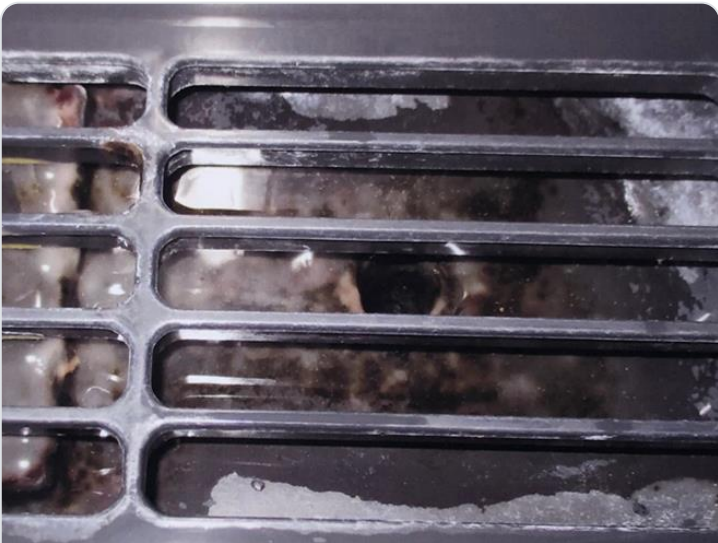
BEFORE

Scale accumulation on ice tray before treatment

- Scale accumulated across the ice-making tray
- Scale and biofilm were visible inside the chute
- Regular maintenance was more difficult

- Hard scale accumulated across the ice-making tray
- Scale and biofilm were visible inside the chute
- Regular maintenance was difficult and time-consuming
- Potential contamination risk affected staff and patients

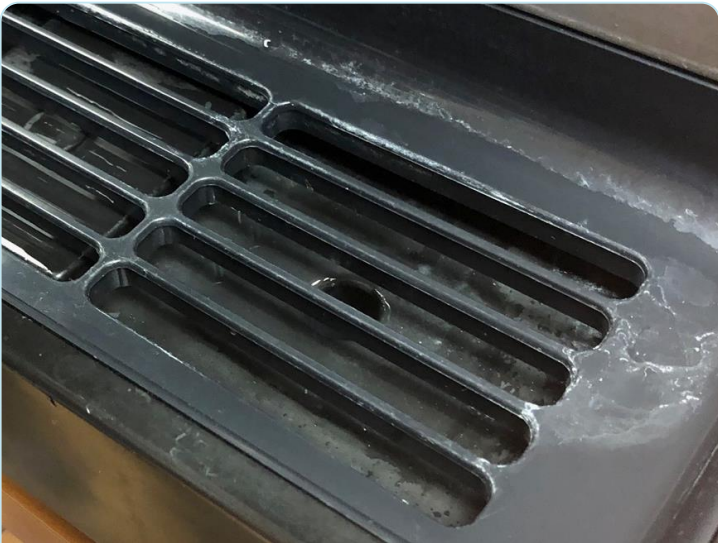
AFTER

Ice tray visibly cleaner after 90-day

- ✓ Existing scale and biofilm progressively removed
- ✓ Tray and chute remained visibly cleaner
- ✓ Routine maintenance became easier

Existing scale and biofilm were progressively removed during the 90-day evaluation.

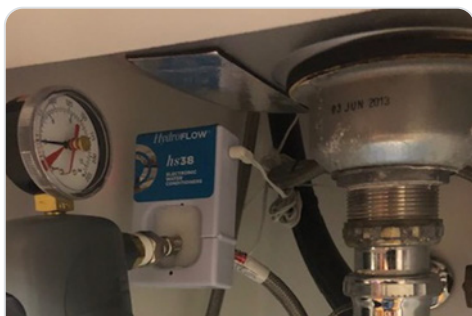
### INSTALLATION

*HS38 on the ice-maker cold-water supply*

A HydroFLOW® HS38, was installed on the cold-water supply feeding the Hoshizaki ice maker. The product evaluation ran for 90 days.

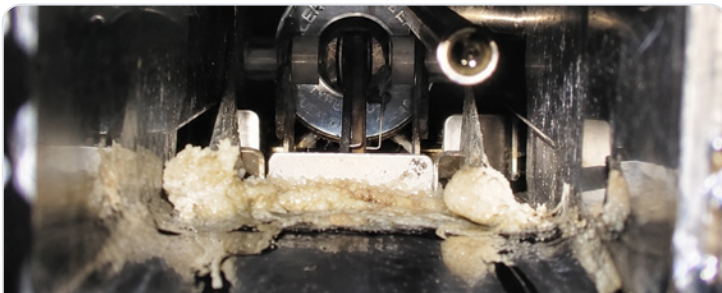
**BEFORE***Ice chute with visible scale and biofilm growth*

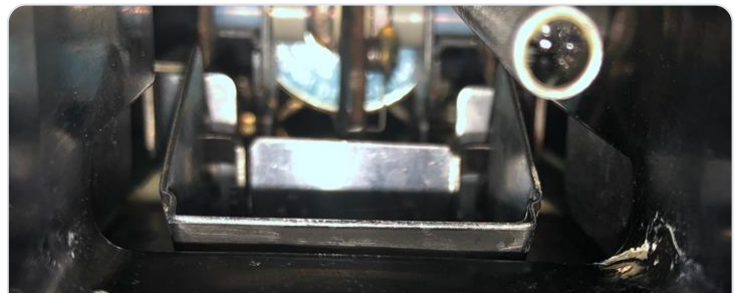
**AFTER***Ice chute visibly cleaner after the 90-day evaluation*

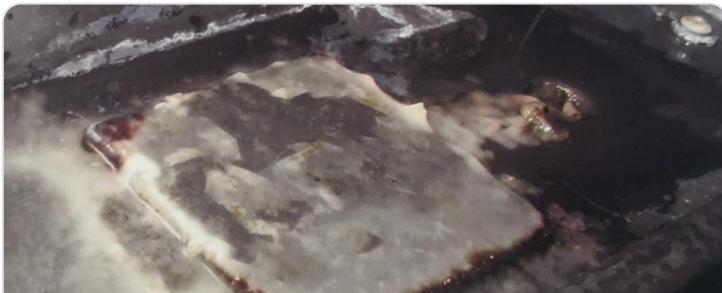
**BEFORE***Heavy deposits across the internal ice-making surface*

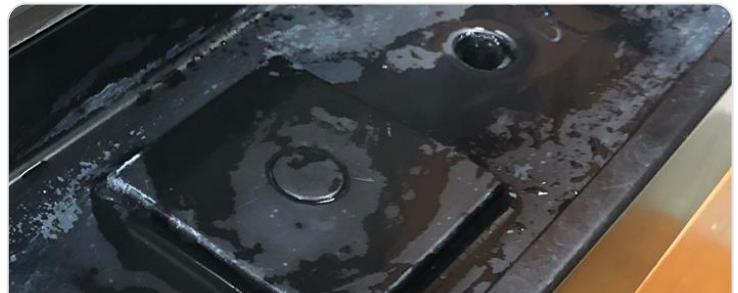
**AFTER***Internal surface visibly cleaner after 90 days***HYDROPATH**
