● COMMERCIAL HEATING/COOLING

# Plate Heat Exchanger Scale and Biofouling Protection Case Study Ukraine

A HydroFLOW® K40 protected two plate heat exchangers, progressively removing existing deposits and leaving the inspected flange free from scale and biofouling after ten months.

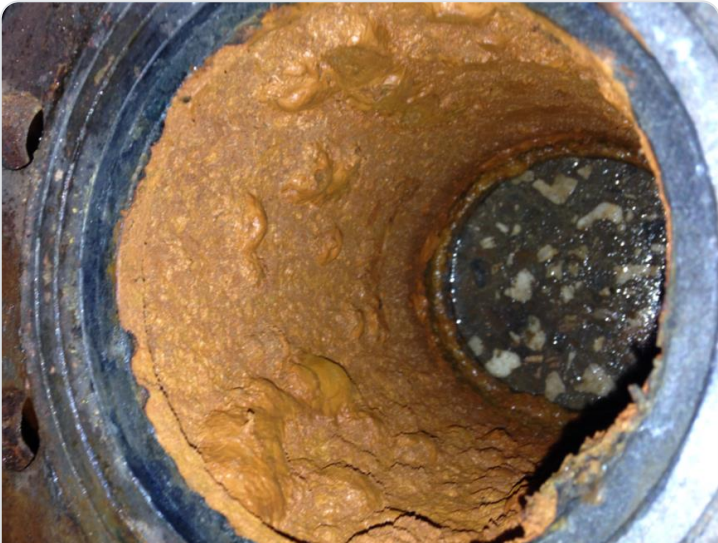
BEFORE

- Flange contained biological deposits
- Rust was visible inside the connection
- Scale had accumulated on internal surfaces

Scale and biofouling before treatment

State Enterprise 410 Plant operated two plate heat exchangers supplied by a cold-water line. Internal inspection before treatment showed a combination of biological deposits, rust and scale on the heat-exchanger connection. The plant needed to protect both exchangers and progressively clean existing deposits without dismantling the system for continuous mechanical treatment.

- Biological deposits visible inside the connection
- Scale covered internal flange surfaces
- Rust was also visible before treatment

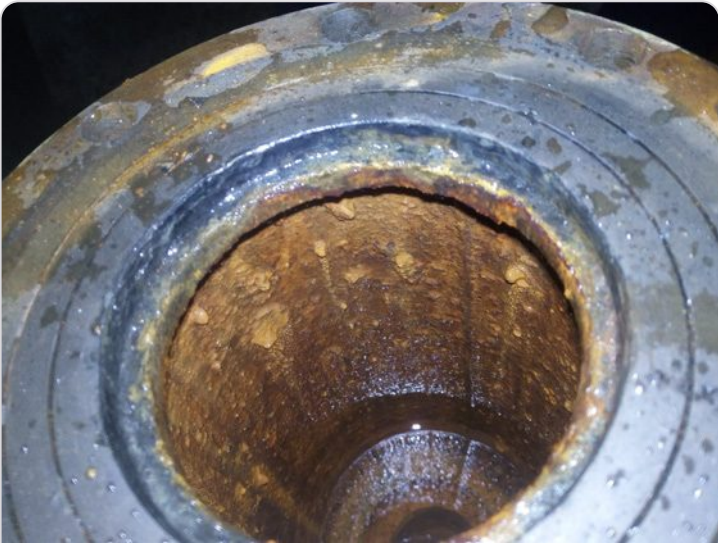
AFTER

- ✓ Biological deposits completely removed
- ✓ Existing scale progressively removed
- ✓ No scale or biofouling after ten months

Biofouling gone; scale reducing

Biological deposits were completely gone at the four-month inspection.

Remaining scale deposits were visibly undergoing progressive removal.

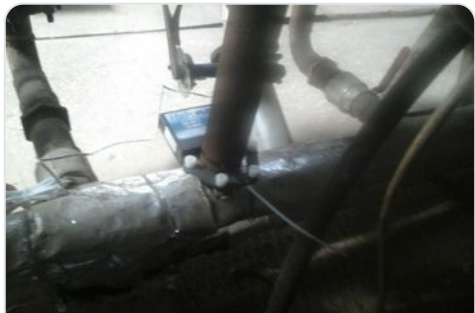
### INSTALLATION

A *HydroFLOW*® K40 was installed on the cold-water supply to protect both plate heat exchangers. Inspections assessed the system after four and ten months.

*K40 on cold-water line*

Cold-water supply pipe

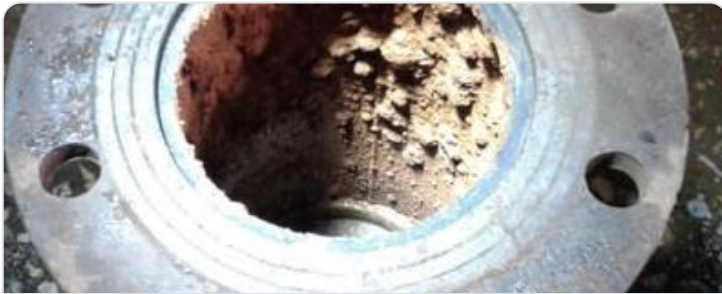
**INSPECTION***Biological deposits gone as existing scale begins to clear*

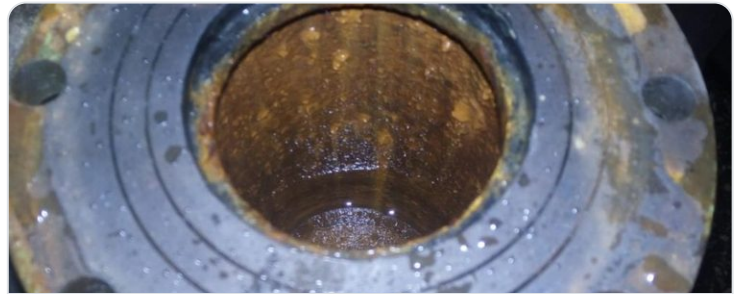
**AFTER***Further deposit reduction after ten months of treatment*

The inspected heat-exchanger flange showed no scale formation after ten months.

No biological deposits were found during the ten-month control opening.
