● COMMERCIAL HEATING/COOLING

# Residential Building Hot-Water Boiler Treatment London, Ontario

Boiler tubes remained free of scale and corrosion, chemical dosing was eliminated and minimum annual savings were calculated at \$11,639.

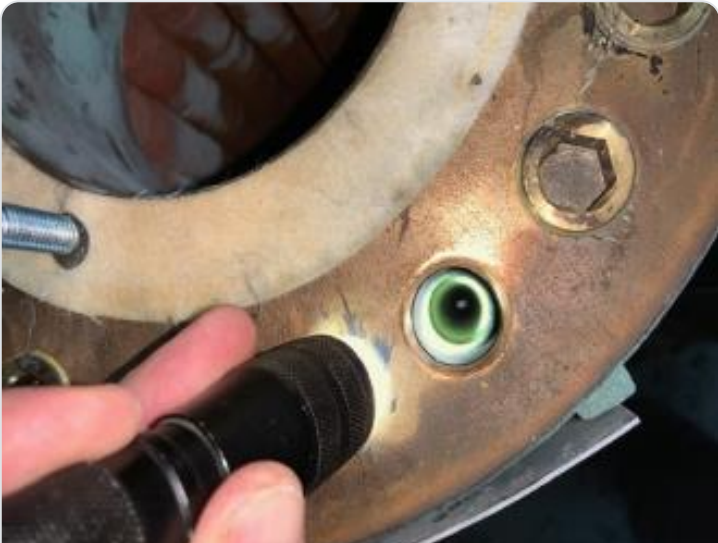
BEFORE

Scale build-up inside boiler tube

- Visible scale build-up within three months
- Scale affected boiler heat-transfer surfaces
- Parafoss chemical dosing was required

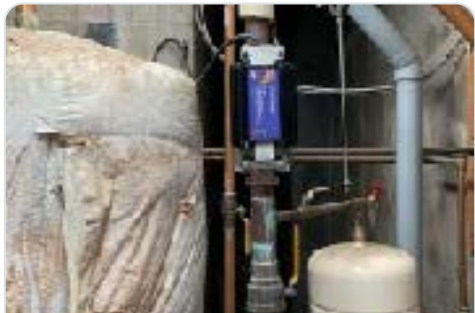
### INSTALLATION

*Unit installed before boiler pump inlet*

Two *HydroFLOW*® i60 units were installed, one before the boiler pump inlet and one on the cold make-up water line.

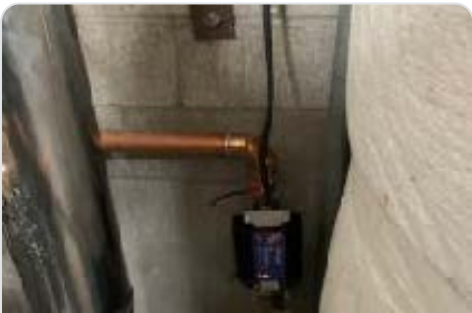
### INSTALLATION

*Unit fitted to cold make-up water line*

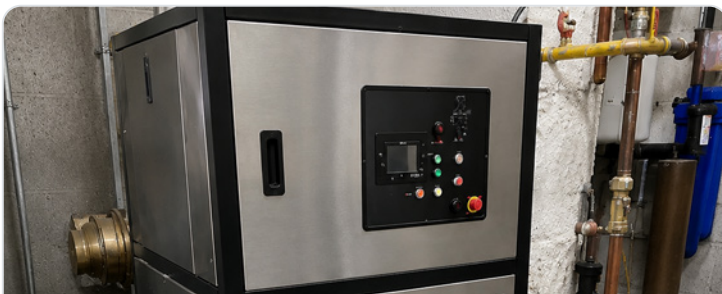
### SYSTEM

*Futura boiler serving the domestic hot-water system*

Northview REIT's 301 Baseline Road property is an 11-storey residential building with approximately 180 rental units. Its domestic hot-water system used a Futura boiler that had developed scale within only a few months of operation. The pilot assessed whether *HydroFLOW*® could control deposits while reducing projected energy, chemical and maintenance costs before a wider portfolio rollout.
