# BHFZ Steam Boiler Case Study Ukraine

A HydroFLOW® i60 removed established scale from a pharmaceutical plant steam boiler, reduced blowdown demand and left the boiler drum free of scale at the 11-month inspection.

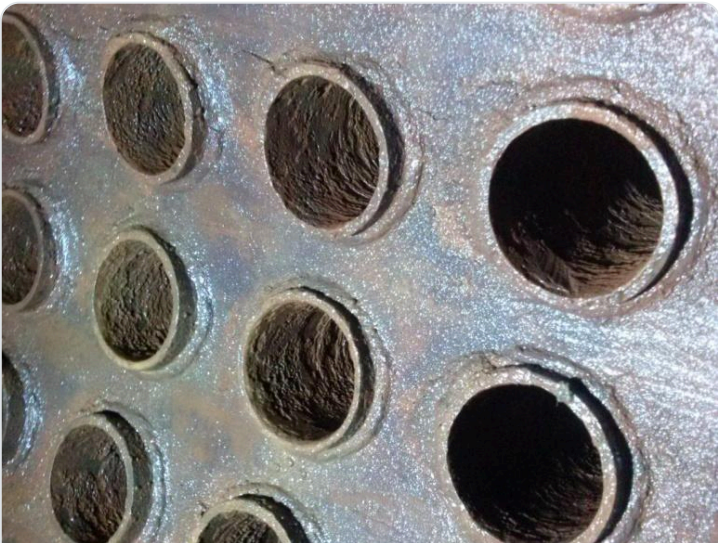
BEFORE

Dense 1.5–2 mm scale covering the tube

- Dense hard scale coated the boiler tubes
- Scale thickness reached 1.5–2 mm
- Blowdown was required two to three times daily

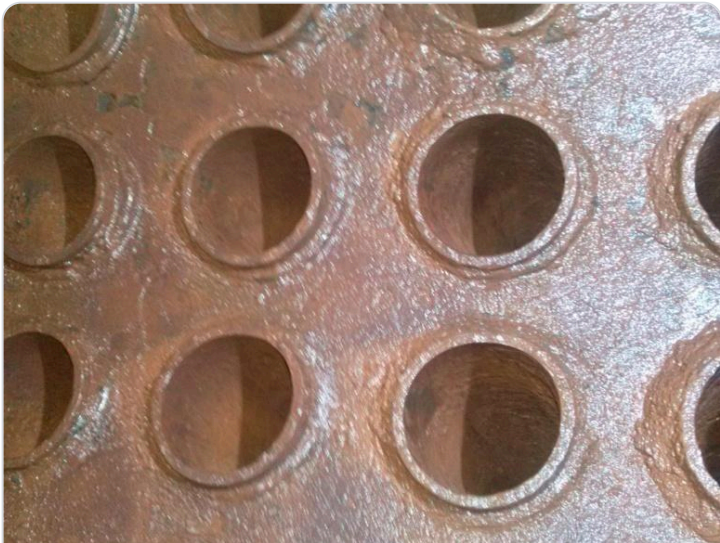
AFTER

Most scale removed after treatment

- ✓ Most established deposits disappeared
- ✓ Remaining scale was soft and easy to wash away
- ✓ No scale was found in the drum after 11 months

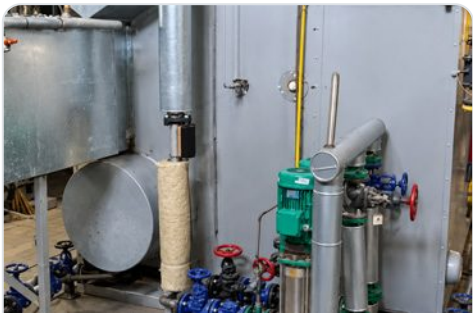
### INSTALLATION

*i60 installed after the feed pumps*

*HydroFLOW®* was installed after the feed pumps on the supply line to the steam boiler to address established scale, stabilise boiler-water conditions and reduce the need for frequent manual blowdown.

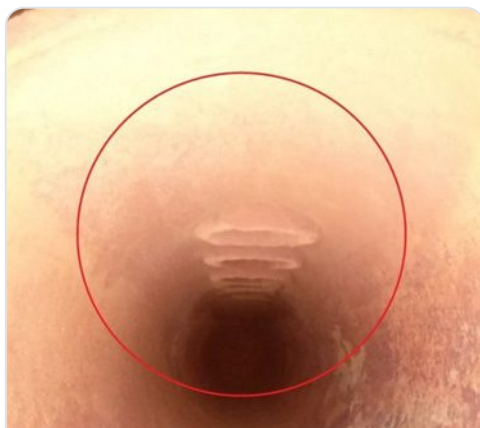
**BEFORE**

Dense hard scale covering the boiler screen tubes

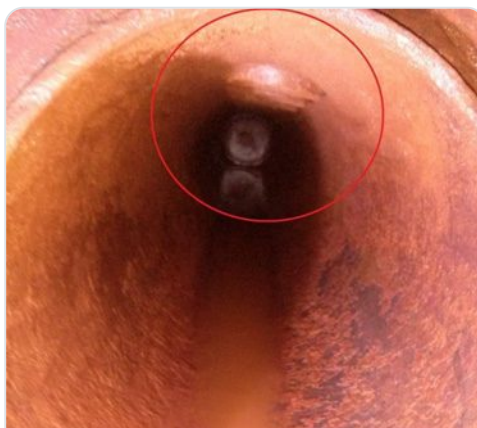
**AFTER**

Screen tubes almost free of scale after the trial

After the trial, almost no scale remained on the screen tubes and residue washed off easily.

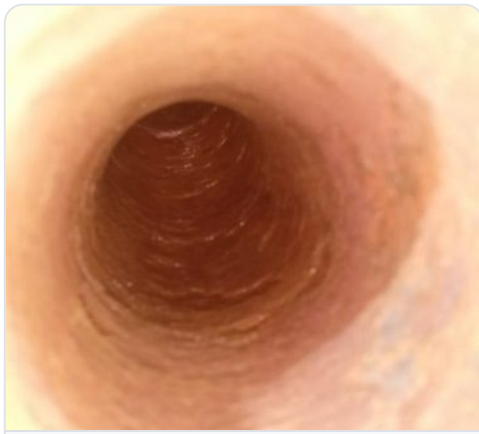
#### BEFORE

1.5–2 mm scale completely covering the tube

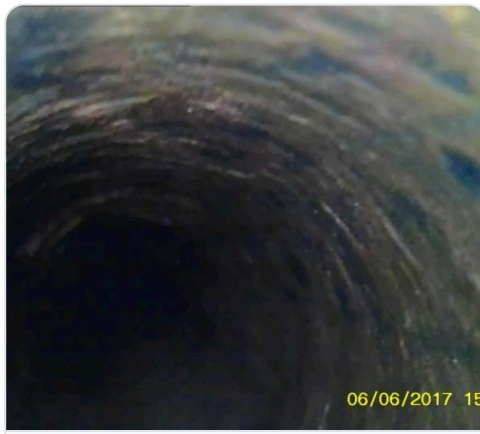
#### AFTER

Most scale disappeared; remaining deposits were soft

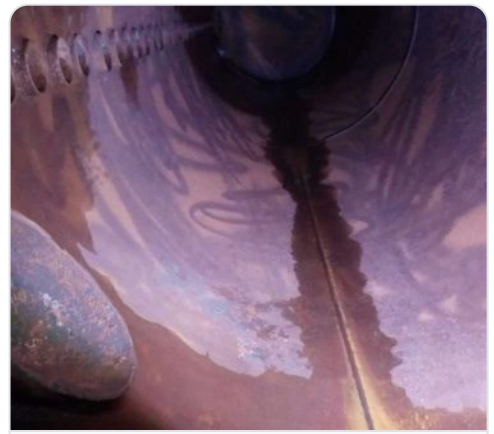
#### INSPECTION

No scale deposits found inside the boiler drum

The follow-up drum inspection found no scale deposits; a thin rust layer was easily removed.

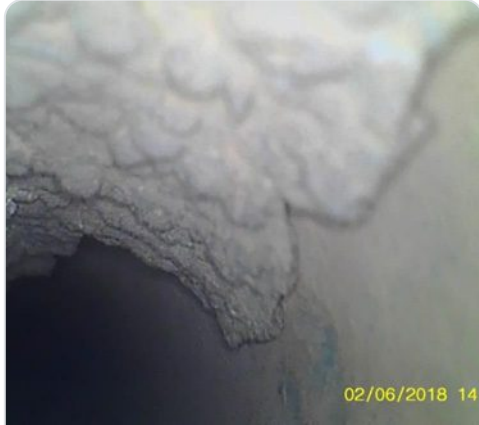
#### AFTER

Intense scale exfoliation inside the steam boiler

Established scale exfoliated from the screen tubes, collectors and boiler drum.

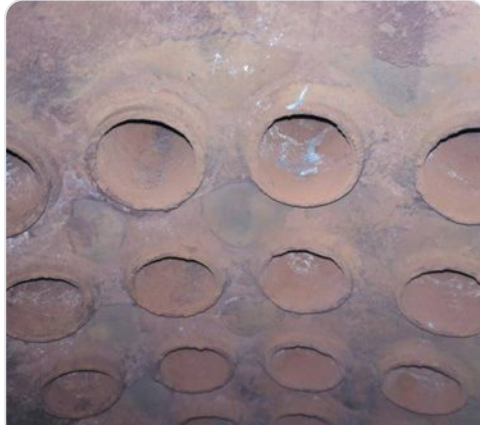
#### AFTER

Scale was not detected after HydroFLOW® treatment

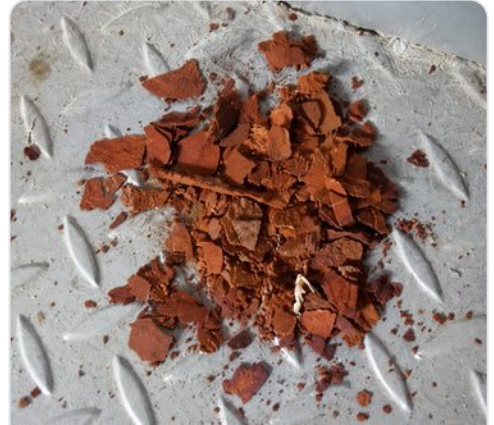
#### RESULTS

Scale released from inside the boiler

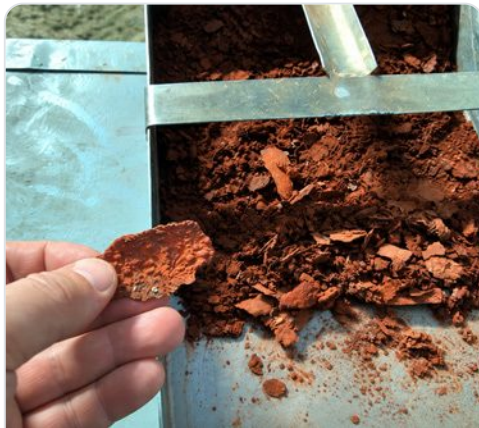
#### RESULTS

Exfoliated scale removed from the boiler

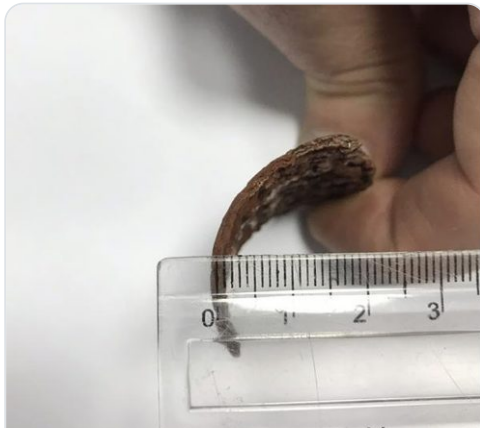
#### RESULTS

Thick exfoliated scale removed from the boiler tubes

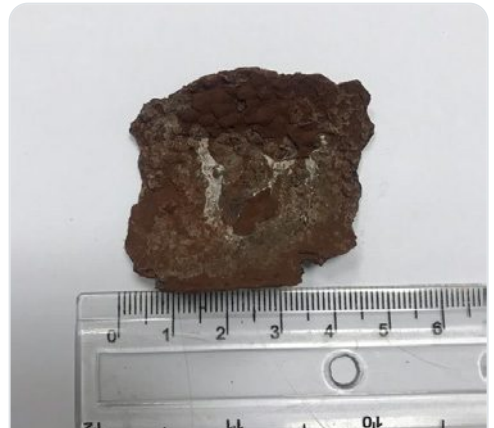
#### RESULTS

Thick exfoliated scale removed from the boiler tubes
