# Medical Centre Steam Boiler Case Study **Florida, USA**

A *HydroFLOW® i60* controlled hard scale in an electric steam boiler, removing existing deposits within 60 days and achieving a reported 16-month payback.

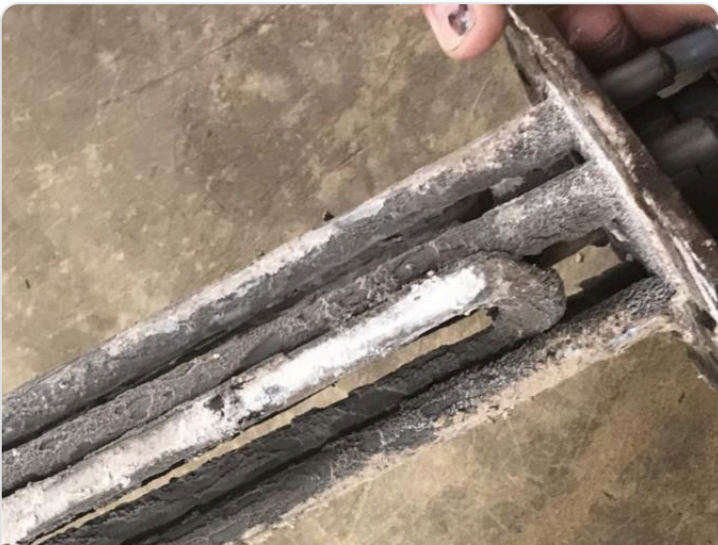
BEFORE

- Heating elements carried about 3 mm of hard scale
- Eight elements averaged four years' service life
- Scale affected elements and heating chambers

Hard scale on heating elements

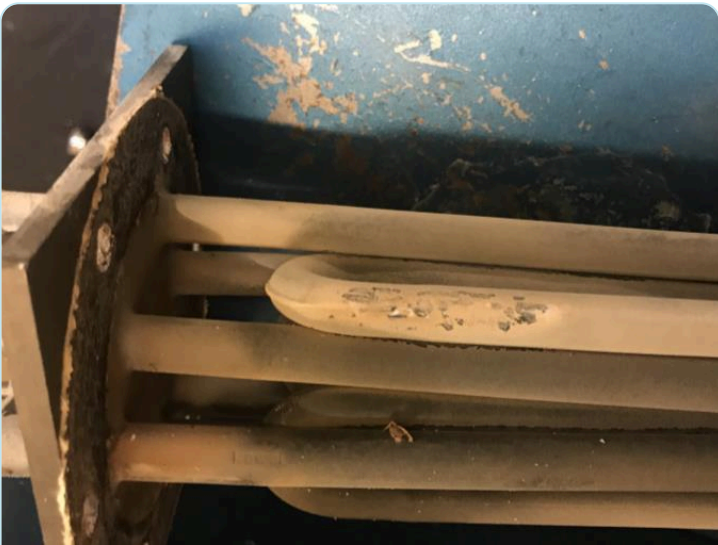
AFTER

- ✓ No new hard scale found after 60 days
- ✓ Existing hard scale was removed
- ✓ Residual deposits became loose powder

Elements clear after 60 days

Existing hard scale was removed from the electric heating elements.

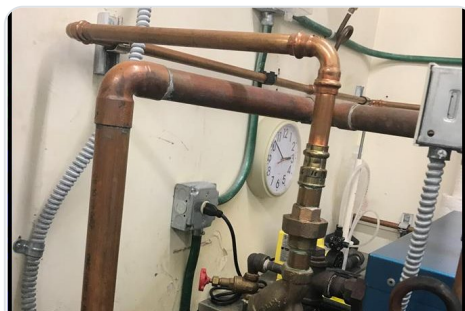
### PIPEWORK

*Cold-water feed to steam boiler*

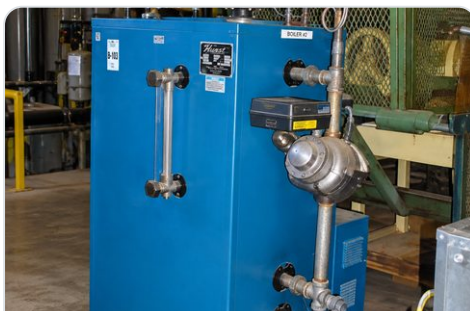
### SYSTEM

*Sussman ES135 boiler*

A Florida medical centre operated a Sussman ES135 electric steam boiler with eight heating elements, each averaging four years of service. Excessive hard-scale accumulation of approximately 3 mm affected the elements, prompting an evaluation of *HydroFLOW*® to improve scale control and equipment performance.

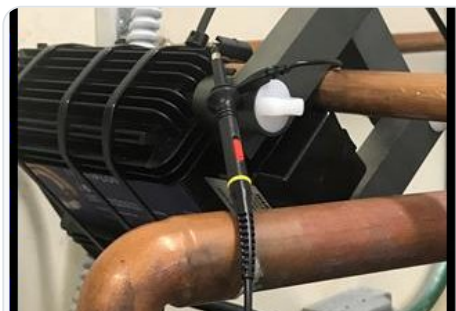
### INSTALLATION

*i60 fitted to the cold-water feed*

A *HydroFLOW*® i60 was installed on the incoming copper cold-water pipe feeding the Sussman ES135 electric steam boiler. Performance was assessed after 60 days of operation.

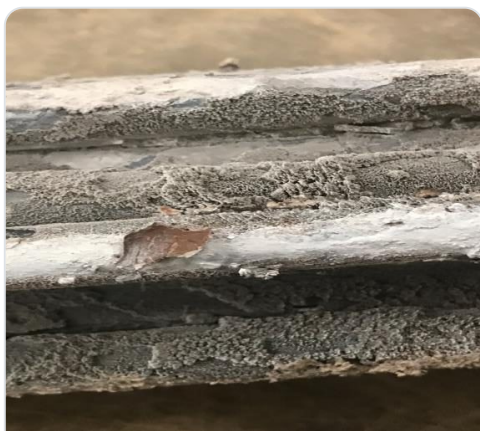
**BEFORE**

Close-up of hard scale on a heating element
