PAPER MANUFACTURING

# Paper Mill Shower Nozzle Case Study Wallula, Washington, USA

After 11 weeks, treated shower nozzles at Boise Paper Mill remained substantially clearer than the untreated comparison.

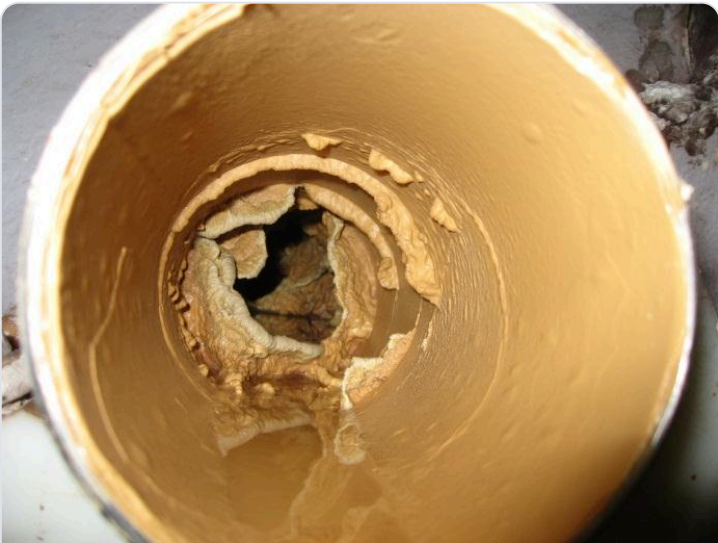
BEFORE

- Untreated nozzles showed heavy deposits
- Scale restricted nozzle openings
- Nozzles required regular cleaning

Untreated D1 nozzle – close up

Close-up images show a clear E1 nozzle beside substantial deposits in D1.

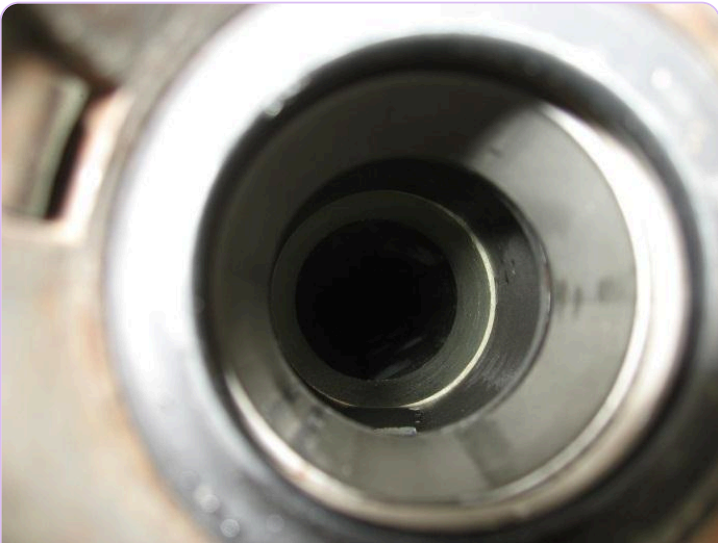
AFTER

- ✓ Treated nozzles opening remained clear
- ✓ No Hydroblasting Required
- ✓ Substantially less visible scale build-up

Treated E1 nozzle – close up

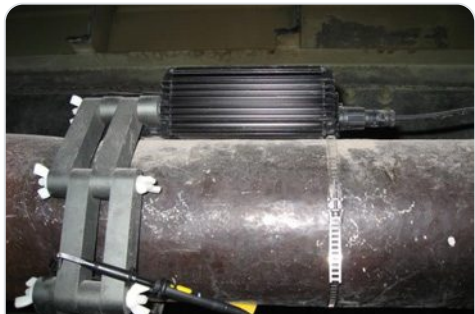
### INSTALLATION

HydroFLOW® unit was installed on the metal inlet pipe approximately 30 ft before the treated shower nozzles.

Custom 8" on E1 inlet pipe

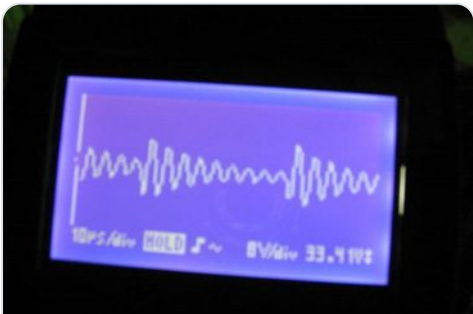
### SIGNAL

33–37 V peak-to-peak scope reading

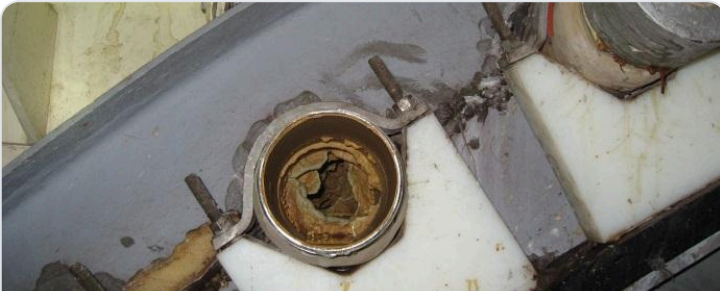
**INSPECTION**

Untreated D1 unit

The treated E1 unit opening appeared much clearer than the untreated D1 opening.

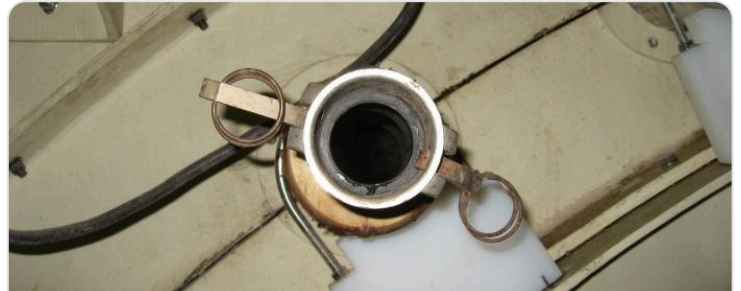
**INSPECTION**

Treated E1 unit

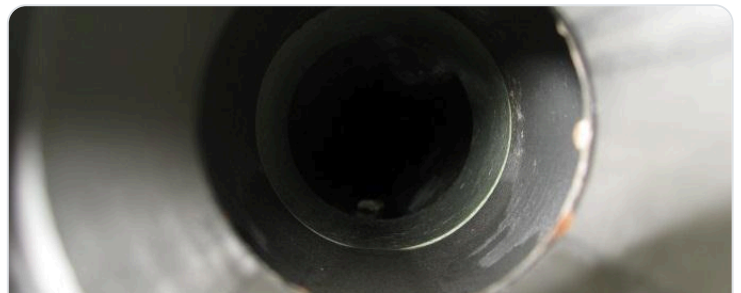
**RESULTS**

Treated E1 nozzle – 30' down the line

The E1 nozzle 30 ft down the line appeared clear; its D1 counterpart was scaled.
