# Steel Mill Spray Bar Case Study Ontario, Canada

HydroFLOW® reduced reported supply-line clogging from 65% to 10%, with no reported shutdowns or blockages during the following year.

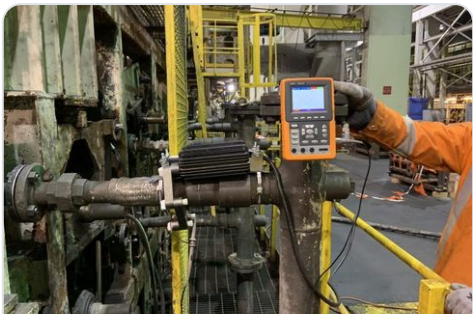
### INSTALLATION

HydroFLOW® was installed on the pump output line for a three-month onsite trial. The system was inspected at three-week intervals to assess scale build-up and blockage.

Output pipe downstream of system pump

*On the pump output line*

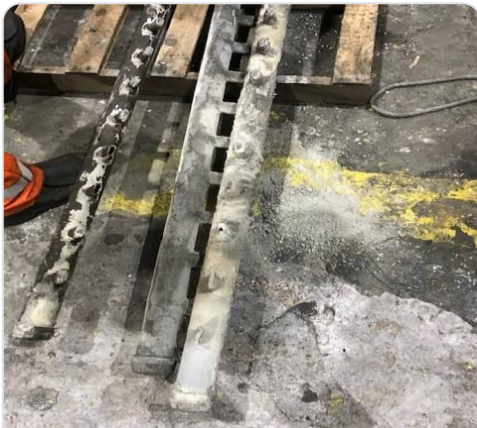
BEFORE

Scale build-up across cooling spray bars

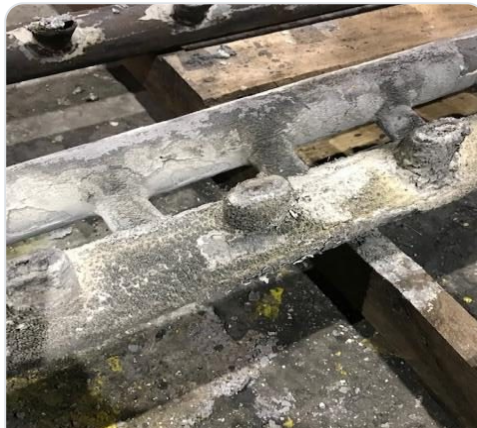
BEFORE

Heavy deposits on spray bar surfaces

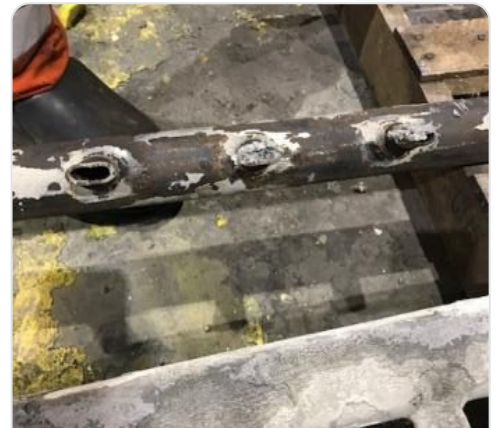
BEFORE

Blocked spray bar before treatment
