## Distillate Cooler Case Study Zaporizhzhya, Ukraine

At Zaporizhzhya Nuclear Power Plant, 2 *HydroFLOW*® Industrial test units softened heavy scale, removed biological fouling during the trial, and prevented new deposition on control beacons.

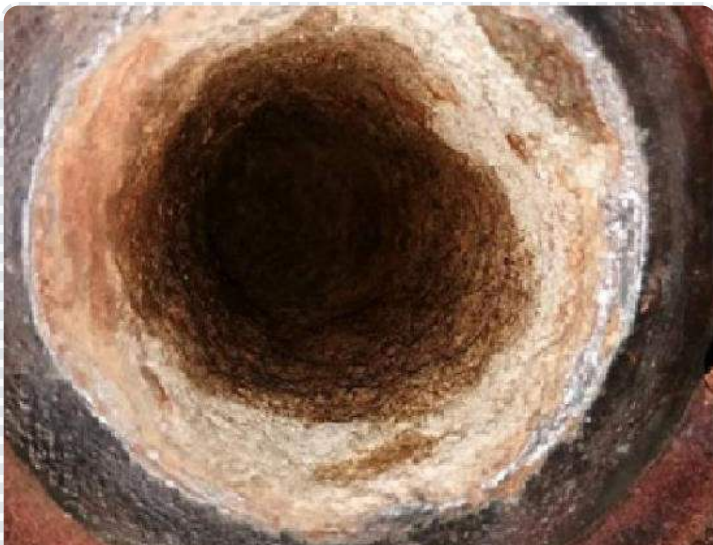
**BEFORE***Heavy carbonate scale inside pipe*

- ✗ Hard calcite deposits up to 12 mm
- ✗ Sludge, biofilm and putrefactive odour
- ✗ Snails found inside heat exchange tubes

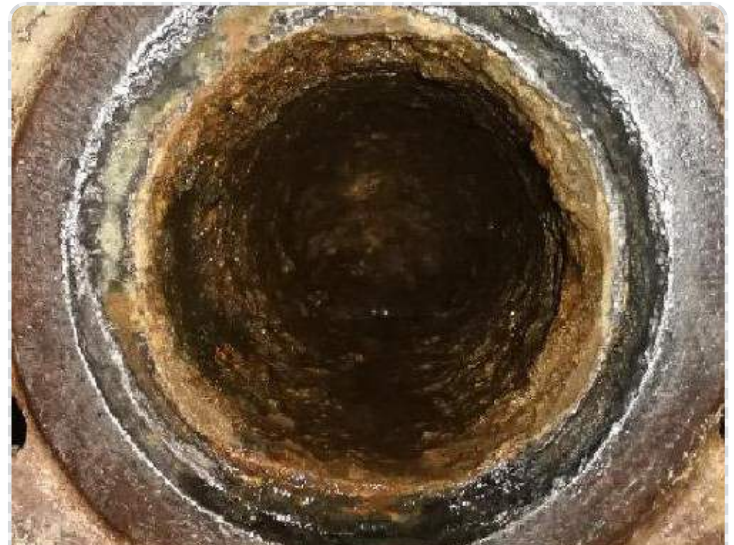
**AFTER***Softened and reduced deposits*

- ✓ Deposits softened, cracked and reduced
- ✓ Biological fouling removed during trial
- ✓ No new scale observed on control beacons

Previously hard calcite layers became brittle and could be removed with simple tools.

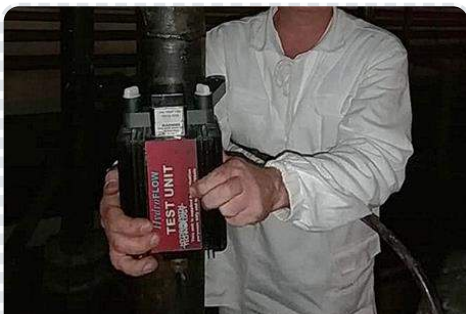
### INSTALLATION

Unit on supply pipe

Two HydroFLOW® Industrial test units were installed on 108 mm cooling water supply pipes upstream of the distillate coolers. Thermal sensors recorded data every two hours during the trial.

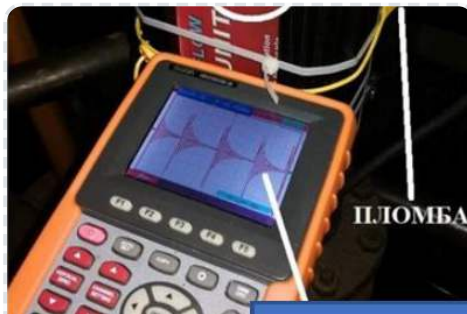
### MONITORING

Signal verification

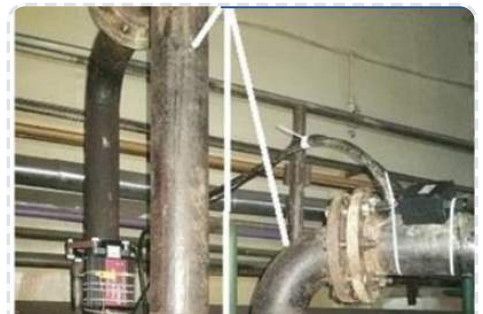
### SITE

Trial pipework

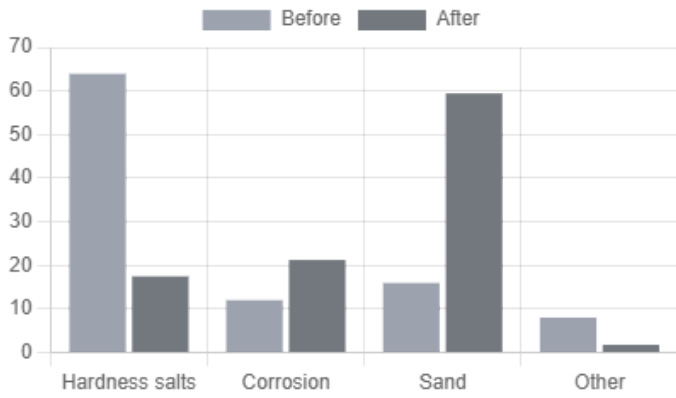
### Reduction in hard scale (Object 0)

Deposit samples showed reduced bound scale and loose material after treatment.

Lab analysis showed carbonates in hard pipe deposits fell from 63.93% to 17.5%.

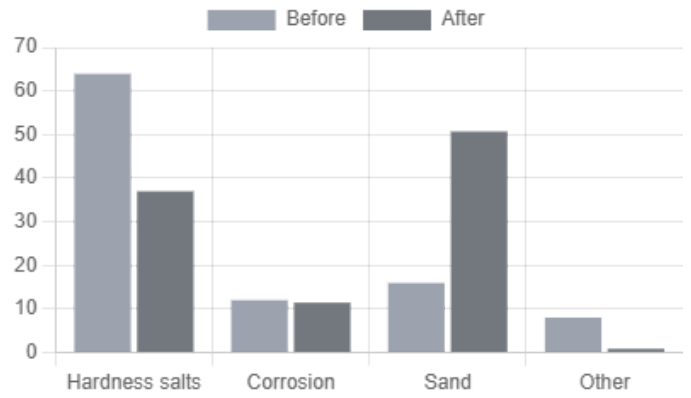
### Deposits became looser (secondary sample)

Final samples showed a shift away from hard bound scale towards looser material.

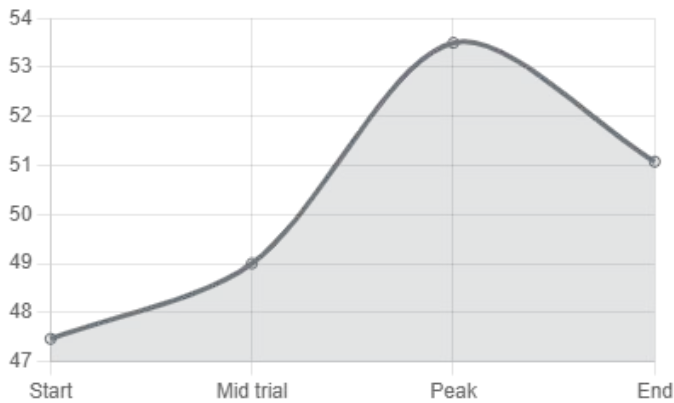
### LMTD trend during the trial

LMTD increased over the trial, indicating improved heat transfer performance.

A steady increase in LMTD was recorded from 47.46 to 51.08 during the trial.

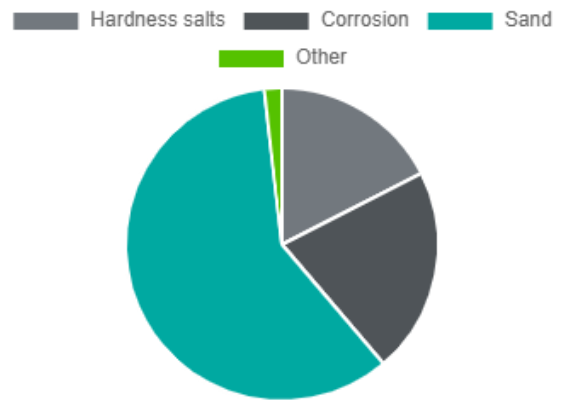
### Final deposit composition (Object 0)

Final deposit sample from Object 0 showing less hard scale and loose material

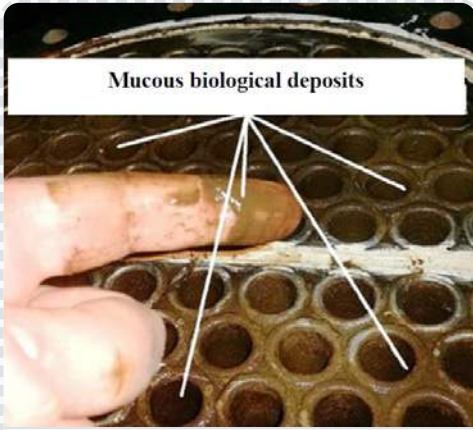
**BEFORE**

Mucous biological deposits

Biological deposits on the tube sheet before treatment

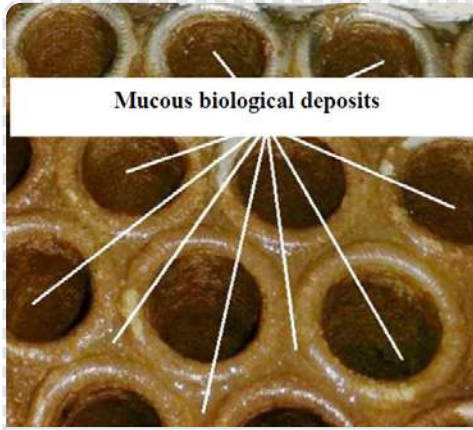
**BEFORE**

Mucous biological deposits

Close up of biological fouling before treatment

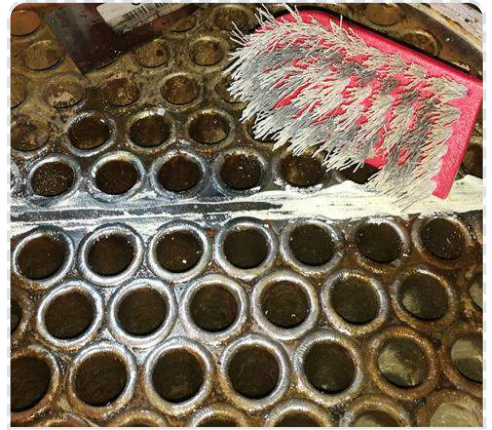
**BEFORE**

Tube sheet cleaned with a household plastic brush

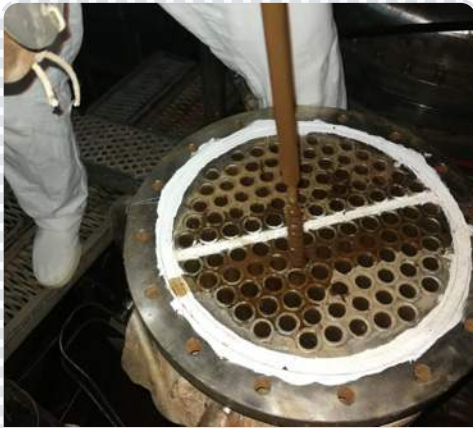
**BEFORE**

Cleaned beacons on the pipe using a household plastic brush

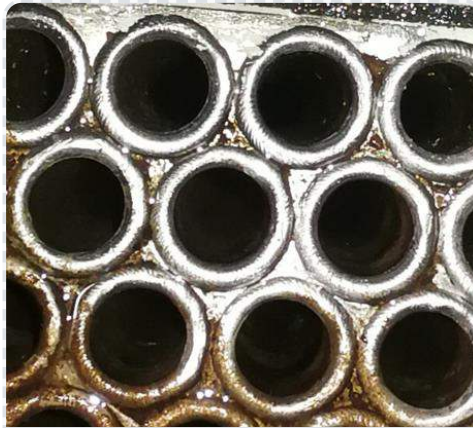
**AFTER**

Heat exchange tubes cleaned during final inspection

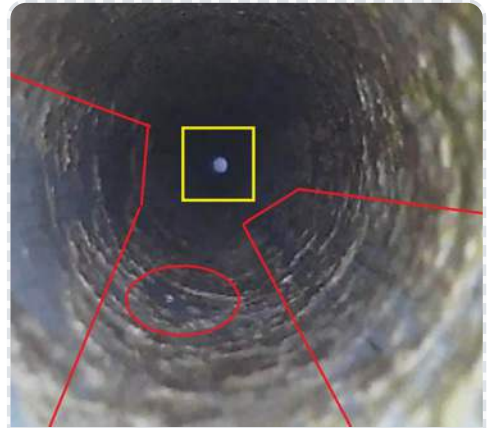
**RESULTS**

Carbonate layer loosened inside the tube wall

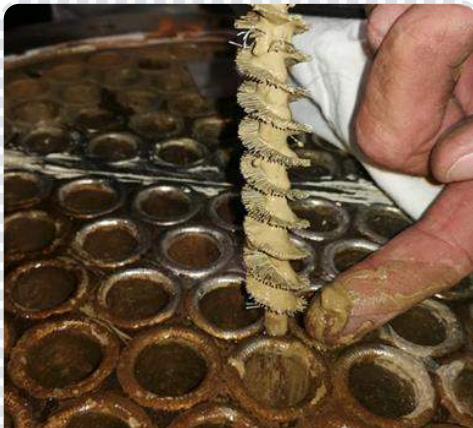
**RESULTS**

Sampling deposits from the inner surface of the heat transfer tube

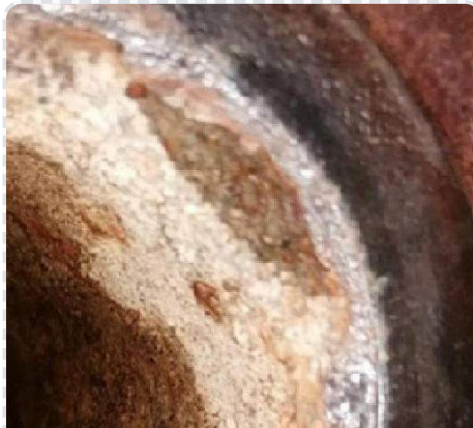
**BEFORE**

Pipe surface before treatment, close up view

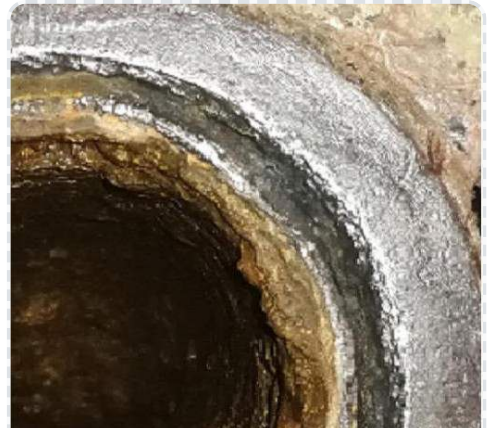
**AFTER**

Pipe surface after treatment, close up view
