# City Water Chiller Case Study Hong Kong

HydroFLOW® reduced existing scale buildup in a city water cooled chiller system and improved chiller energy efficiency by 16%.

A global bank building operated two freshwater cooled chiller units with a cooling capacity of 180 TR each to support its server room cooling systems. City water below 30mg/L hardness was treated using inhibitors and biocides. Condenser tubes required annual acid cleaning while cooling towers needed cleaning twice yearly. Hydropath treatment was installed to reduce scale buildup and improve chiller efficiency.

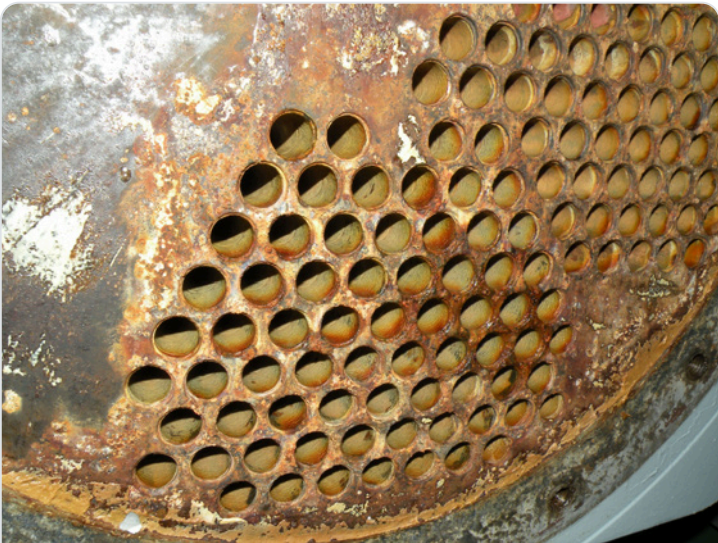
BEFORE

Scale deposits before treatment

- Condenser tubes cleaned with acid yearly
- Cooling towers cleaned twice yearly
- Scale buildup lowered chiller efficiency

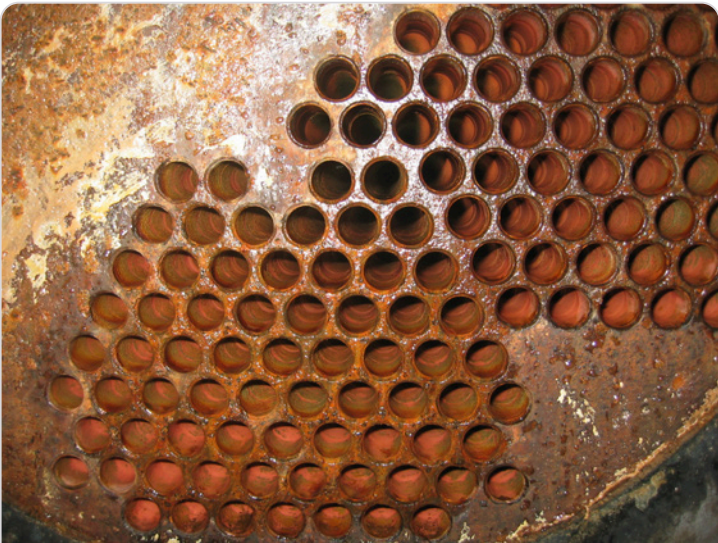
AFTER

Condenser tubes after treatment

Inspection after 1 year showed scale reduction

Clean condenser improved performance
