City Water Chiller Case Study Taiwan

HydroFLOW® reduced existing scale buildup in a city water cooled chiller system and improved chiller energy efficiency by 16%.

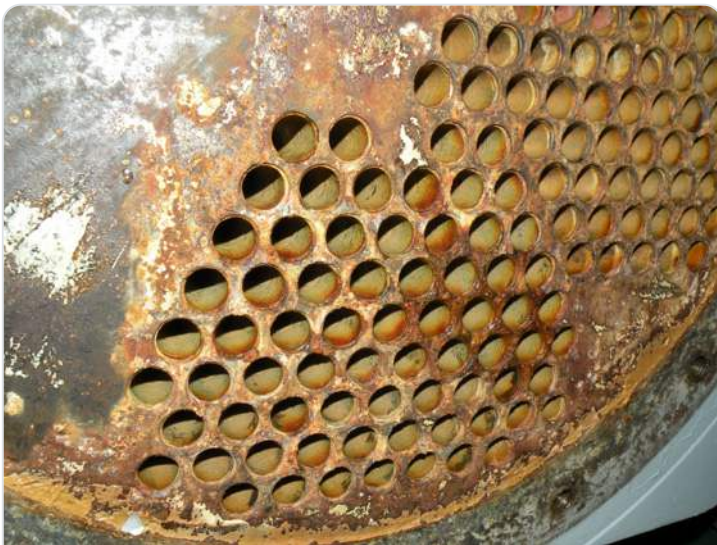
BEFORE

Scale deposits before treatment

- ✗ Condenser tubes cleaned with acid yearly
- ✗ Cooling towers cleaned twice yearly
- ✗ Scale buildup lowered chiller efficiency

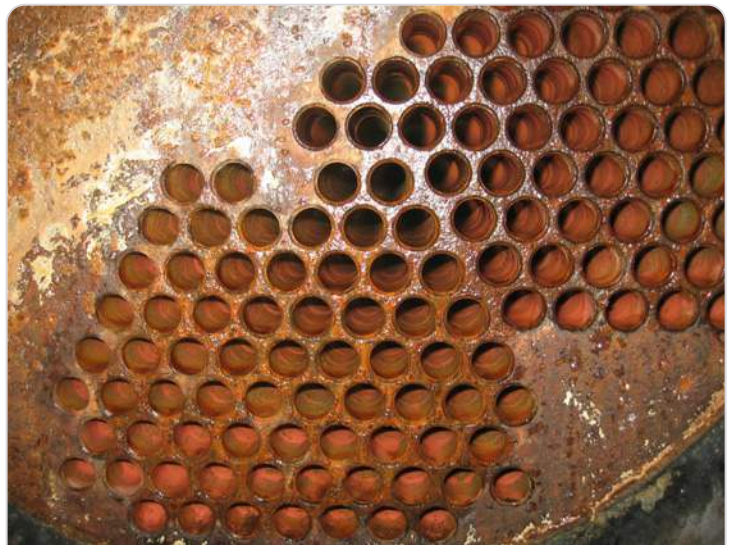
AFTER

Condenser tubes after treatment

- ✓ Existing scale deposits reduced
- ✓ Chiller efficiency improved by 16%
- ✓ Chiller operation remained stable

Inspection after 1 year showed scale reduction
