● COOLING TOWER

Municipal Building Chiller Water Savings Case Study Arizona, USA

HydroFLOW® unit enabled significant water savings and reduced chemical use in municipal cooling towers while maintaining system performance during a 5.5-month evaluation.

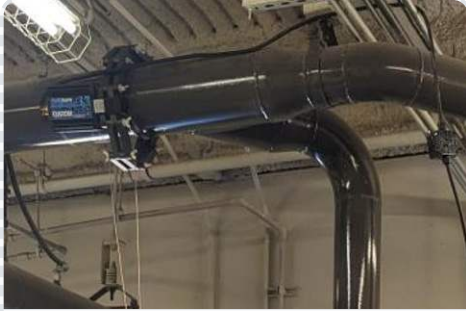
INSTALLATION

i8" on condenser line

1x *HydroFLOW*® i8" Custom unit was installed on the condenser water line between the tower and chiller, enabling higher conductivity and reduced chemical usage.

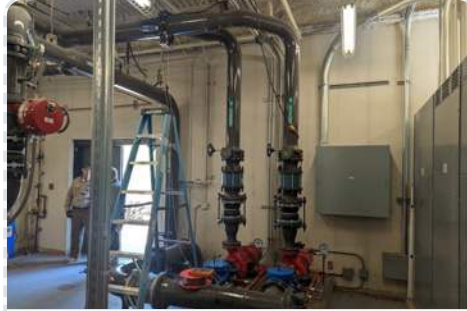
SITE

Chiller plant system

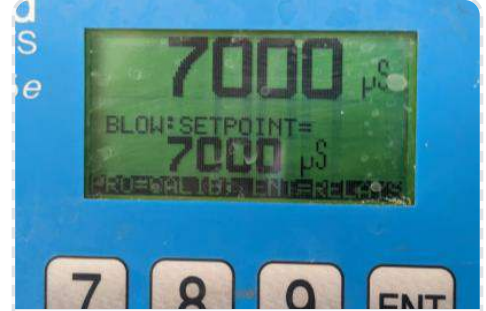
MONITORING

7000 $\mu\text{S}/\text{cm}$ reading

System operated at 7,000 $\mu\text{S}/\text{cm}$ conductivity.

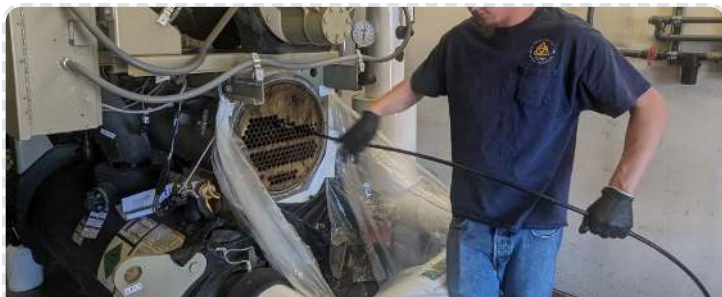
MONITORING

Chiller inspection showing minimal soft scale

Inspection showed minimal soft scale deposits.

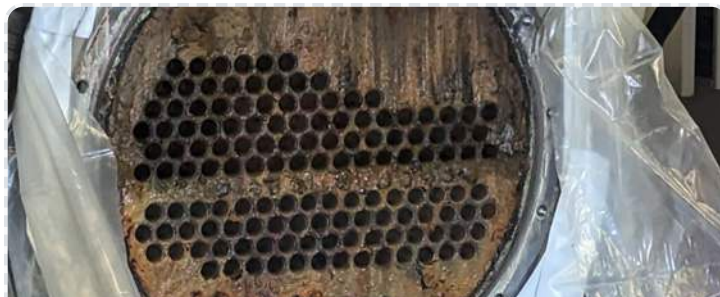
AFTER

Tube sheet showing minimal soft scale
