# High-End Resort Scale Reduction Case Study **Santa Fe, New Mexico, USA**

HydroFLOW® units reduced scale buildup in resort water systems with extremely hard water, supporting improved heater operation and enabling full site installation.

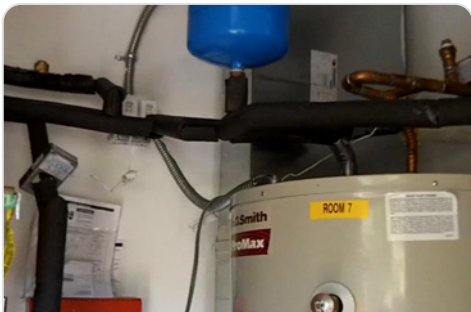
### INSTALLATION

s38 units on pipework

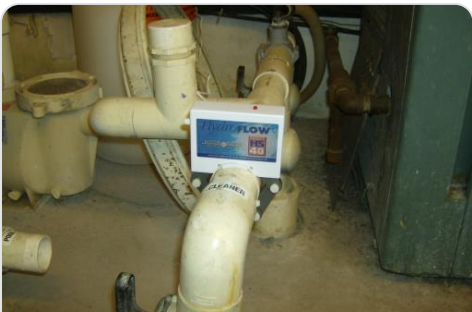
### INSTALLATION

HS40 unit on water line

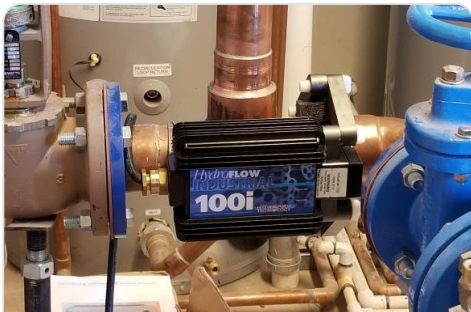
### INSTALLATION

i100 unit on pipework

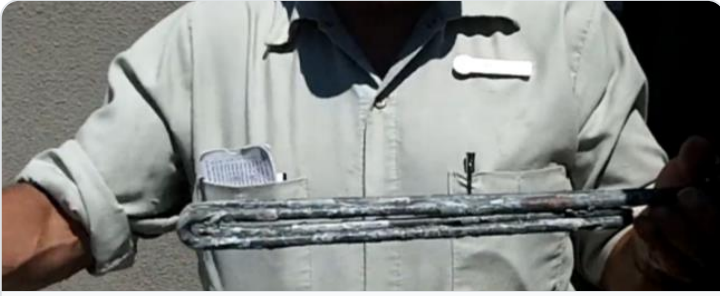
### AFTER

Reduced scale buildup on heating element after 4 months

Scale reduction observed on heating elements after trial.

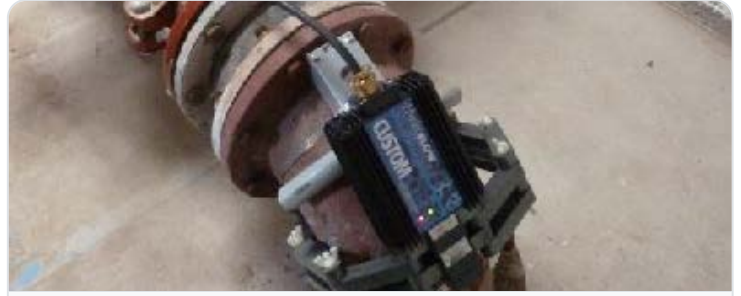
### INSTALLATION

HydroFLOW® installed as part of wider rollout across resort
