## Food Packaging Line Case Study **Puglia, Italy**

HydroFLOW® improved a glass-jar washing line, eliminating dried mineral marks and nozzle slime while significantly reducing chemical dosing.

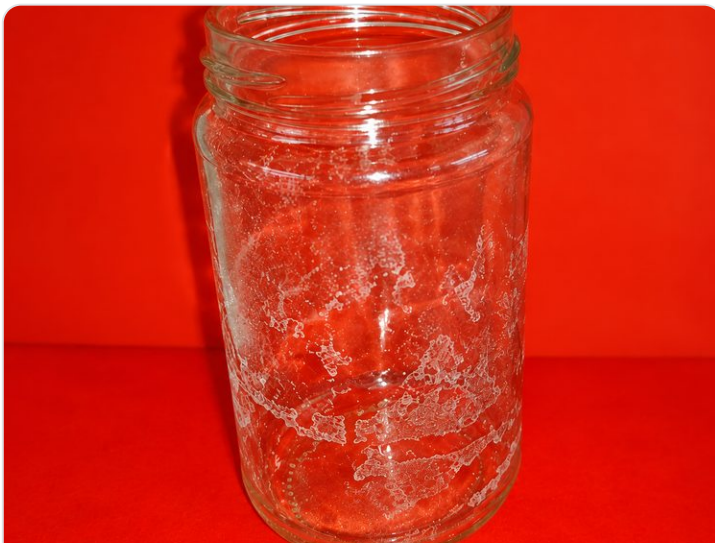
- White mineral marks after jar drying
- Slime clogged spray nozzles
- Dispersant and surfactant dosing required

**BEFORE***Jar without HydroFLOW®*

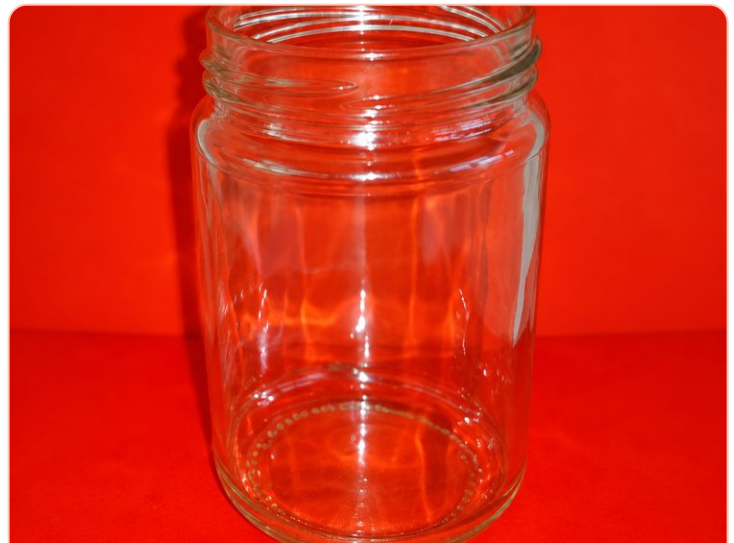
- ✓ No jar deposits after seven days
- ✓ No nozzle slime after 60 days
- ✓ Dispersant stopped; surfactant cut 80%

**AFTER***Jar with HydroFLOW®*

No mineral deposits were reported on dried jars after seven days.
